Address : Vicki Silva  
1511 Vine St. Paso Robles, CA 93446

## Arborist Report for Tree Removal

This arborist report is for one Valley Oak ( *Quercus lobata* ) tree being requested for removal. The tree is located at 1511 Vine Street in Paso Robles in the back yard on the corner of the house. The tree is marked with a pink flagging ribbon for easy identification.

## Tree #170 -

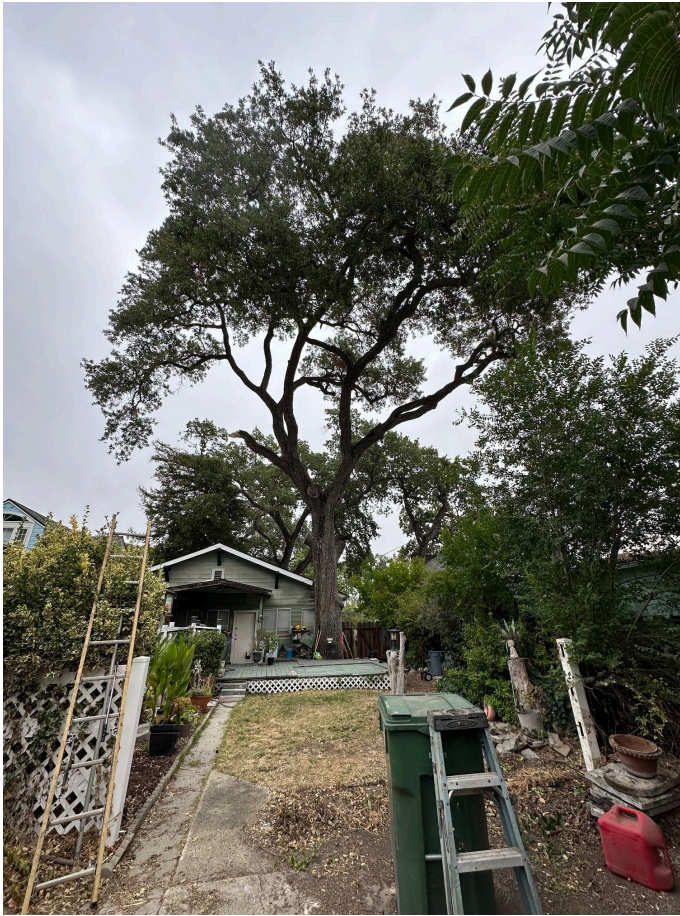
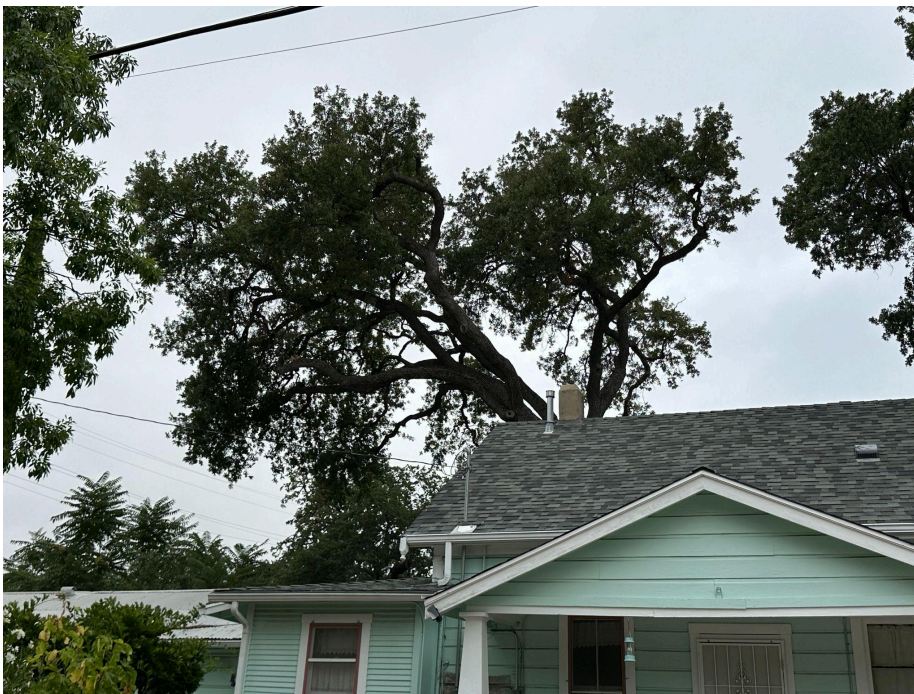
house and the other 1/3 being the yard, a board fence and neighboring property. The crown is large in size and sparse looking. The crown is unbalanced by about 20%. There is a dead spar along with one broken hanger in the canopy. The tree recently lost a large limb, breaking where a small cavity was and rot / decay was present. This cavity was most likely a wood pecker hole that decayed over time. There are multiple wood pecker holes and small cavities throughout the canopy on branches. When comparing the leaf color to nearby Valley Oaks, the color is less vibrant and density is sparse when compared to other Valley Oaks nearby. There are some branches that are codominants with included bark. When inspecting the canopy, a bee hive was also discovered. Bees will use hollowed out and decayed areas in limbs to create their hives.

↑ both images above show where the bee hive is located.

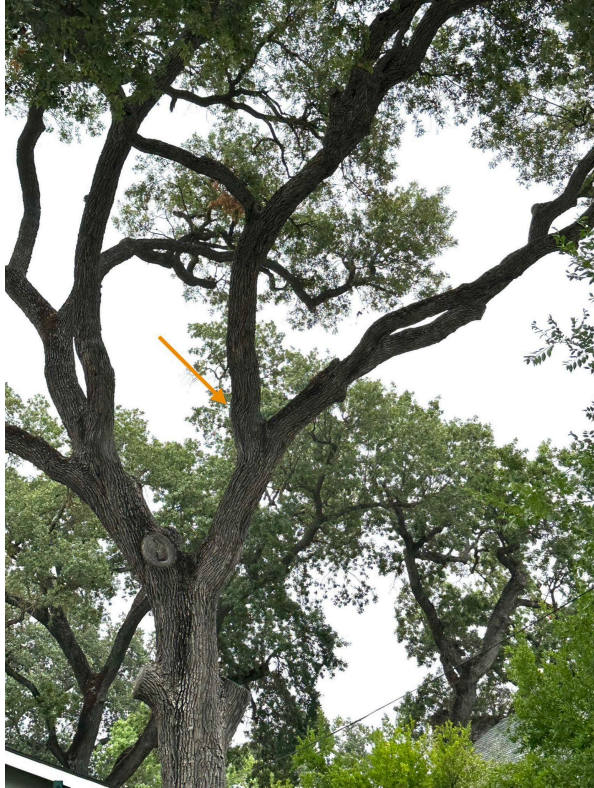
← Orange arrow shows a codominant branch

union with included bark

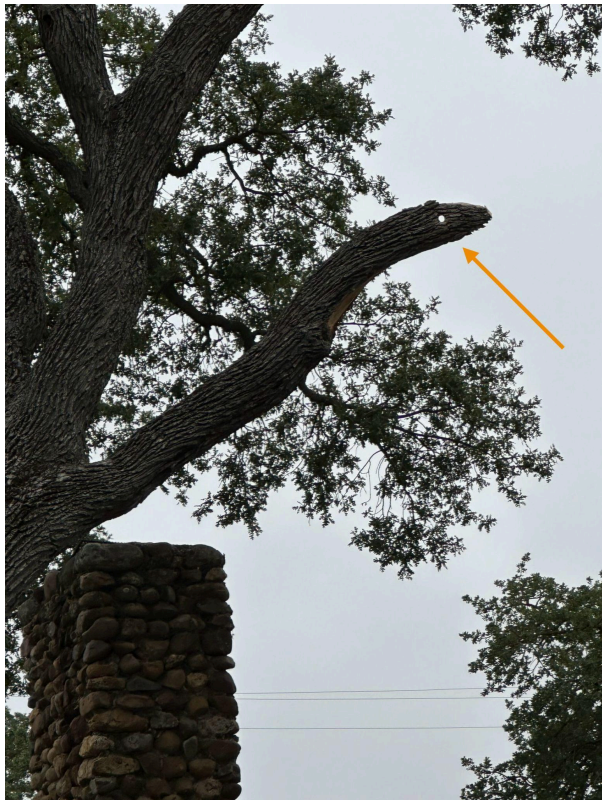
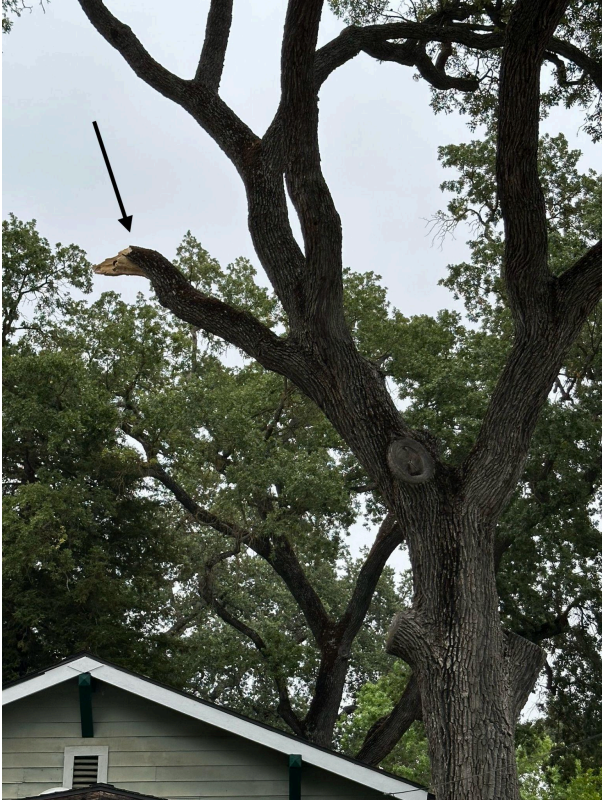
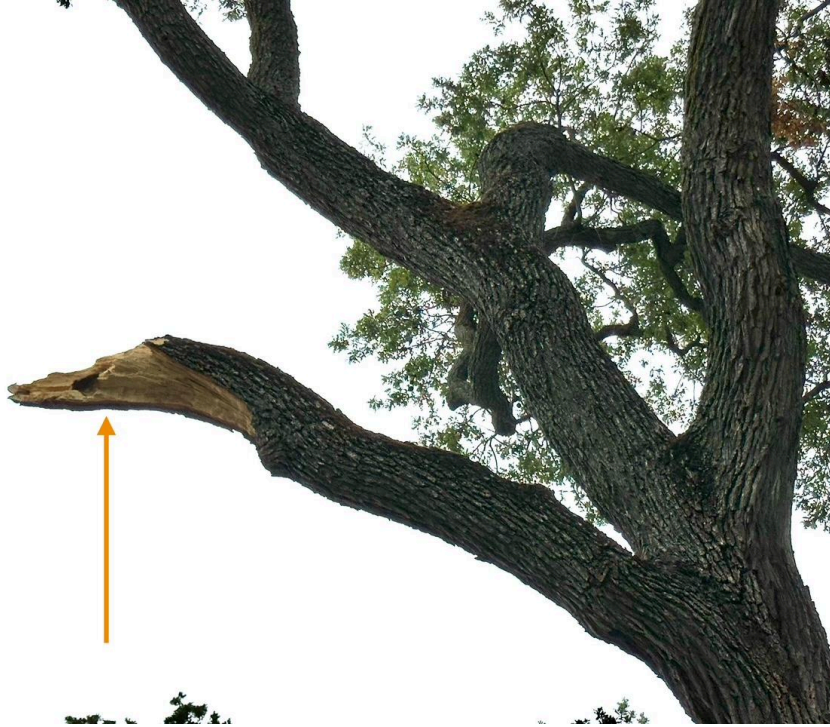
Previous Pruning / Failure History : Was not able to get the last information on when the tree was last trimmed, however the tree did recently lose a large limb. While on site, I reached out to the neighbor on the corner, who also stated that a large limb from this tree failed and broke onto her house. The exact date was not given for this limb failure.

Due to the amount of cavities, and past limb failures being at these cavities ( wood pecker holes ), there is concern that these cavities are rotted and decayed leaving the limbs compromised.

Above images show the recent limb failure. A small cavity created by a woodpecker developed rot, creating a weak spot in the limb. This limb failed and broke due to the integrity of the limb being compromised from the cavity and rot.

Preservation : While preservation is always our goal, trimming would be the recommended preservation technique to reduce weight on the limbs. Due to the sparse canopy and the size, trimming more than 25% of the live canopy would be the only feasible way to actually reduce the risk and weight in the canopy. This is not advisable and is not healthy for the tree to remove more than 25% of the canopy. It is not recommended to trim this tree any further as it would be unhealthy to remove any more live canopy.

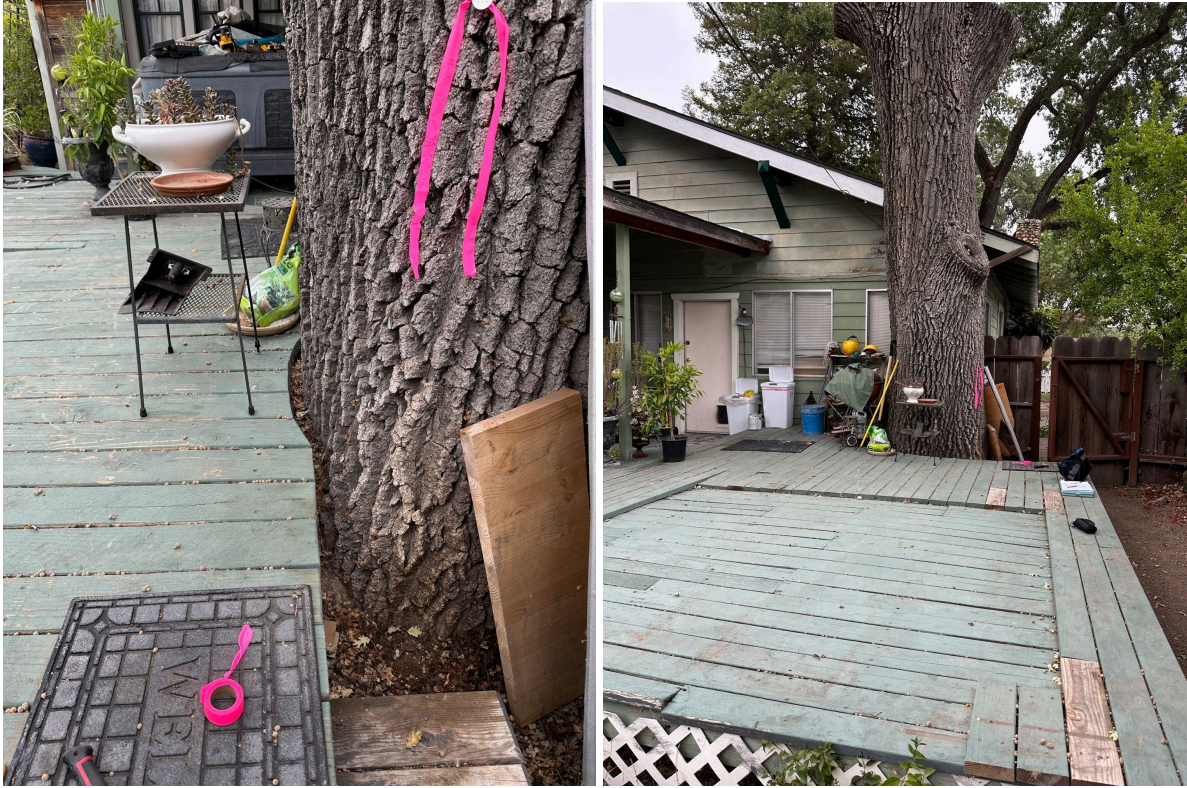
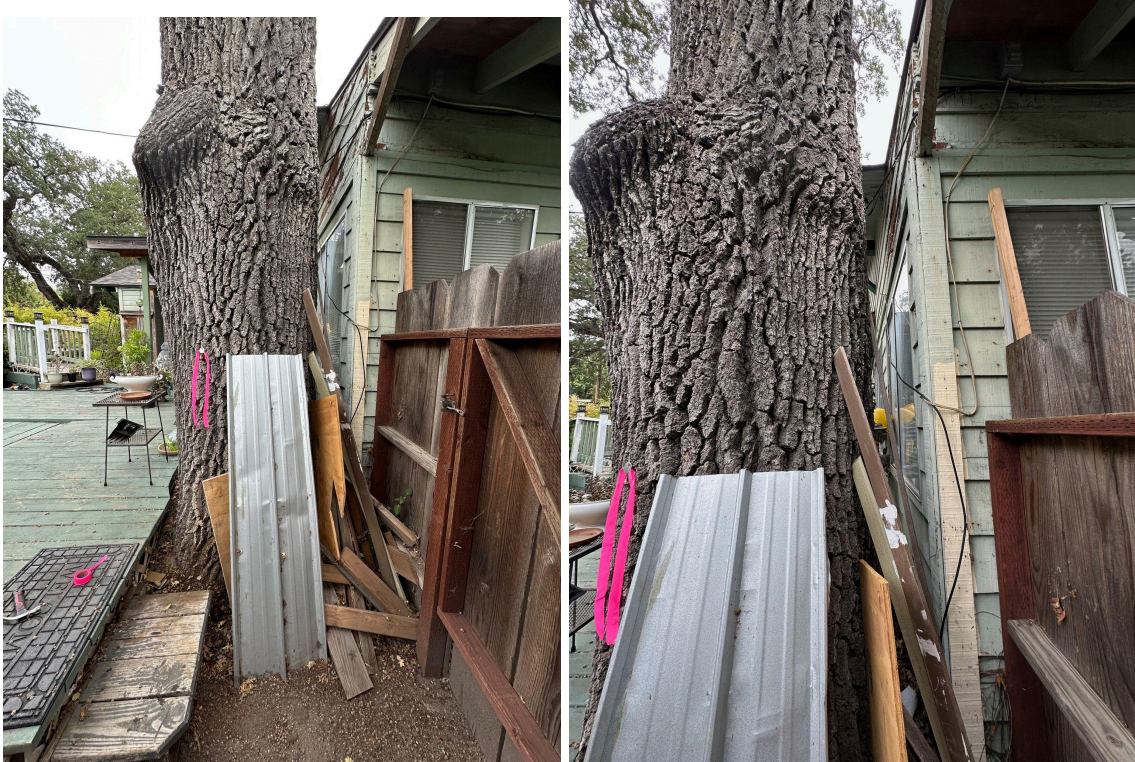
This tree is rated poor based on a visual inspection on July 22, 2025. The vigor of the tree is low. The tree is located on flat topography. This tree's location is in the back yard right as you enter the gate. The house and deck are placed directly next to the trunk. The soil around the critical root zone is compacted. There is a deck covering about  $\frac{1}{3}$  of the CRZ, about  $\frac{1}{3}$  covered by the

Above pictures on this page show how close the house and deck are to the trunk of the tree.

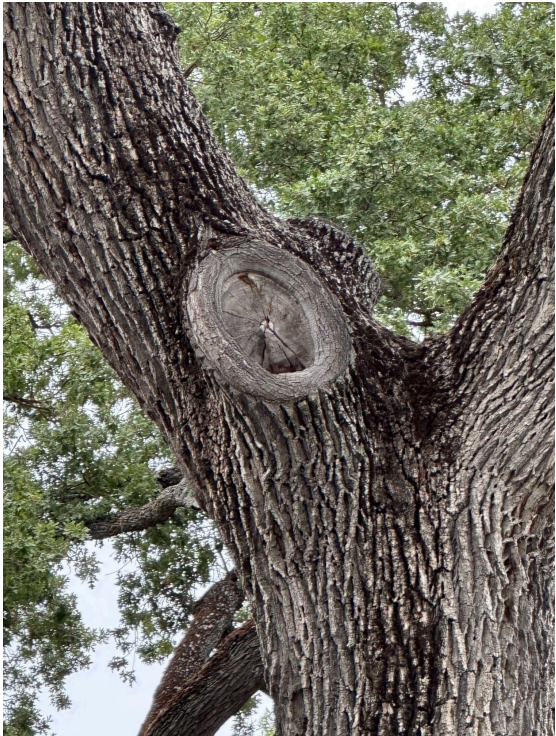
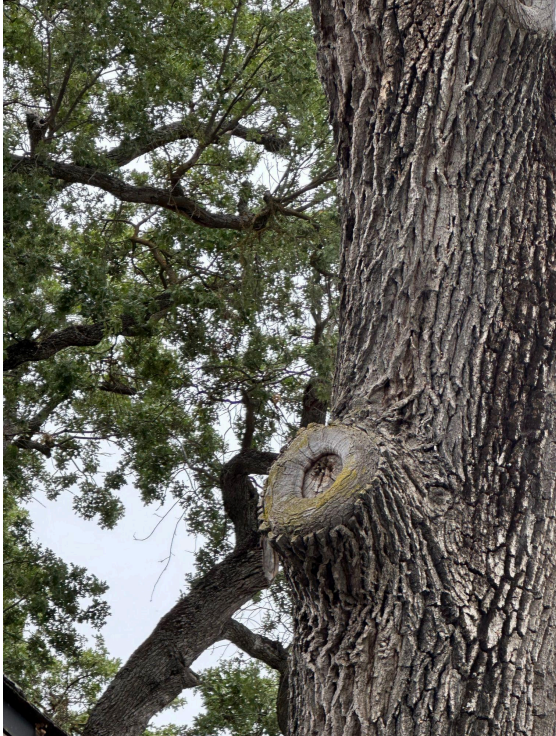
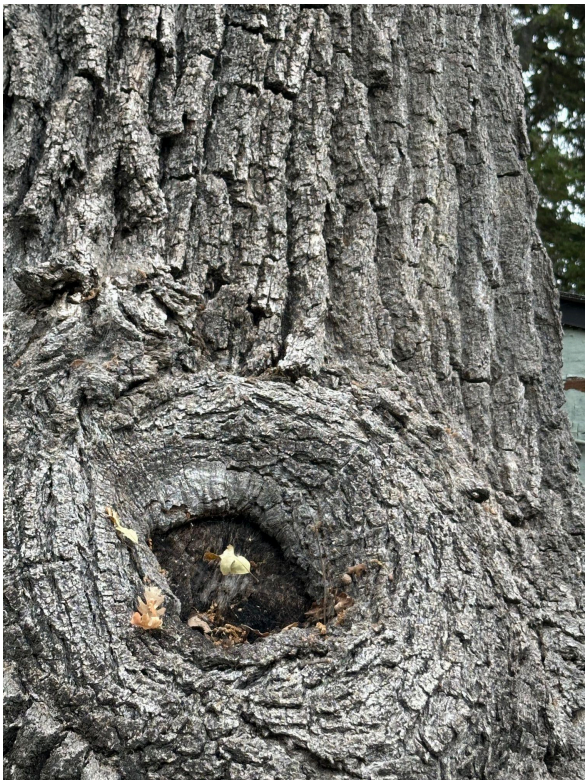
Images on this page are of old limbs that were removed and the wounds that are rotten. Showing signs of decay in the old wounds.

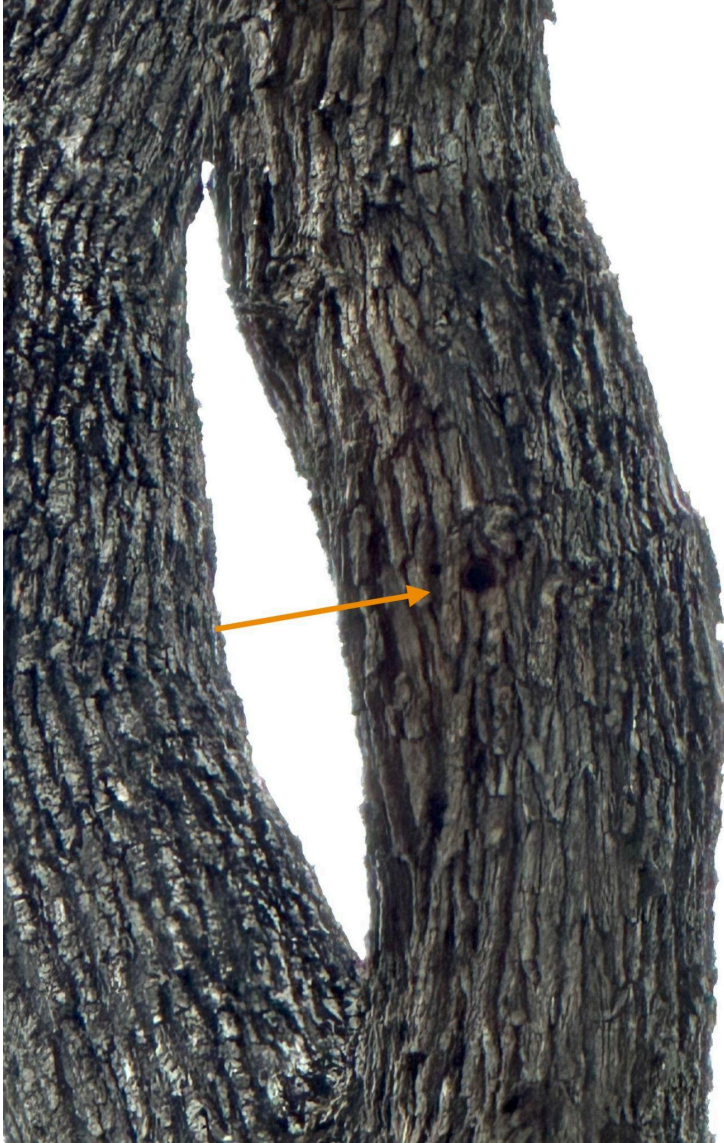
↑ This image shows another small cavity most likely created by a wood pecker. This cavity is similar to the cavity that was present on the limb that recently failed.

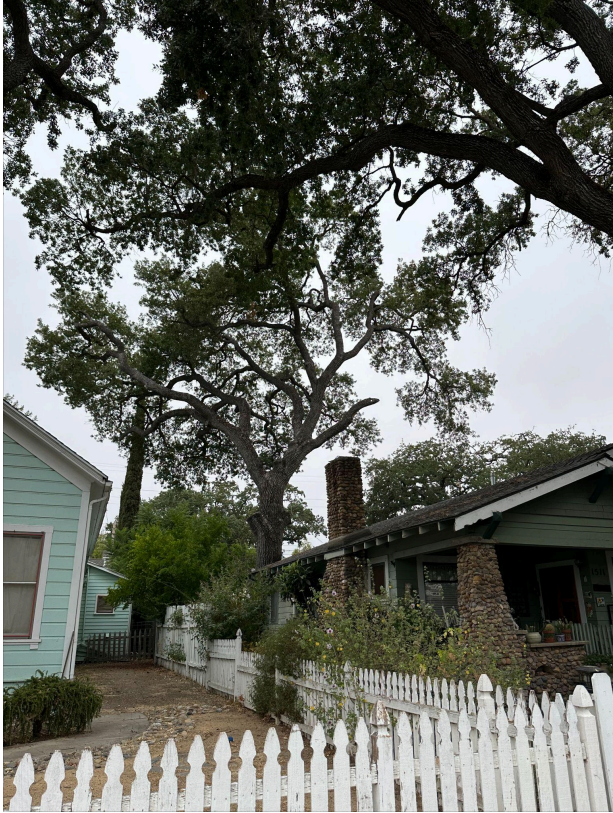
The sparse canopy shown
