## Oak Tree Impact Report

**Project Location:** 420 Creston Road, Paso Robles,

**Re:** Oak Tree Impact Report in regard to proposed residential development at 420 Creston Road.

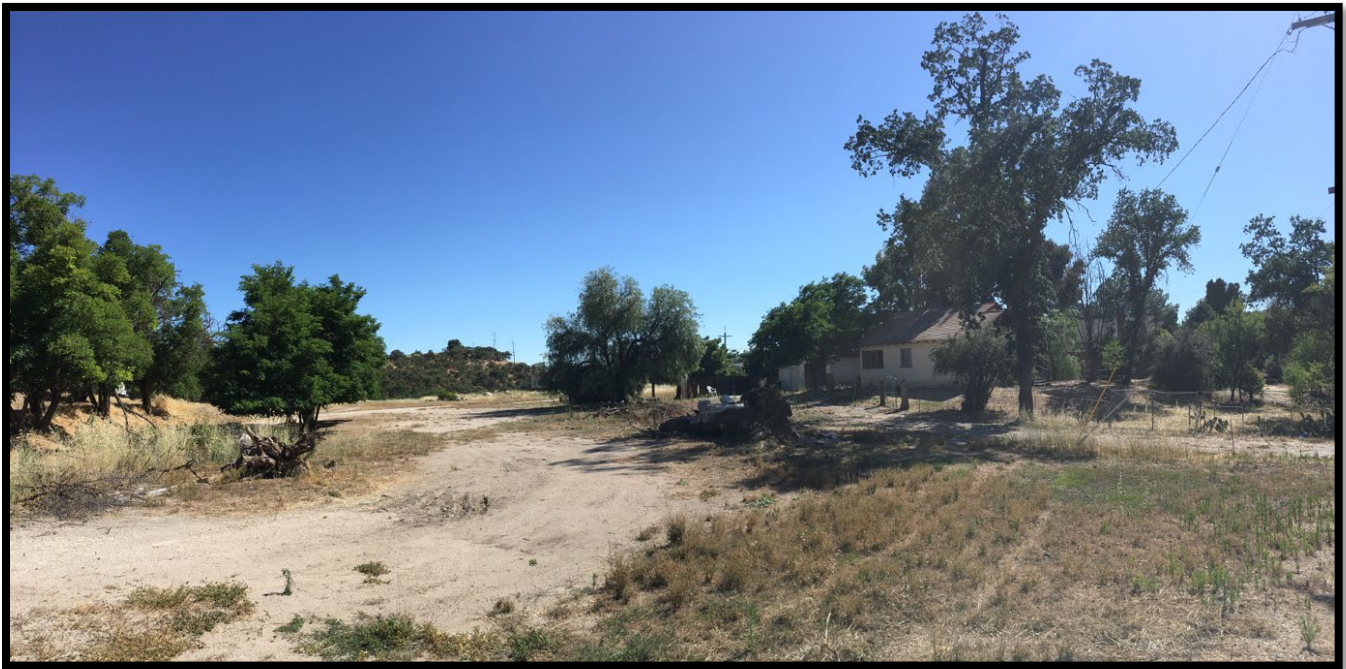
The property is located on the south side of Creston Road between Capitol Hill Drive and Ferro Lane. You have proposed to build multiple residences on this site. Associated paved access roads and parking areas are also proposed. The terrain is relatively flat on the northern half of the property. The southern half of the property slopes off significantly to a seasonal drainage below. See Appendix A – Photographs - Photo 1.

**Photo 1** - Panorama view looking south into lot from Creston Road.

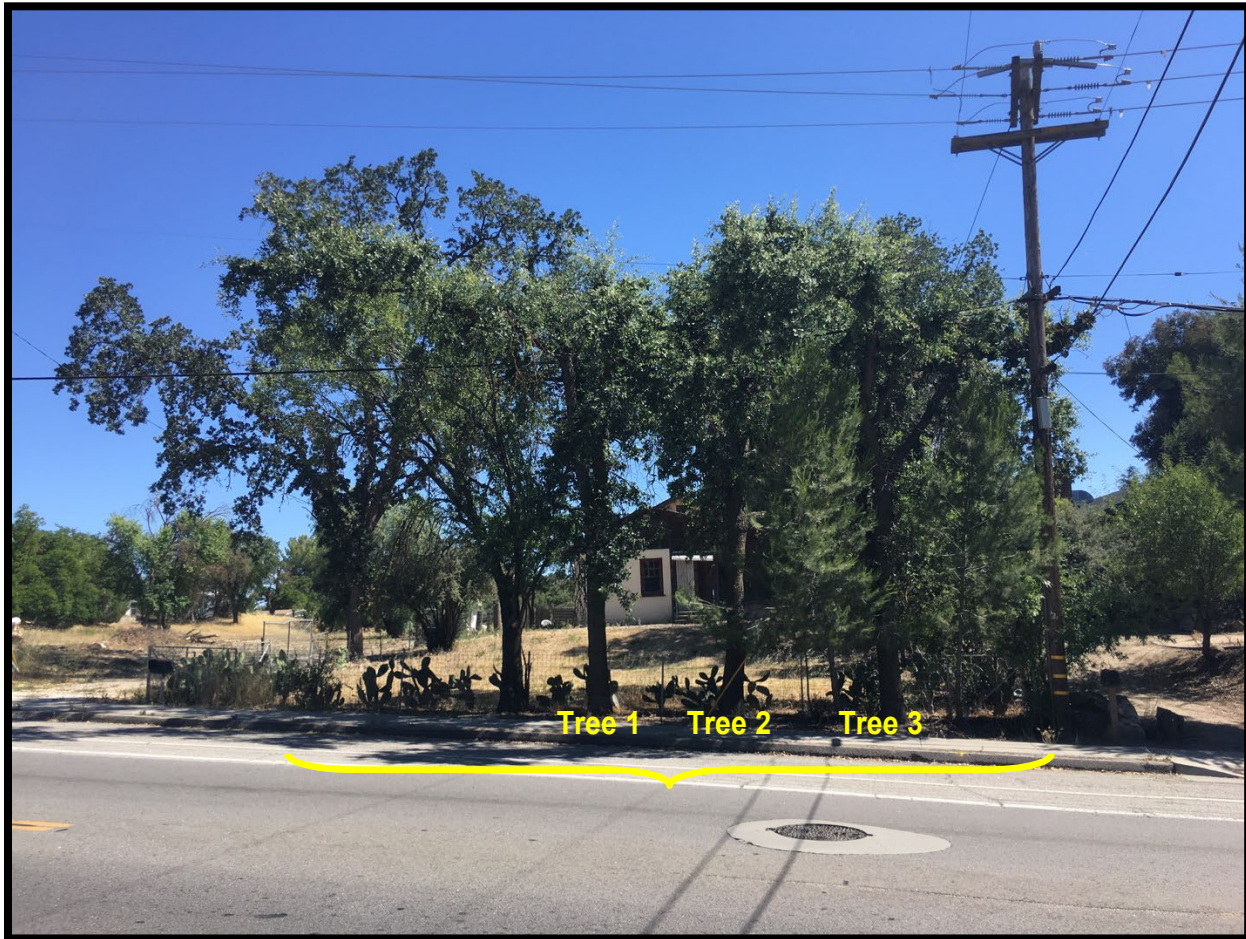
**Trees 1-3** were given a condition rating of fair. All of the trees had been utility pruned for power line clearance. Although not specimen trees, they were viable. See Appendix A - Photographs - Photo 2

**Trees 1-3** were in fair condition and located next to the existing sidewalk at Creston Road. The entrance into the development is planned for this area. The impacts from the entry construction will be 100%. Based on current plans, I do not recommend these trees for retention.

**Photo 2** - View of Trees 1-3 along Creston Road. New driveway entry planned for area.

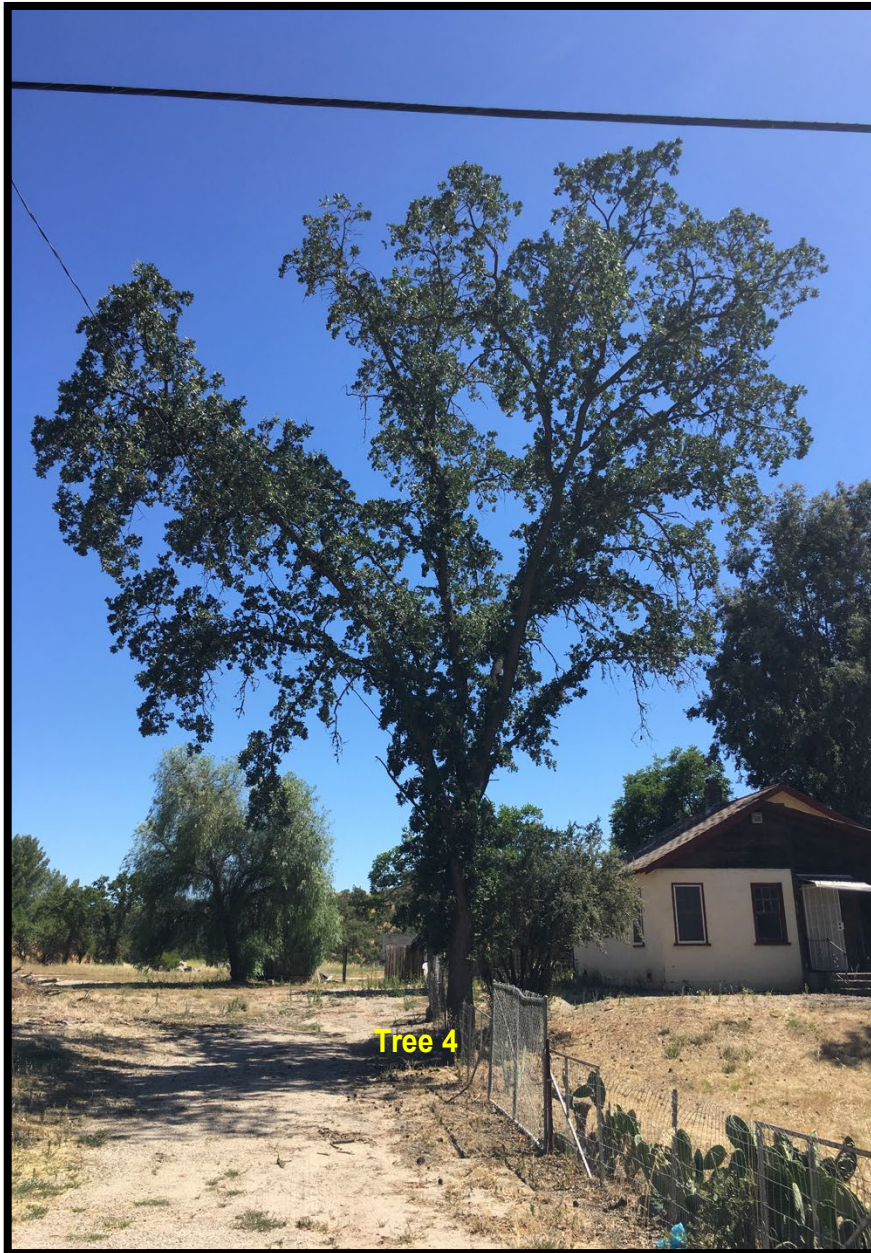
**Tree 4** was given a condition rating of poor. It was growing along the west edge of the western driveway that enters the property. The tree had grown into the wire fence and the wire was causing damage to the trunk and compromising its structure. Additionally, the tree was moderately drought stressed and had heavy soil compaction from driveway use in its *\*critical root zone or CRZ*. No damage to the structural roots was apparent. The main issue contributing to the low rating was the wire fence embedded into the trunk. The embedded wire had compromised the wood structure and was also an entry point for decay. Long term, the stem will become more unstable and prone to failure. See Appendix A - Photographs - Photos 3 & 4.

**Tree 4** had severely declined due to drought. Although it was a larger tree, because of the damage to the trunk caused by the embedded fence, its structure had been compromised which makes it more prone to whole stem failure. Additionally, a building and parking area are proposed in this location. I do not recommend this tree for retention.

Photo 3 - View south of Tree 4 from Creston Road.

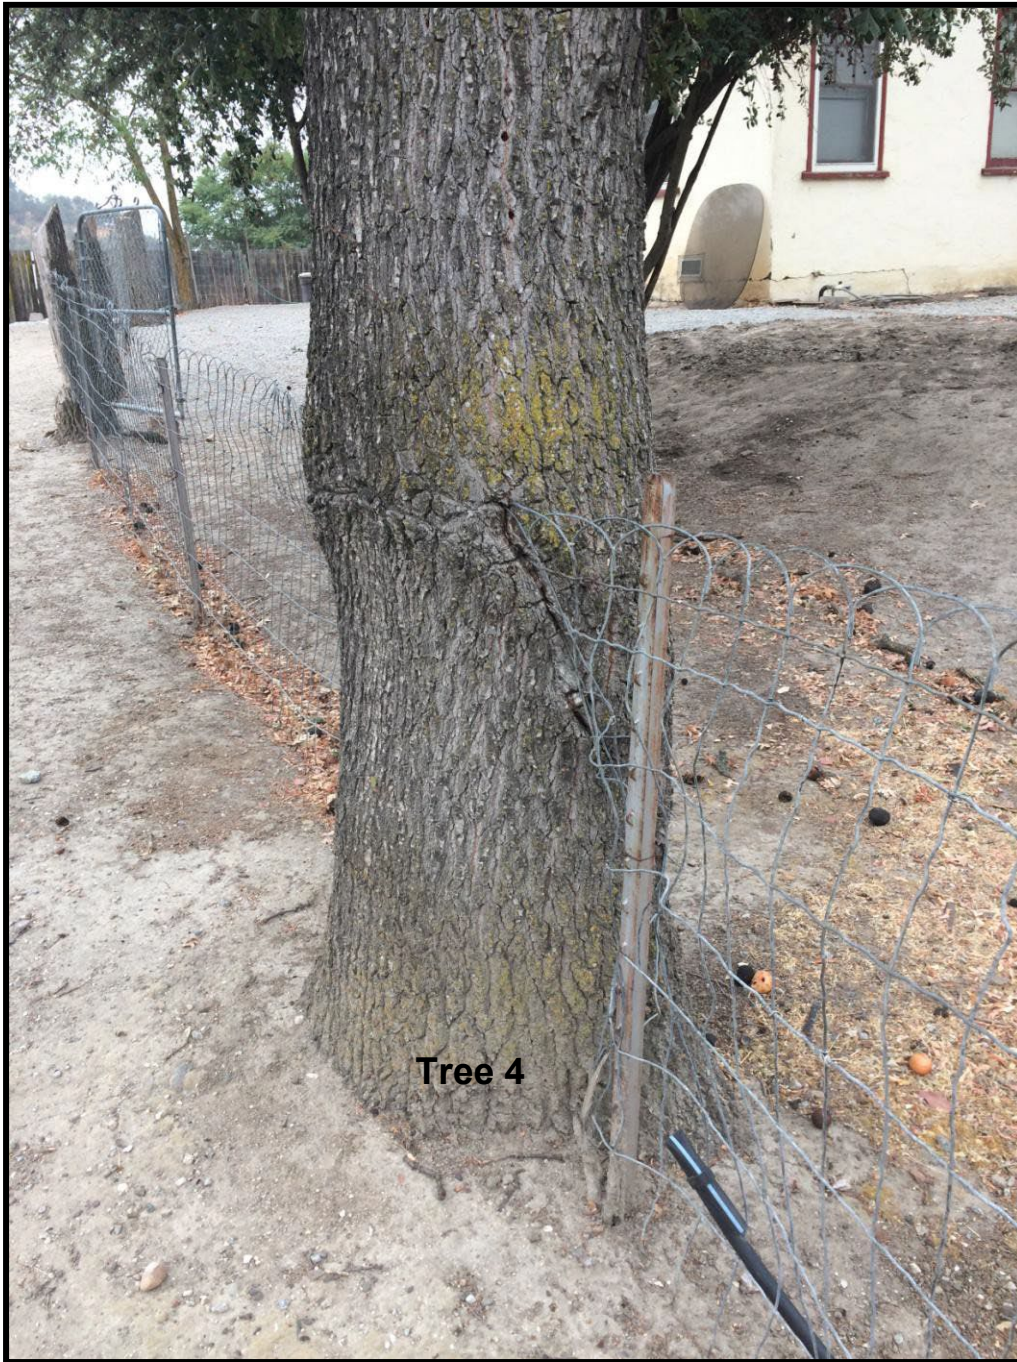
**Photo 4** - View south of Tree 4 trunk growing into fence. Trunk is not structurally sound.

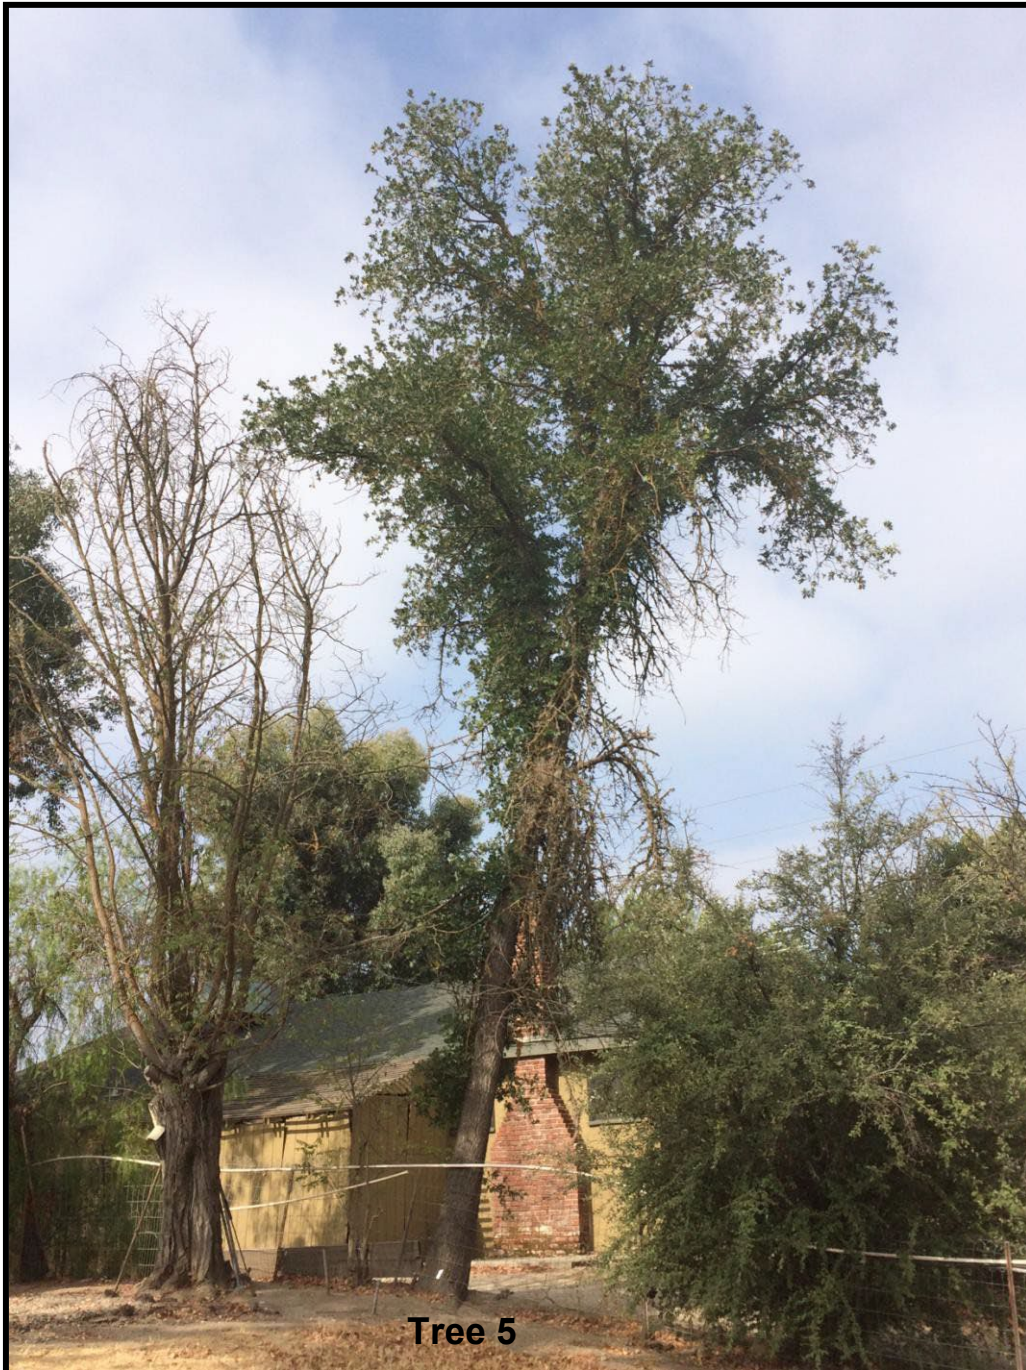
**Tree 5** was given a condition rating of poor. The tree was growing on western property line, approximately 50 yards south of the street. It had severe drought stress which was indicated by twig die-back in the *\*canopy* and decline of small diameter branches. See Appendix A - Photographs - Photo 5.

**Tree 5** had also declined due to drought. Because of its poor vigor I anticipate it will decline further. Additionally, construction impacts from grading and paving the parking area will severely impact the roots of the tree and contribute further to its decline. Grading may also cause the tree to become unstable. If this tree were of higher quality, I would recommend creating a tree island to protect and retain it. In its current condition, I don't anticipate it being long lived, therefore I do not recommend retention. ***This tree is located on the property line and you must gain permission from the adjacent owner before it can be approved for removal by the city.***

**Photo 5** - View southwest of Tree 5 - Note drought stress indicated by dead branches and sparse canopy. Tree is outside property line.

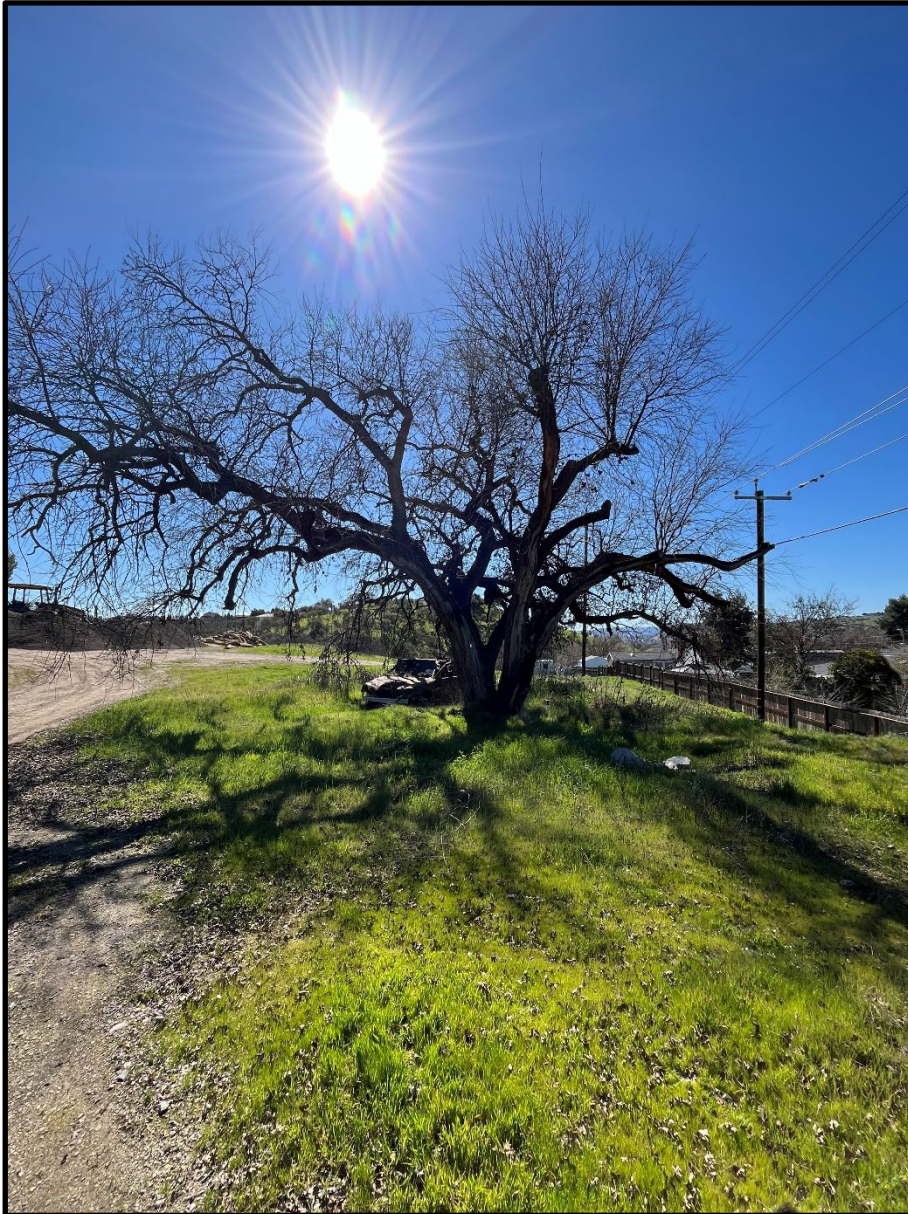
**Tree 6** was given a condition rating of very poor. Fire had damaged 3 of 4 stems and they were severely burned on the north side. The scaffold branch growing off the south stem was completely burned with no signs of life. The remaining viable canopy was approximately 50%. Decay was present in 3 of 4 burned stems. Large stems of the tree were likely to fail due to decay. The tree will present risk to people and property post development if it is retained. See Appendix A - Photographs - Photos 6 & 7.

**Tree 6** suffered significant damage during a 2020 fire. Its structure and health has been compromised. It is not safe to retain this tree in a housing development. Current plans indicate a building is planned for this location. I do not recommend this tree for retention.

**Photo 6** - View south of tree 6 – A mature valley oak that was badly burned in a June 2020 fire. The tree is alive but in very poor condition. It is not safe to retain in a housing project.

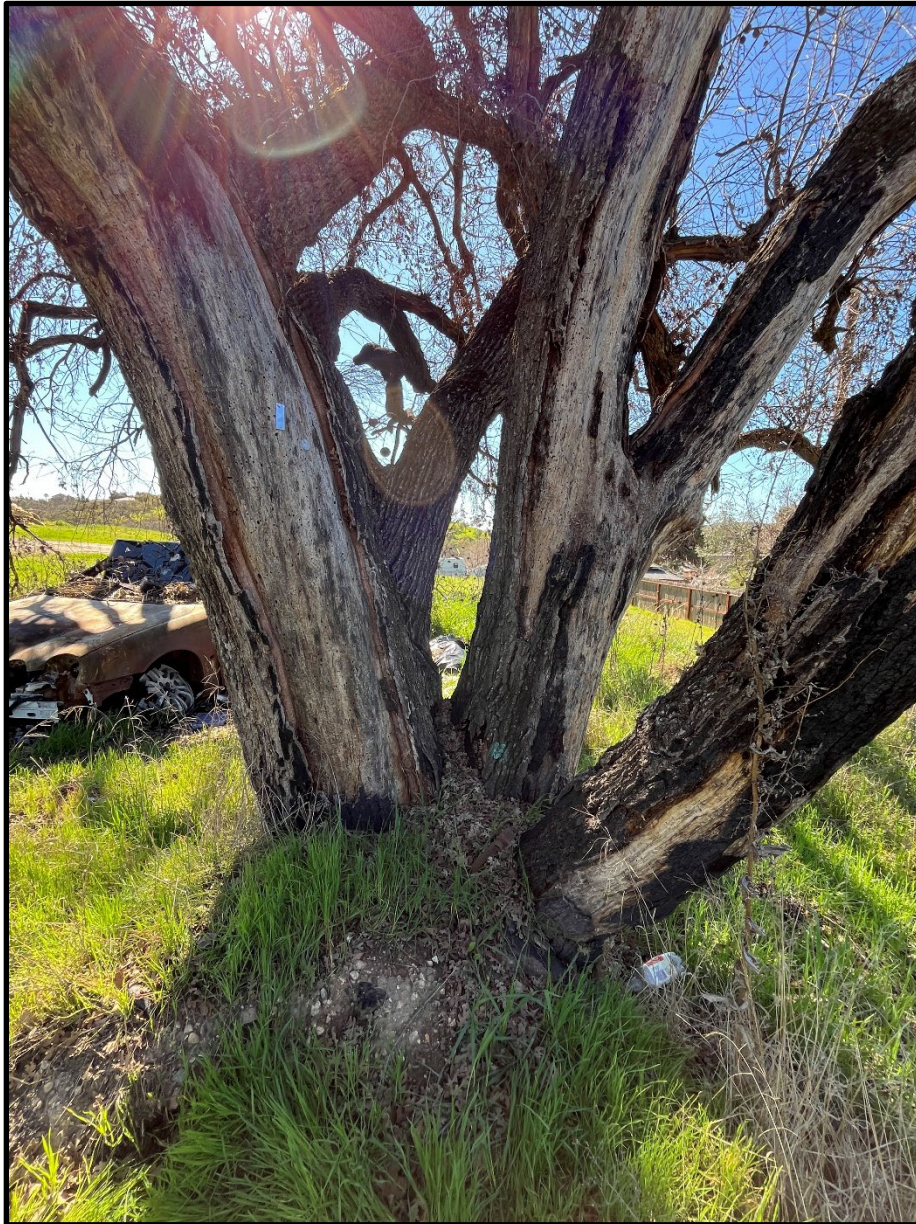
**Photo 7** - View of Tree 6 trunk on north side – 4 of 4 primary stems were badly burned and starting to decay. The tree is not safe to retain in a housing project.

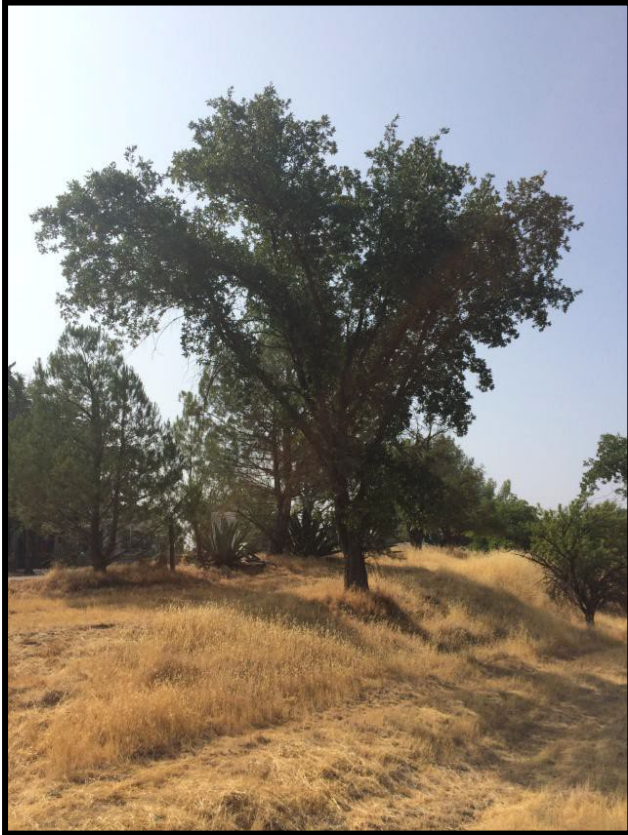
**Photo 8** - View south of Tree 7

**Tree 7** was given a condition rating of poor. The tree was located along the eastern property line at the mid-point of the parcel. It had moderate drought stress which was indicated by twig die-back in the canopy. This tree also had a multi-stem trunk with *\*included bark* that will make it more prone to failure in the future. See Appendix A - Photographs - Photos 8 & 9.

**Tree 7** was in poor condition overall. In regard to health the tree rated as fair, however the tree was a two-stem with included bark which makes it prone to failure and lowered its rating for structure. Additionally, the tree is located within the footprint of a proposed building. If this tree were of higher structural quality, I would recommend redesign to protect and retain it, but as it stands, I do not recommend retention of the tree based on its poor structure.

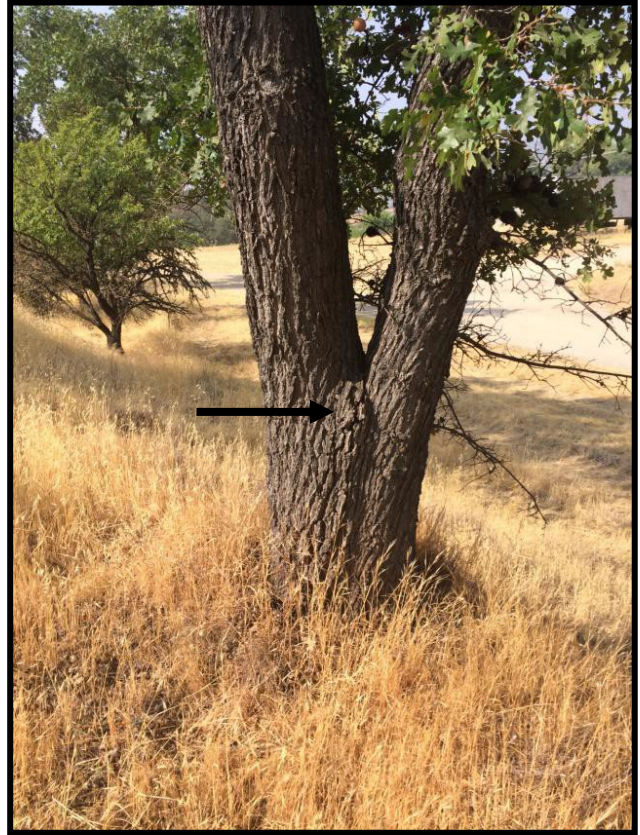
**Photo 9** - Tree 7 with included bark indicated by arrow.

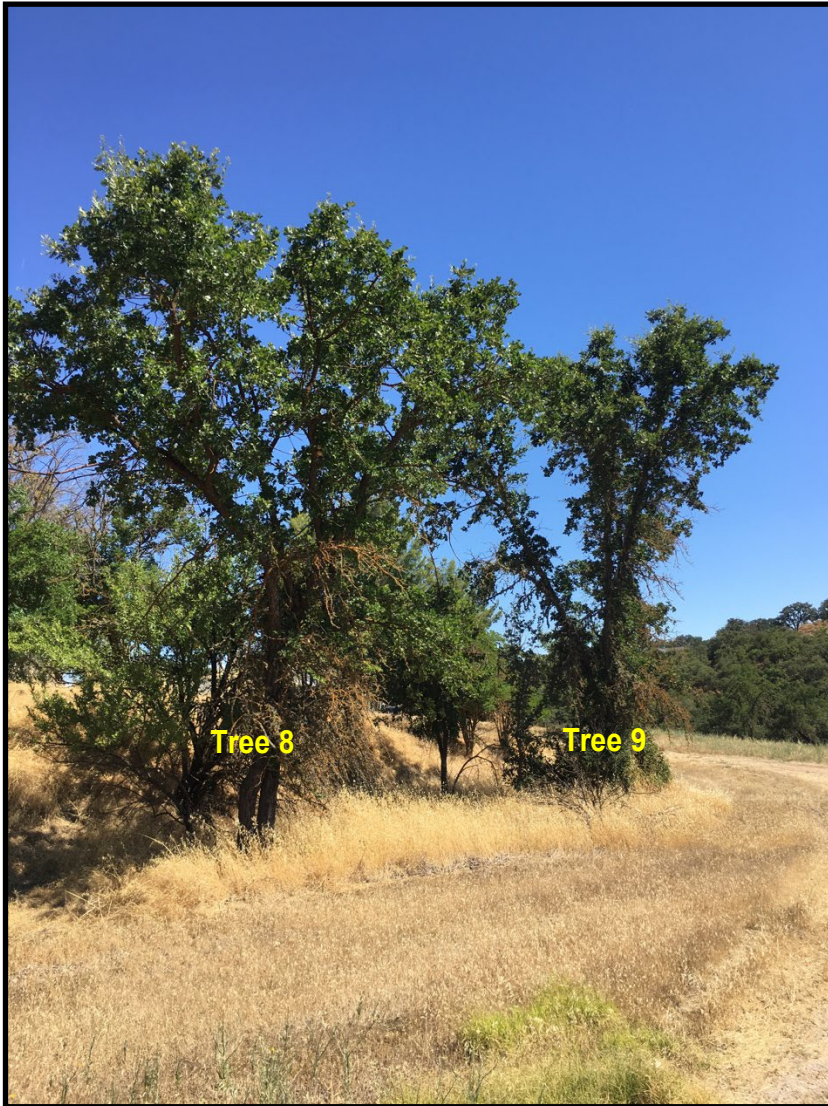
**Tree 8** was given a condition rating of poor. The tree was also located along the eastern property line at the mid-point of the parcel. It had moderate drought stress which was indicated by twig die-back in the canopy. This tree also had a multi-stem trunk with included bark that will make it more prone to failure in the future. See Appendix A – Photographs - Photos 10 & 11.

**Tree 9** was given a condition rating of very poor. The tree was also located along the eastern property line at the mid-point of the parcel. It had severe drought stress which was indicated by twig die back and decline of small diameter branches. This tree also had a multi-stem trunk with included bark that will make it more prone to failure in the future. See Appendix A – Photographs - Photos 10, 12 & 13.

**Trees 8 & 9** were rated poor and very poor. They had declining health from years of drought stress and their structures were compromised due to included bark between their co-dominant stems which makes them prone to failure. Additionally, the trees are located within the proposed footprint of a building. If these trees were of higher structural quality, I would recommend redesign to protect and retain them, but as it stands, I do not recommend retention based on their poor structure and low vigor.

**Photo 10** - View of Trees 8 & 9 - Note dead branches indicating drought stress.

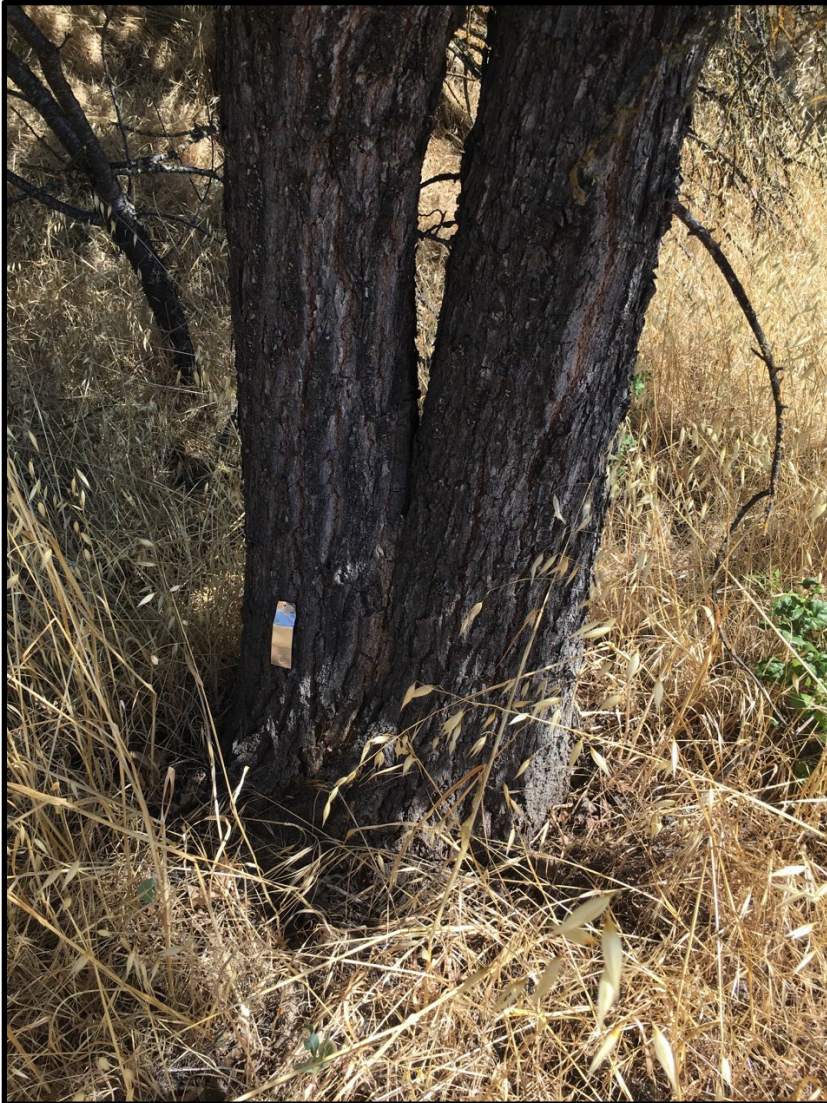
Photo 11 - Trunk of Tree 8 with included bark.

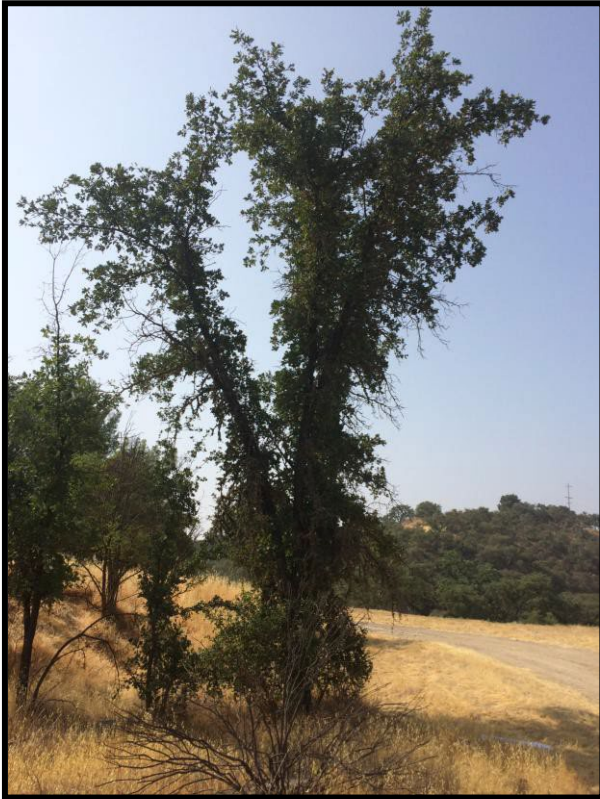
**Photo 12** - View of Tree 9 - Note drought stress indicated by dead branches and sparse canopy.

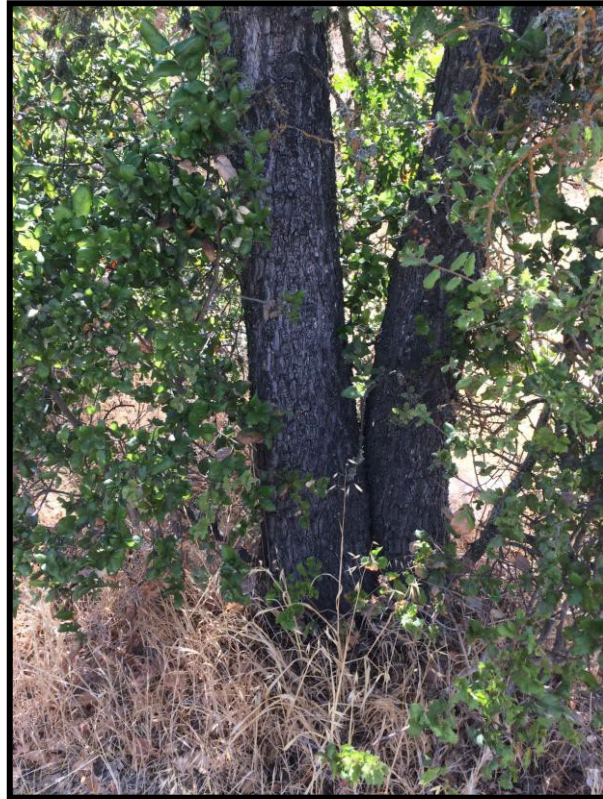
**Photo 13** - Trunk of Tree 9 with included bark .

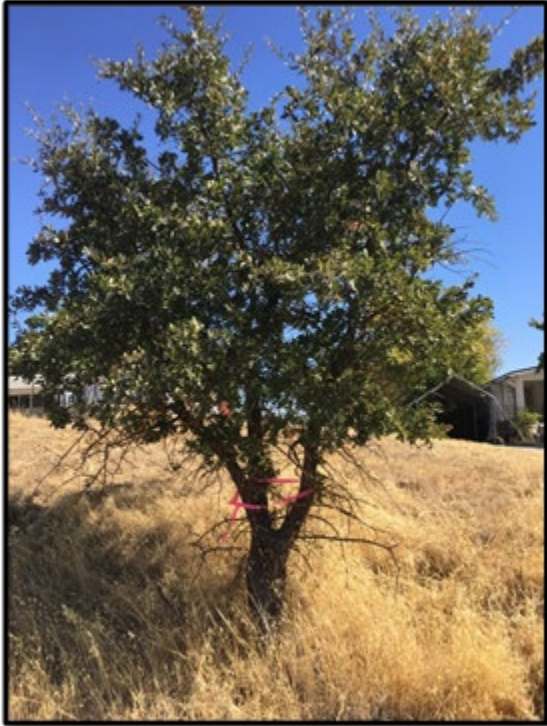
**Tree 10** was given a condition rating of very poor. The tree was also located along the eastern property line at the mid-point of the parcel. It had severe drought stress which was indicated by twig die back and decline of small diameter branches. This tree also had a multi-stem trunk with included bark that will make it more prone to failure in the future. See Appendix A – Photographs - Photos 14 & 15.

**Tree 10** was rated very poor. It had declining health due to drought and its structure was compromised due to included bark between its co-dominant stems. Included bark makes the tree prone to failure. Additionally, the tree is located within the proposed footprint of a building. If this tree were of higher structural quality, I would recommend redesign to protect and retain it, but as it stands, I do not recommend retention based on its poor structure and low vigor.

**Photo 14** - View of Tree 10 - Multi-stem tree with included bark.

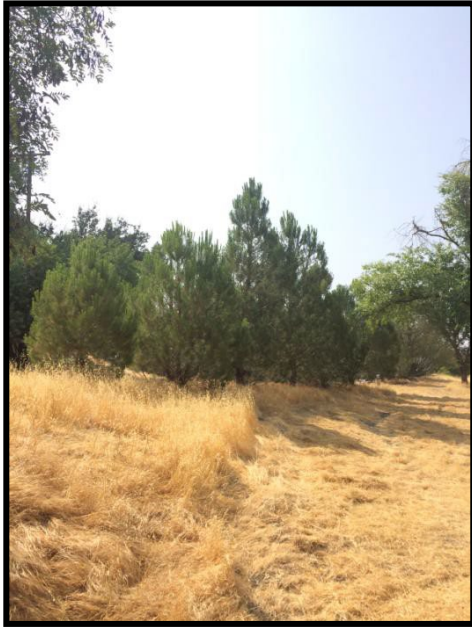
**Photo 16** - Pines

**Non-Native Trees** - There were approximately thirty-three (33) non-native trees on site which included: Aleppo pine (*Pinus halepensis*), Almond (*Prunus dulcis*), Siberian elm (*Ulmus pumila*), Ailanthus (*Ailanthus altissima*), black locust (*Robinia pseudoacacia*), and California pepper (*Schinus molle*). See Appendix A - Photographs- Photos 13 - 16 for examples. According to the City of Robles Paso tree ordinance, there is no restriction on removing non - native trees. For the most part, these trees occurred along the eastern border of the property. Many were drought stressed and in severe decline.

The pines along the eastern border were young and vigorous; however, their potential for red turpentine beetle (*Dendroctonus valens*) infestation is high. Aleppo pines also grow to 60 or more feet tall and are prone to large branch failure. Furthermore, pines are highly flammable. If left in place, the branches of these trees would encroach on buildings, pose failure, and fire hazards.

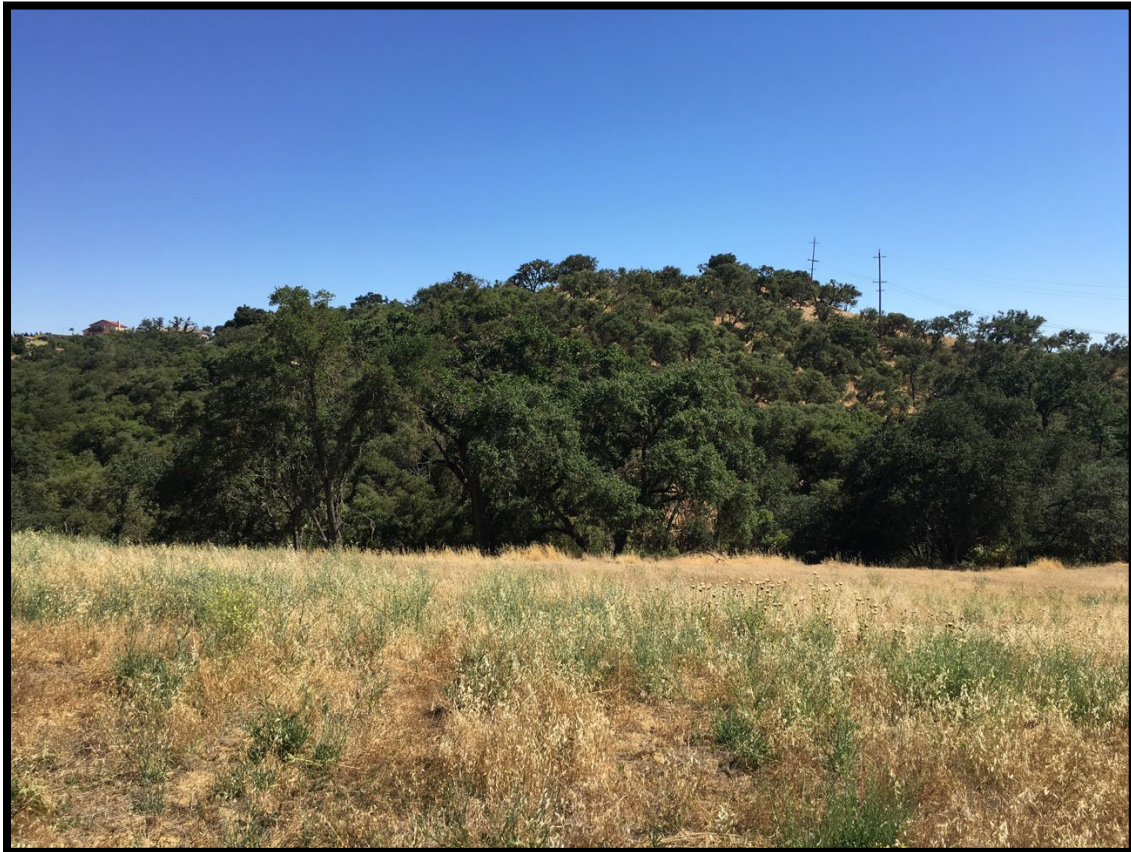
**Photo 20** - View of open-space above existing oak woodland at the south end of the parcel.

Because valley oaks have a large mature size and require unrestricted root-space, planting the trees in a grove in the open-space adjacent to the existing wooded area at the south end of the parcel would be ideal. See Appendix A – Photographs - Photo 20. The trees shall be planted 30 feet on center.
