721 28TH ST, PASO ROBLES,  
CA, 93446

Oak Tree Removal Permit/Arborist Report

## Arborist Report

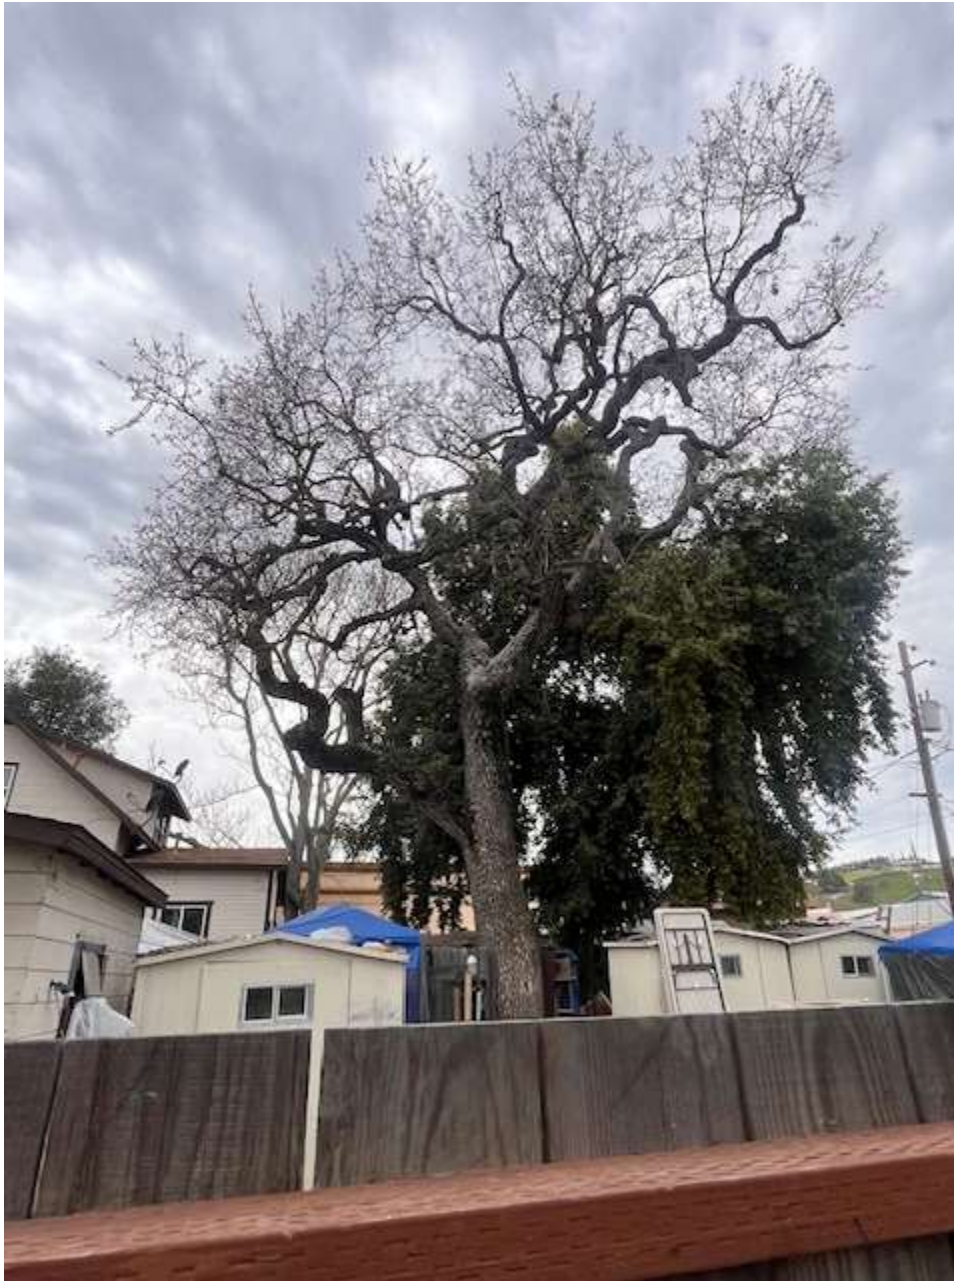
### EXHIBIT A- Subject Tree

This project involves the evaluation of a Valley Oak (*Quercus lobata*) to the rear of 721 28<sup>th</sup> St, Paso Robles, CA 93446. The subject tree shown in Exhibit A is a mature Valley Oak classified as a protected tree under the City of Paso Robles Oak Tree Preservation Ordinance (Title 10, Chapter 10.01). The subject tree has a diameter at breast height (DBH), measured at 4 feet 6 inches above grade, of approximately 38 inches, an estimated height of 42 feet, and a crown spread of approximately 33 feet.

Photograph showing the subject Valley Oak (*Quercus lobata*) located to the rear of 721 28<sup>th</sup> Street, Paso Robles. Image illustrates overall site context, adjacent residential structures, utility lines and asymmetric canopy.

It is the professional opinion of the undersigned arborist that removal of the subject Valley Oak is warranted and justified under the City of Paso Robles Oak Tree Preservation Ordinance (Title 10, Chapter 10.01) due to hazardous conditions and the tree's condition beyond correction.

Removal is recommended in the interest of public safety, protection of residential structures, and prevention of damage to utility infrastructure.

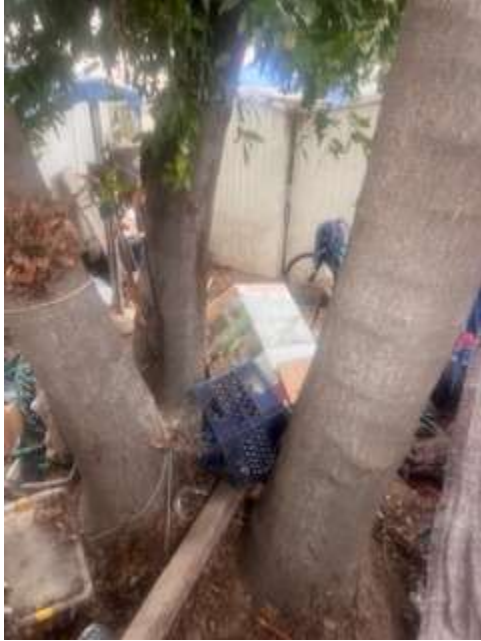
## EXHIBIT B- Critical Root Zone Constraints

The Critical Root Zone (CRZ) is an imaginary circular area around the tree trunk with a radius in feet equal to the tree's diameter in inches. The subject tree is located to the rear of a frequently occupied residence. The CRZ is constrained by a competing Bay Laurel (*Laurus nobilis*) standing approximately 8 feet from the subject Valley oak, identified in Exhibit B & C. The Bay Laurel is multi-stemmed, with a height of 33 feet and a DBH of approximately 34 inches and displaying vigorous canopy. This proximity creates chronic competition for soil moisture, nutrients, and rooting space. Canopy displacement and asymmetric loading is result of the competition from the Bay Laurel.

Close- range photograph of the multi-stem Bay Laurel (*Laurus nobilis*) trunk in close proximity to the Subject Tree.

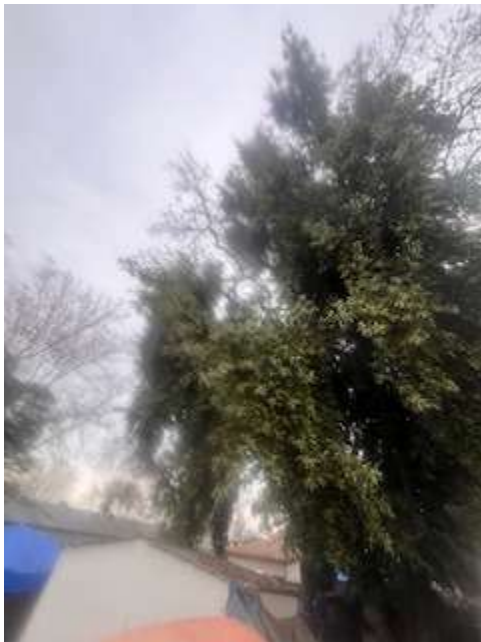
## EXHIBIT C- Critical Root Zone Constraints

The large canopy from the Bay Laurel (*Laurus nobilis*) is in competition with the Subject Tree.

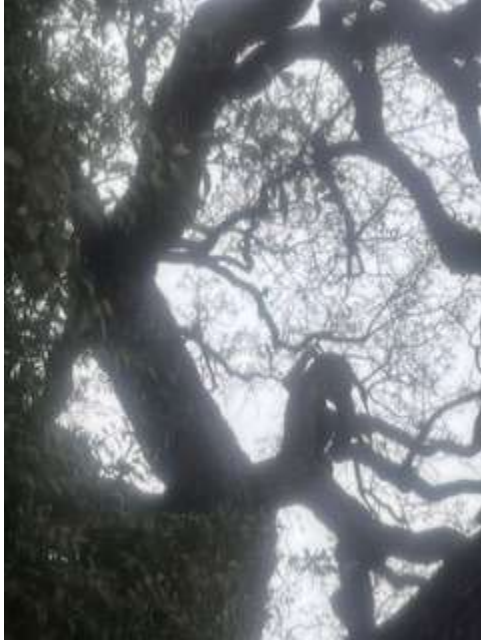
## EXHIBIT D- Tree Health

The tree contains multiple large scaffold limbs ranging from approximately 10 to 18 inches in diameter exhibiting poor attachment characteristics, Exhibit D. Poor attachment unions significantly increase the likelihood of limb failure, particularly during high wind or saturated soil conditions common during winter storm events.

In my professional opinion, the risk of large scaffold limb failure within 3 years and striking utility lines, structures or people, causing moderate consequences is severe.

Photograph shows the multiple large scaffold limbs.

While removal of large scaffold limbs and supplemental support systems were considered, such measures would not adequately mitigate risk without extensive canopy reduction (Greater than 25%) requiring removal of multiple limbs greater than 6 inches in diameter would further accelerate the decline in tree health and still leave residual risk due to the

target occupancy and utility lines. The only way to eliminate all risks is complete tree removal.

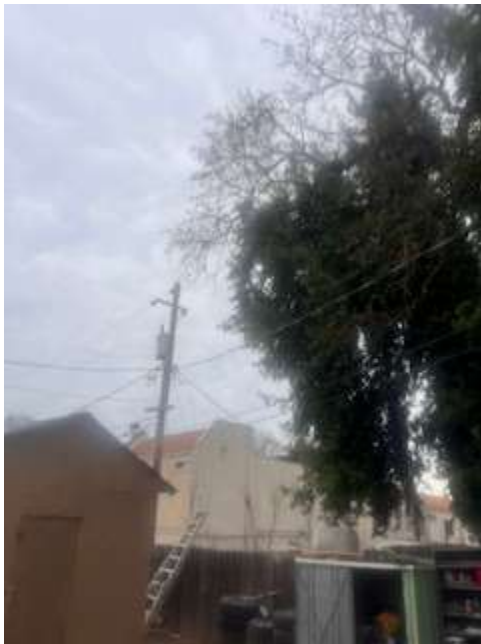
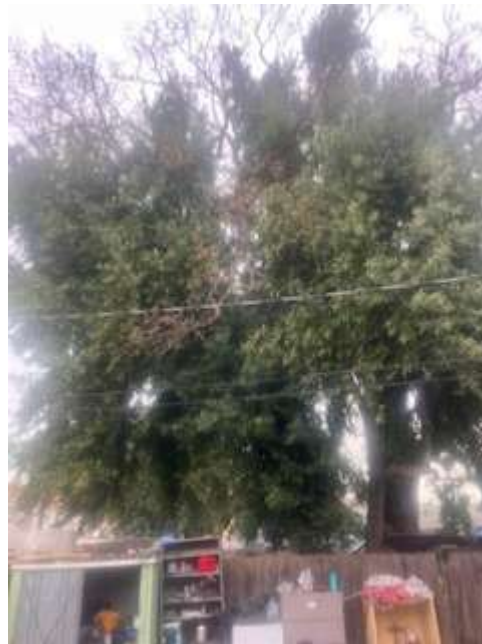
## EXHIBIT E- Communication and Power Utility Lines

Two residential dwelling units with frequent occupancy are located approximately 25 to 30 feet from the subject Valley Oak. In addition, overhead utility power and communication drop lines serving the residences and neighboring properties are located within the tree's fall zone, Exhibit E.

Photograph shows the proximity of the Subject Tree to the Utility Lines which are located well within the fall zone.
