Planning Entitlement Application P26-0014

Oak Tree Removal Application – OTR26-01

Address: 721 28th Street B, Paso Robles, California

Purpose- Notice of Incomplete Entitlement Application-P26-0014

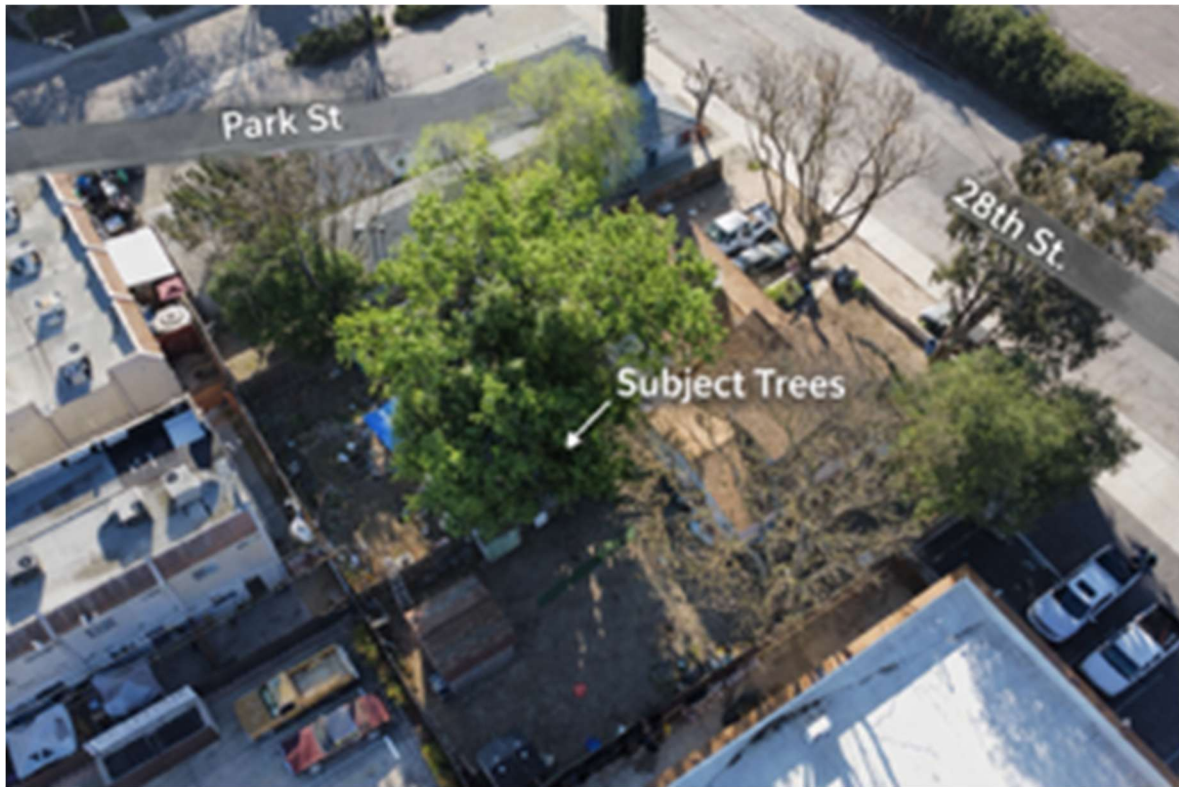
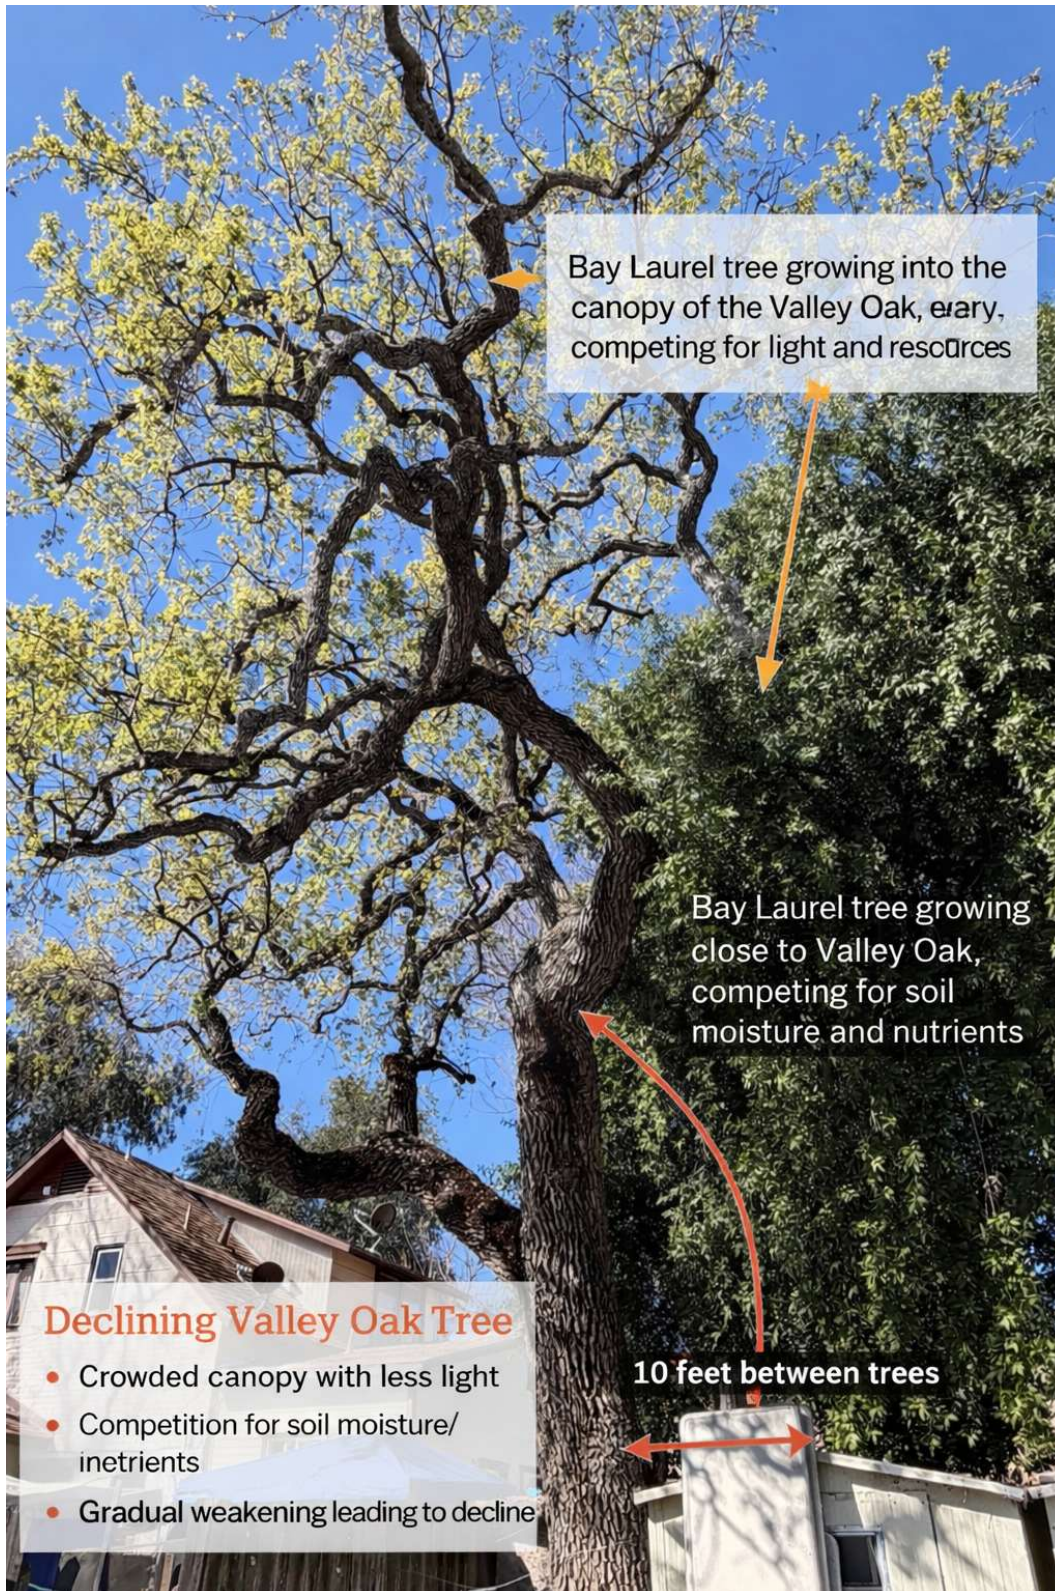
Exhibit A- General Site Plan And Other Vegetation Conflict

A site plan should identify the trunk location and canopy spread of both the Valley Oak and the adjacent Bay Laurel tree. The plan demonstrates canopy encroachment and root zone competition between the two trees. See attachment “A”

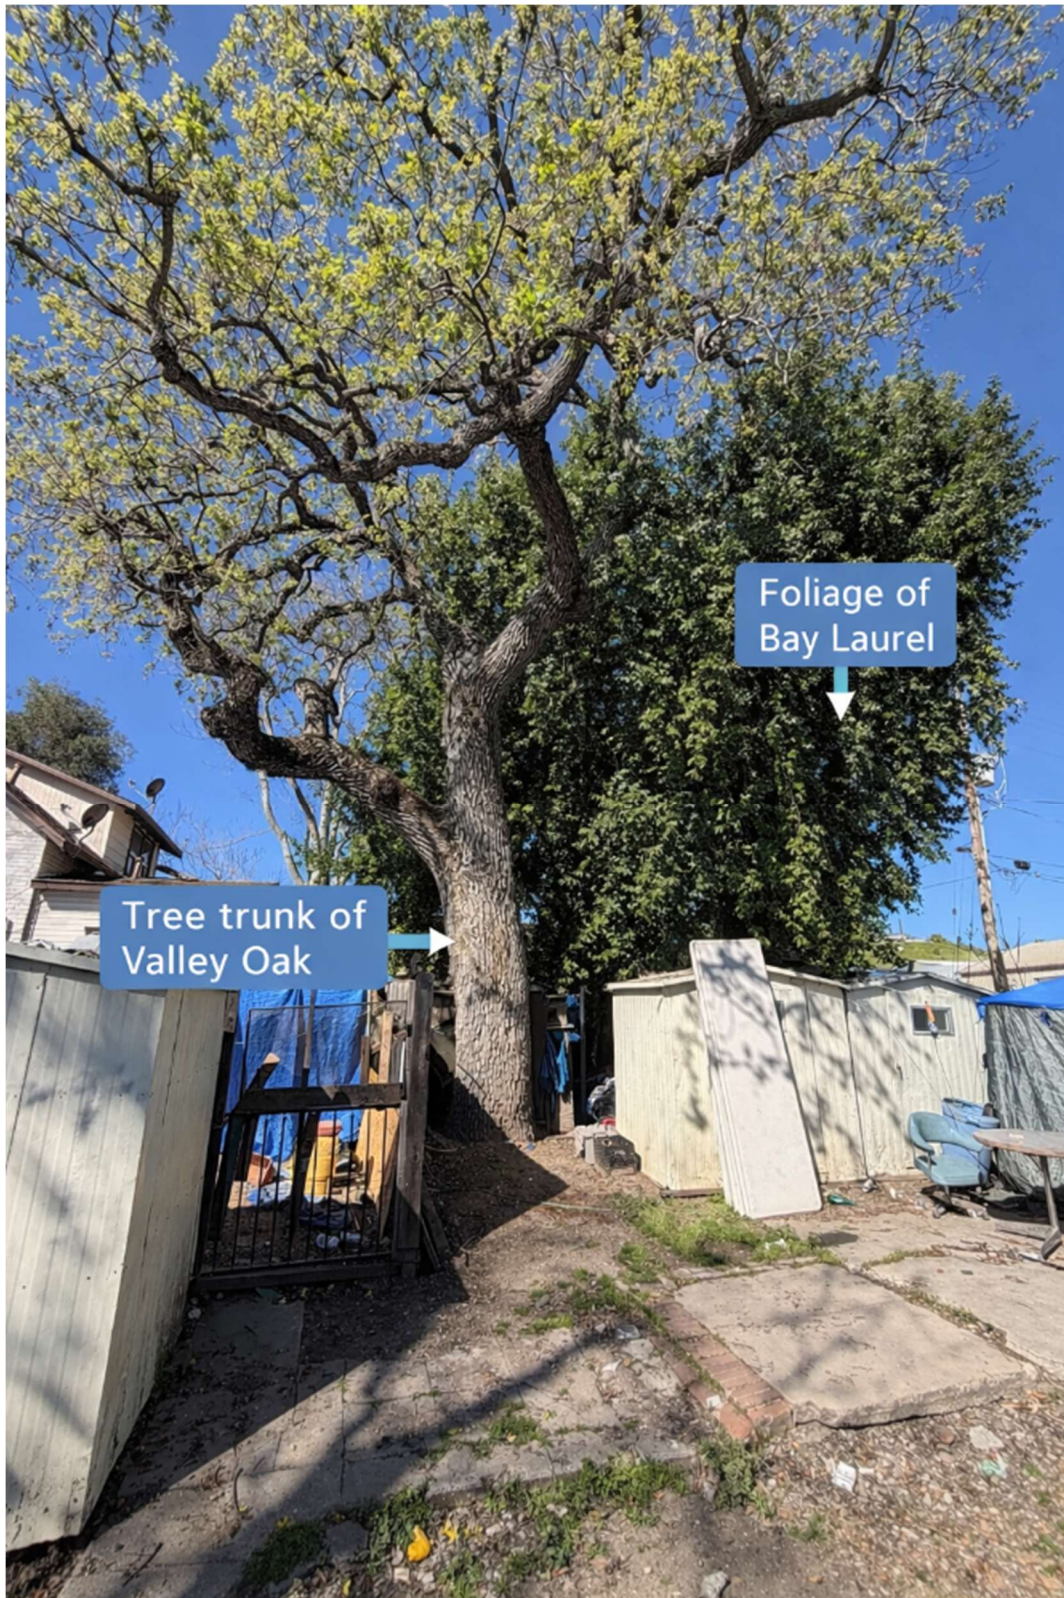
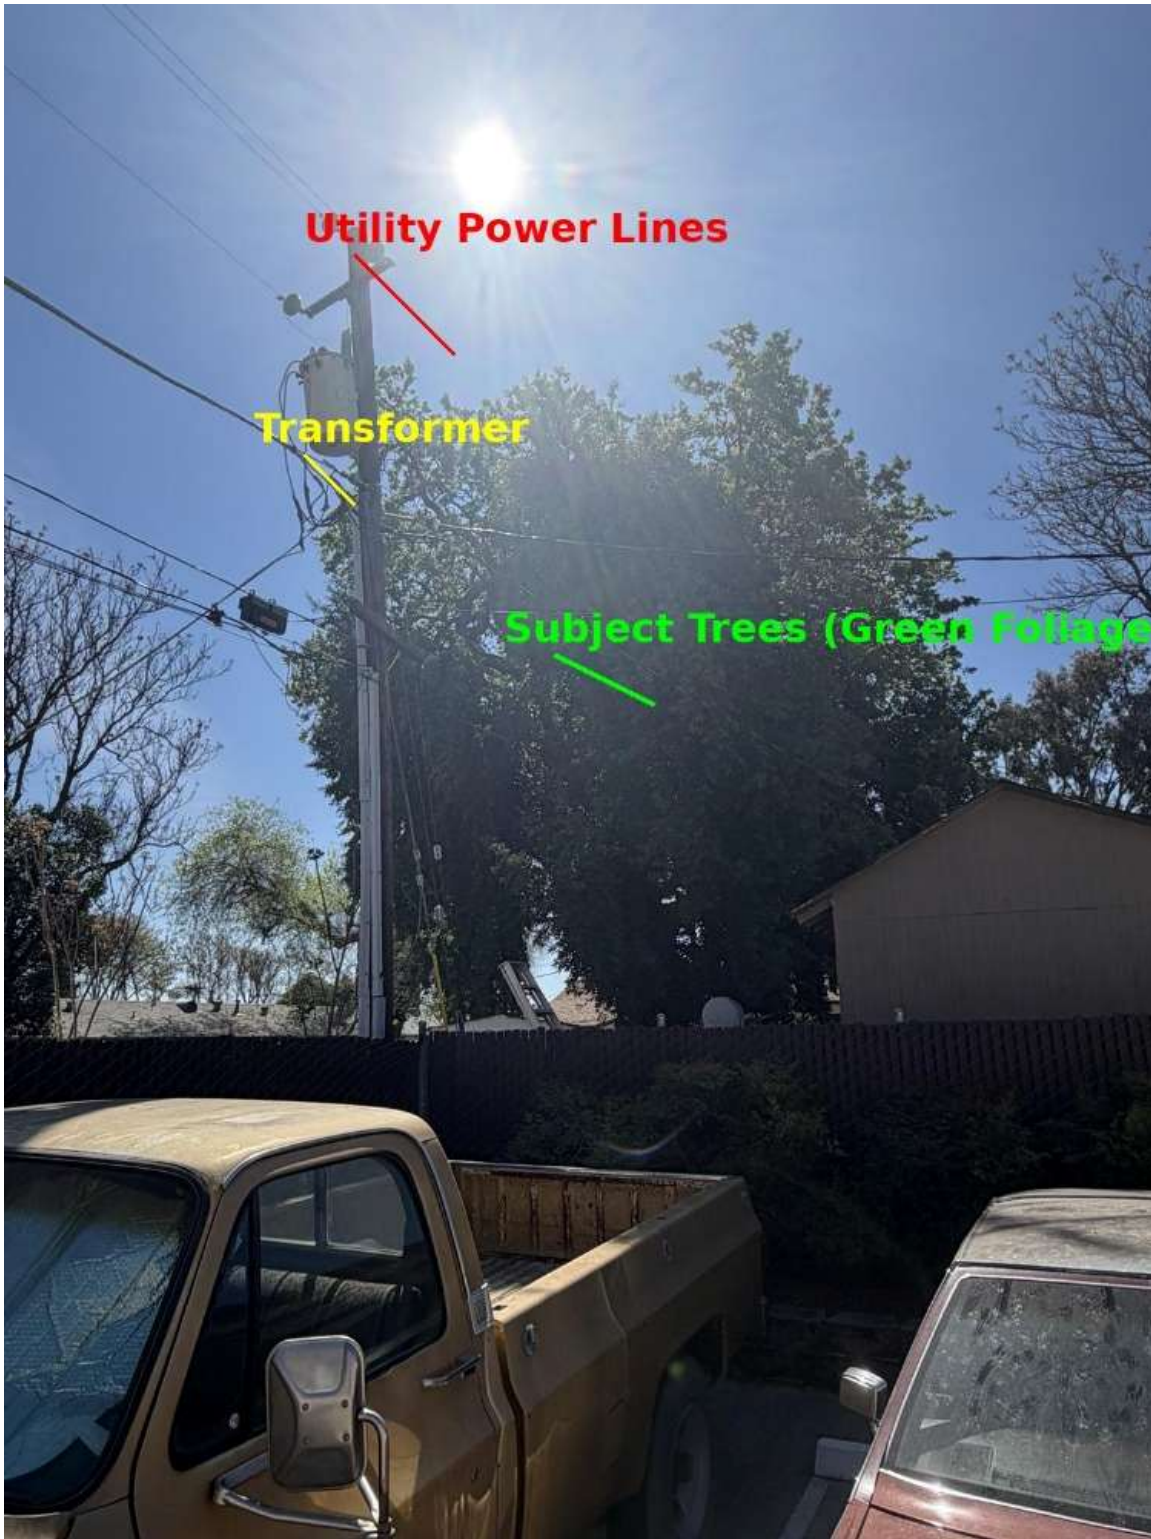
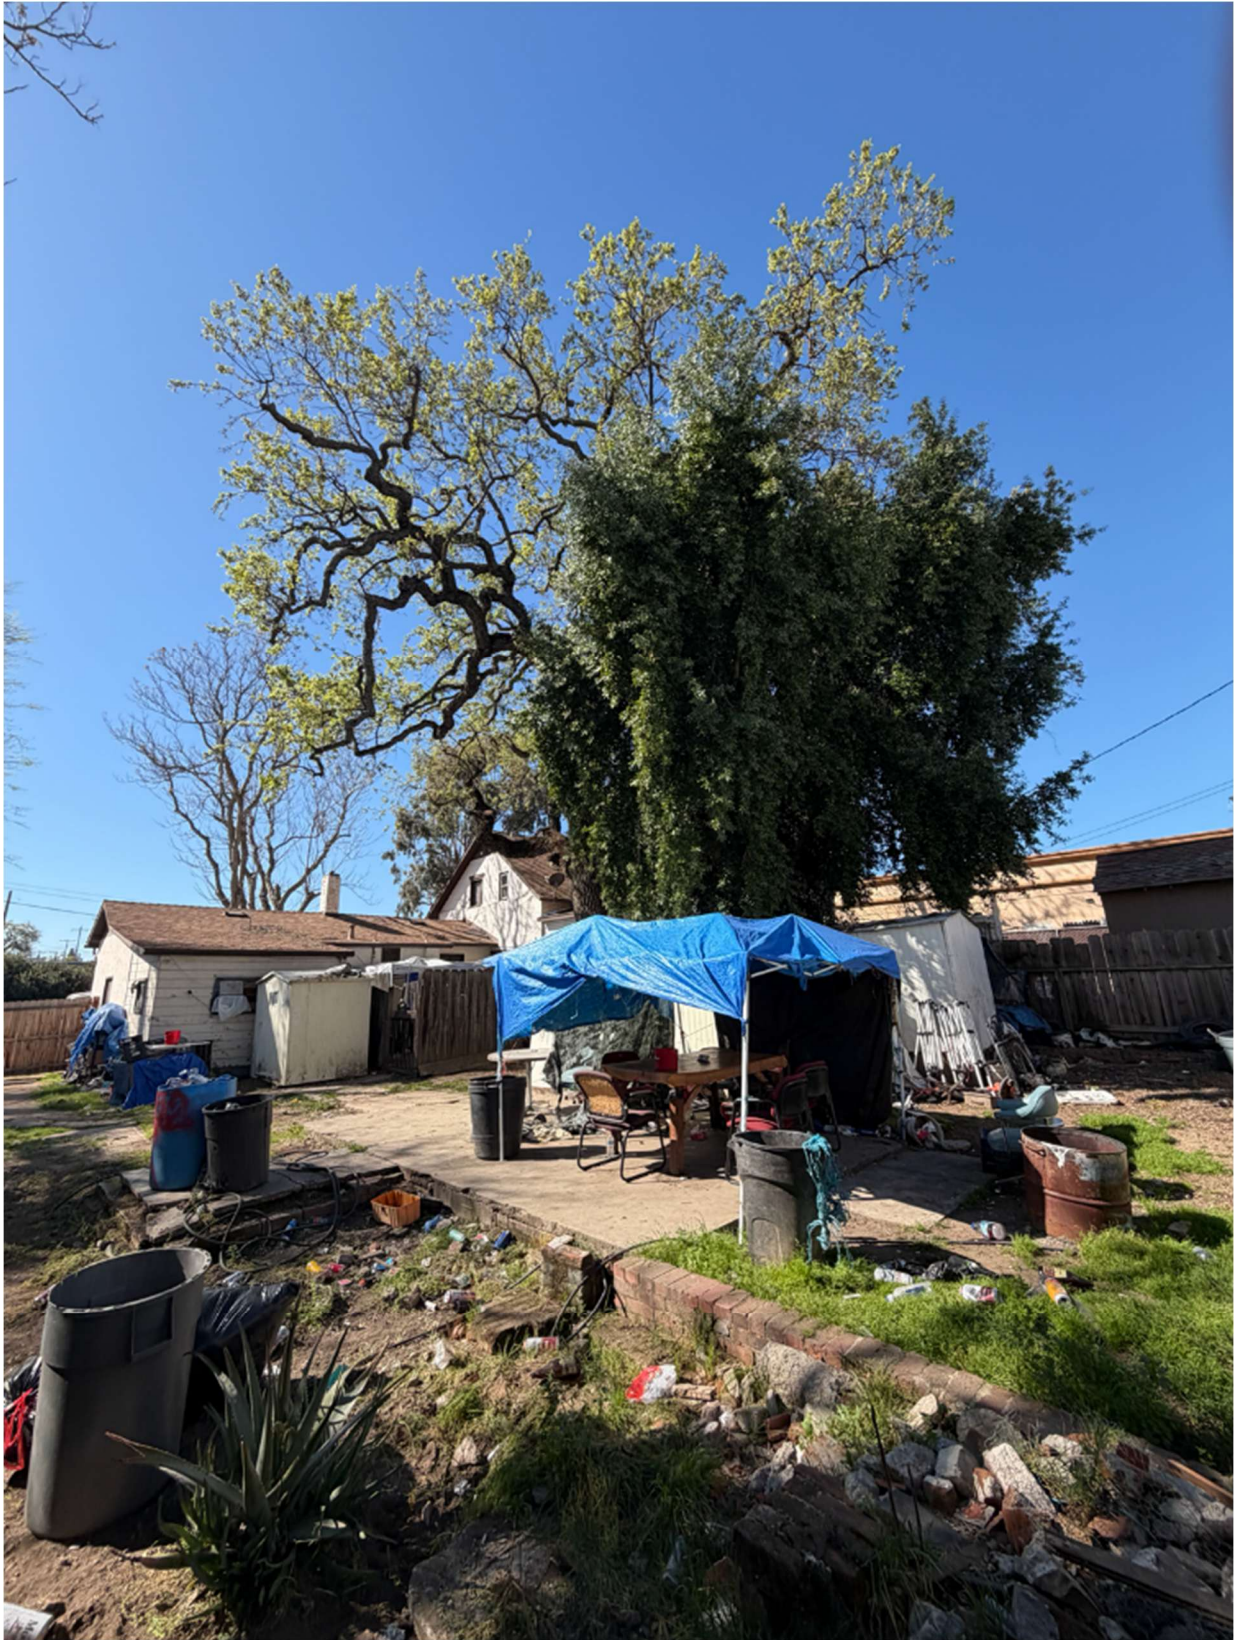
Exhibit B- Supplemental Photos of Whole Trunk, Tree and Surrounding Areas

Supplemental photographs documenting the entire tree, trunk condition, surrounding area, and the competing Bay Laurel canopy have been included. See attachment “B”
