Re: Tree 903 Removal Request for Viñedo Phase 2B Mass Grading Plans, City of Paso Robles

ATTACHMENT 1. OAK TREE ASSESSMENT FOR TREES #903 & #906 ALONG HANSON ROAD

**Re: Oak Tree Assessment for Trees #903 & #906 along Hanson Road
Viñedo; Olsen-South Chandler Ranch SPA, City of Paso Robles**

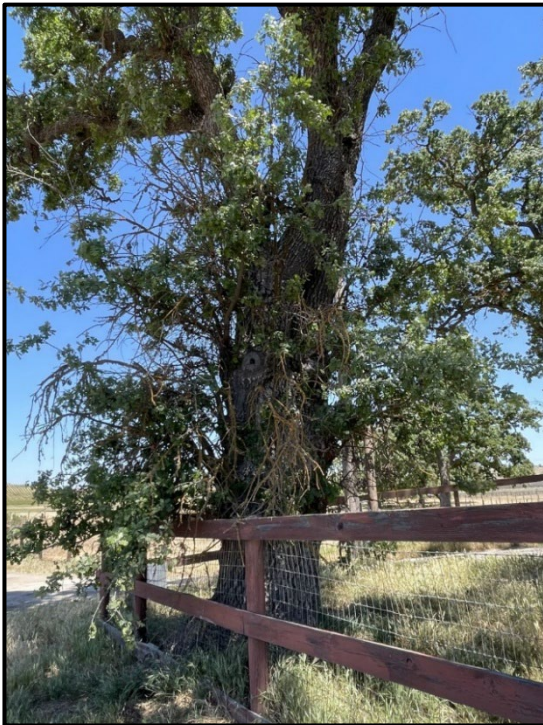
Tree 903 is exhibiting signs of stress since our initial survey on May 6, 2025. A large amount of epicormic sprouting around the trunk and on major branches indicates a stress response (Photo 1). Additionally, root rot was found on two sides of the tree, indicating a reduction in root function capacity and possible structural compromise. Our most recent winter survey on February 18, 2026, found the same indications of stress and rot. Surveys also noted that the trunk has a weak connection where it branches off into two main stems (Photo 2). Additionally, the tree is retaining many of its dead leaves instead of dropping them during winter, which is a sign of pit scale in valley oaks.

Photo 1. Tree 903 in spring with epicormic sprouts at the base, view northeast, May 6, 2025.

root function, coupled with construction impacts will reduce Tree 903's viability. We believe it is unlikely that the tree will be able to survive long-term after impacts occur. Due to the current poor health of the tree and the significant increase in CRZ impact from road improvement activities, we are recommending the tree for removal.

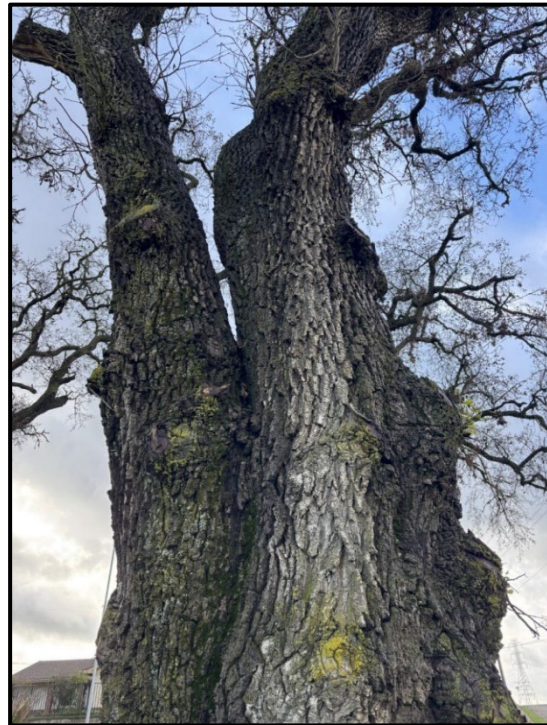
Photo 2. Tree 903, weak codominant stem branch connection and small epicormic resprouting (right), view south, February 18, 2026.

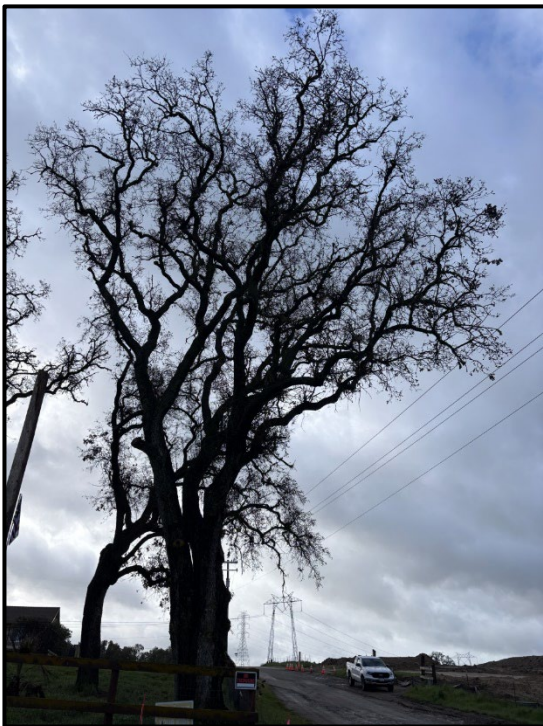
Tree #903 is a 41-inch DBH valley oak (Photo 1) with a height of 55 feet and a canopy width of 50 feet. It is a single trunk tree with a health rating of 3. It is in moderate to poor health, with significant rot at the base of the trunk and roots, as well as signs of stress in the canopy. Approximately 8 feet up the tree, the trunk becomes two co-dominant stems with a weak attachment and included bark, which can increase the chance of the stems splitting and leading to partial tree failure (Photo 2).

Photo 1. Tree #903, view south, February 17, 2026.

The Oak Tree Protection and Mitigation Plan (OTPMP; A&M 2020³) provides guidelines for the mitigation of trees that require removal or impacts to their CRZs. Root systems of oak trees can extend well beyond the canopy dripline, and any disturbance inside this area can cause damage and impact tree health, thus mitigation is necessary. As shown on the draft grading plan from Rick Engineering for Hanson Road (Rick Engineering 3/2/2026), Tree #903 will be significantly impacted by grading and construction. This impact is likely to increase stress on a tree that is already showing signs of decay and poor health. Removal and compensatory mitigation are recommended.

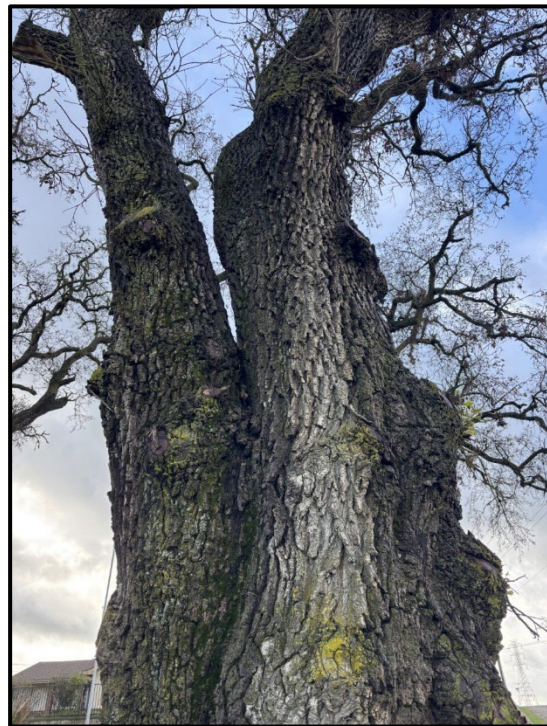
Photo 2. Tree #903, co-dominant trunks and included bark, view southeast, February 17, 2026.

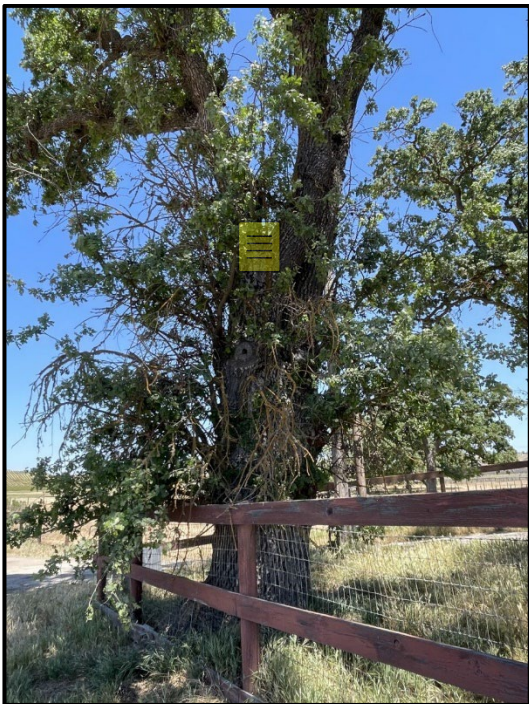
During the May 6, 2025 survey, significant epicormic sprouting on the lower trunk was noted (Photo 3). By the February 17, 2026 survey, all epicormic growth had been pruned. However, the tree is still producing sprouts on the trunk where the branches were cut (Photo 4). Epicormic

Photo 3. Tree #903, mature epicormic sprouts at base, view north, May 6, 2025.

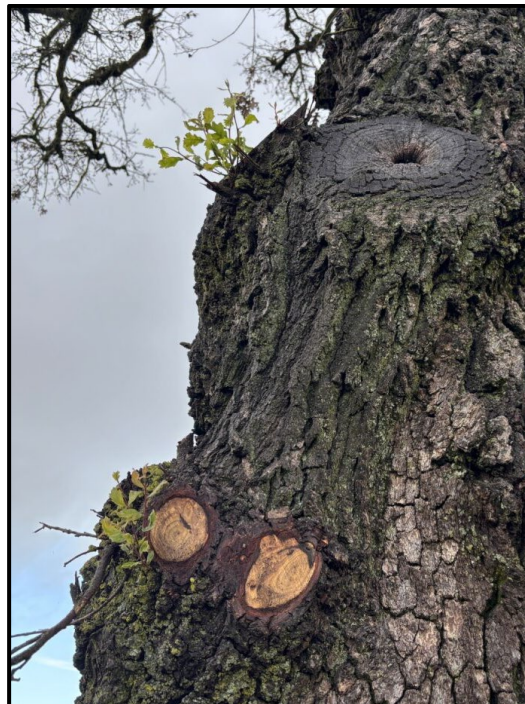
sprouting from the trunk can indicate stress in the tree, as the tree attempts to rapidly grow above-ground biomass to compensate for injury or environmental stress (Bellingham and Sparrow, 2000¹). Tree #903 shows signs of root and trunk decay, weak attachments, dieback in the canopy, and significant epicormic sprouting on the trunk and major branches. The tree has retained a large amount of dead leaves and twigs through winter, which is an indication of possible pit scale infestation. While it will not directly cause mortality, pit scale can increase stress on the tree (Geisel et al, 2013²). The proposed road widening and improvements for Hanson Road will cause significant impacts to Tree #903.

Photo 4. Tree #903, new epicormic sprouting on trunk, view north, February 17, 2026.

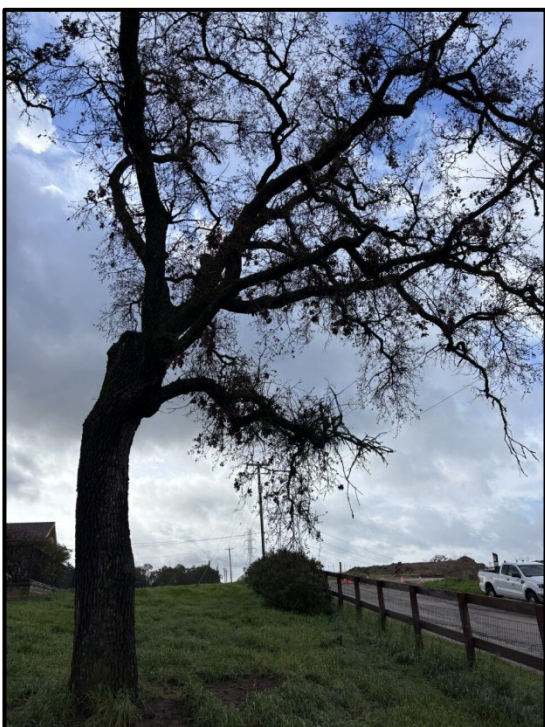
Tree #906 is an untagged valley oak (Photo 5) with a 28-inch DBH, height of 45 feet, and canopy width of 40 feet. It is a single trunk tree with a health rating of 5. It is a moderately healthy tree with some structural weakness in canopy branches and signs of stress. Tree 906 has also retained dead leaves and twigs through winter, indicating pit scale infestation (Photo 6). The tree was not included in the original Olsen-Chandler Arborist Report (A&M, 2018) survey, so it was added into our oak tree database/tracking during the May 6, 2025 survey as Tree #906. The tree is on private property adjacent to Hanson Road. Proposed road widening will impact more than 50 percent of the CRZ and may impact the trunk (Figure 1).

Photo 5. Tree #906, view south, February 17, 2026.

The City of Paso Robles Oak Tree Preservation Ordinance (Chapter 10.01) provides policies, regulations, and specifications necessary to govern preservation of oak trees within the City and to control their pruning and/or removal. Any oak tree slated for removal requires an oak tree removal (OTR) permit and mitigation, where the total caliper diameter of replacement trees shall be equivalent to 25 percent of the total DBH of trees removed. In accordance with the City’s Oak Tree Preservation Ordinance (Section 10.01.050), removal of **Tree #903**, which has a DBH of 41 inches, results in a mitigation requirement of 10.25 inches (25 percent of 41 inches). This requirement can be met through the planting of seven (7) 1.5-inch caliper oak trees. Caliper is measured as the tree trunk diameter taken six inches above ground level for field-grown stock, or at the soil line for container-grown stock. Impacts to **Tree #906** require mitigation at a 2:1 replacement ratio in accordance with the OTPMP.

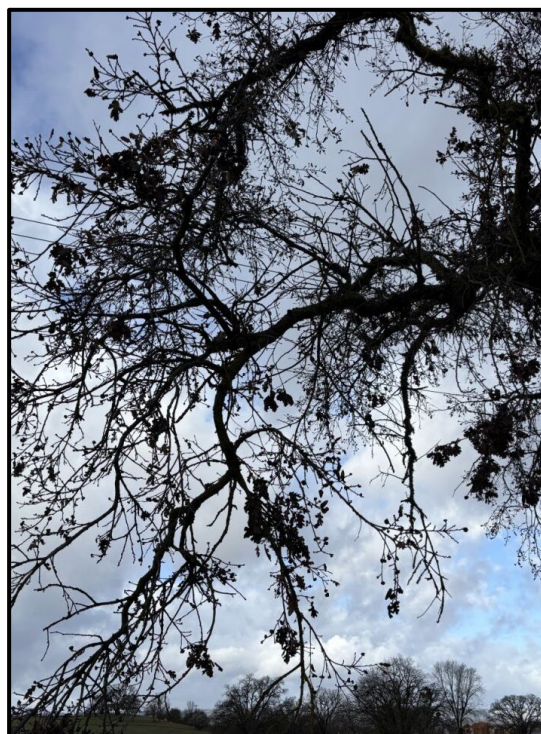
Photo 6. Tree #906, close-up of retained dead twigs and leaves, view north, February 17, 2026.
