Exhibit D

July 31, 2025

Per your request, the following memo is an update of recommendations regarding two (2) native oaks at your Ardmore Project located at 2930 Union Road, in Paso Robles, California.

Tree Assessment Updates

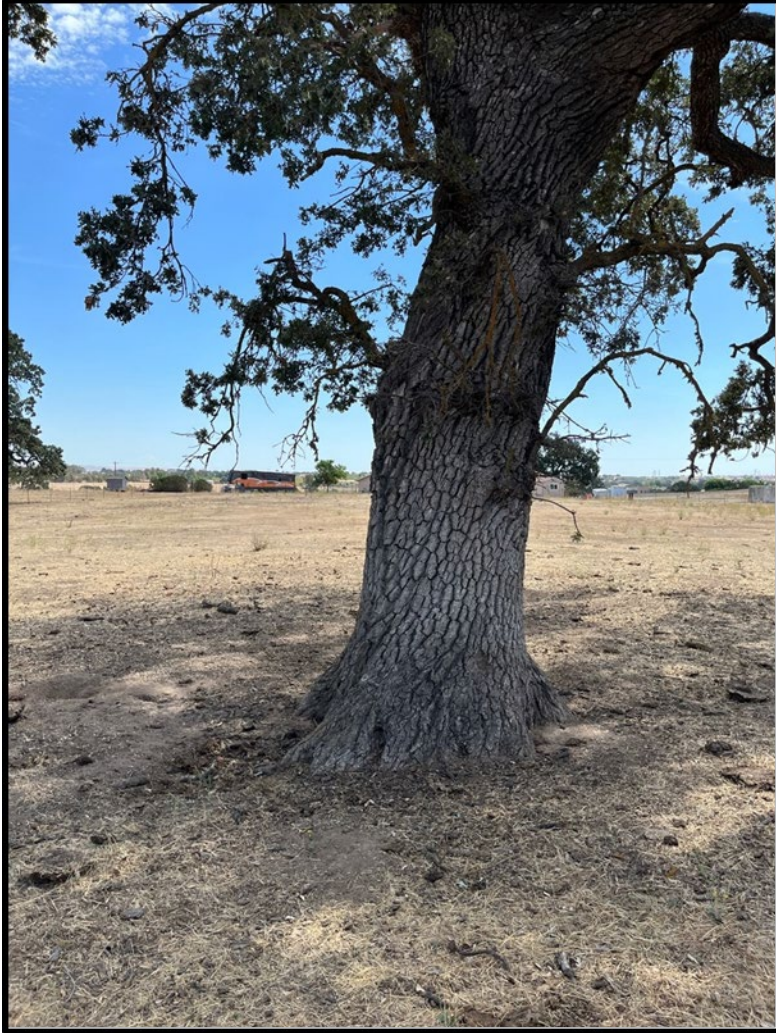
Photo 3 – Tree 13 with bulging root-crown indicating possible butt-rot.

I recommend to the City of Paso Robles planning department that Tree 13 be removed based on the risk of it failing and potentially severely injuring residents of the development.

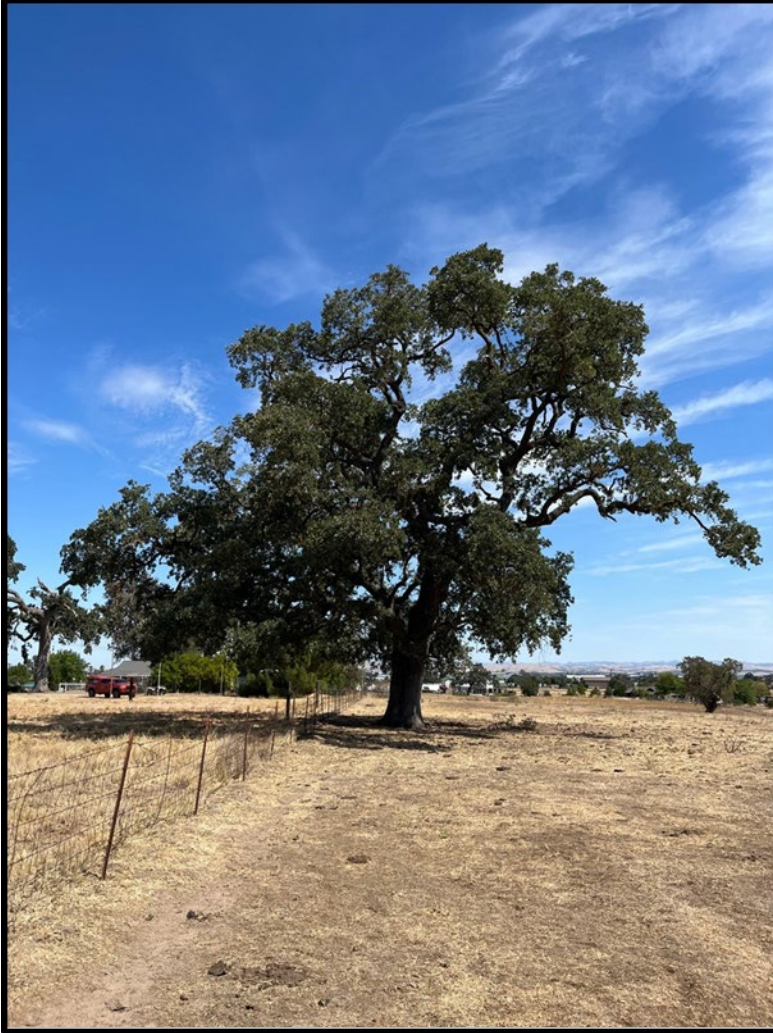
Photo 4 – Tree 2 in 2022. Outwardly, the tree appears to be healthy but internal rot makes it structurally unstable.
