# Exhibit B

October 21, 2022

**Re:** Oak Tree Impact and Protection report for Ardmore Road Project, 2930 Union Rd, Paso Robles, CA 93446

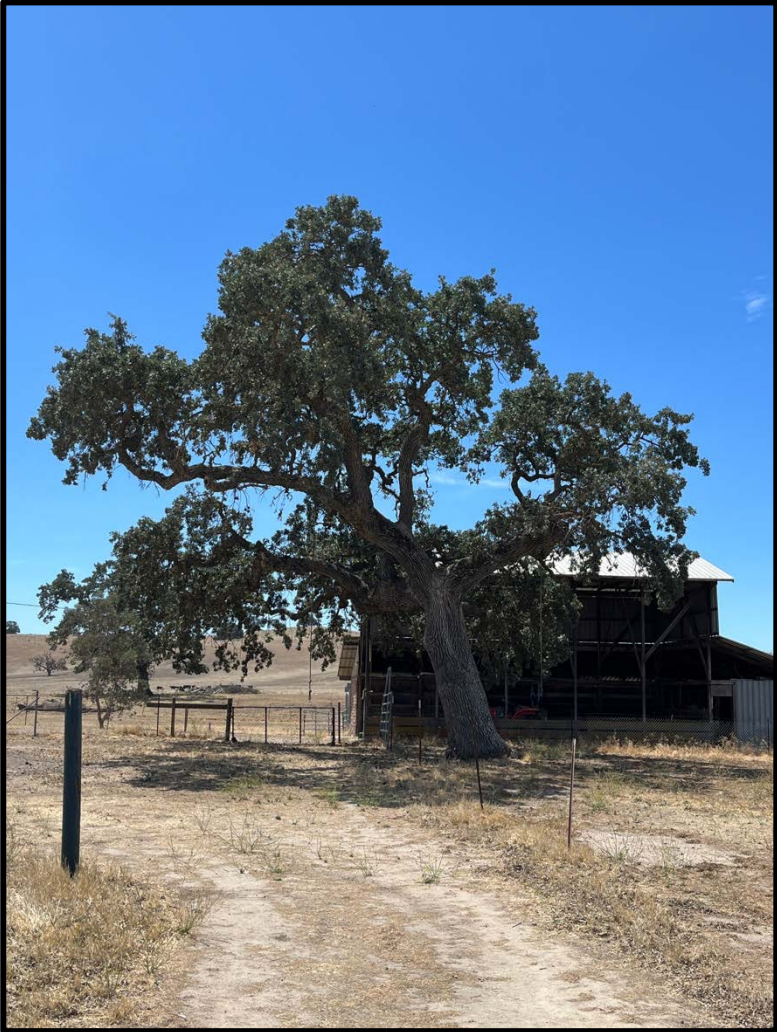
**Tree 1** – A 43” diameter valley oak was in Very Poor condition. See Appendix A - Photographs - Photo 1.

The trunk had an approximate lean to the east of 10 degrees. It also had a horizontal compression bulge on the east side of its trunk approximately 1' above ground. Compression bulges or wrinkles, indicate that wood fibers are being crushed by the weight of the canopy and trunk due to lack of supportive structure in the trunk. Further the tree had a large, decayed, anchor root on its southwest side. The root was on the opposing side of the lean of the tree and is likely to fail as decay advances and stress from the weight of the canopy continues to build. See Appendix A - Photographs - Photos 1-3.

**Photo 1** - View of Tree 1 to south. Note lean to east.

**Roots and Trunk** - Reducing the canopy through end weight reduction would relieve some stress on the trunk but not enough to offset the overall stress being exerted on the buckling area on the north side of the tree. No structural support or bracing will help the stability of the tree's trunk or roots. Significant decay has been detected in the roots as well as the trunk. Based on shell strength measurements, lean of the tree and buckling of wood fibers on the east side of the trunk made failure likely due to lack of structural integrity. I recommend removing the tree before commencement of construction.

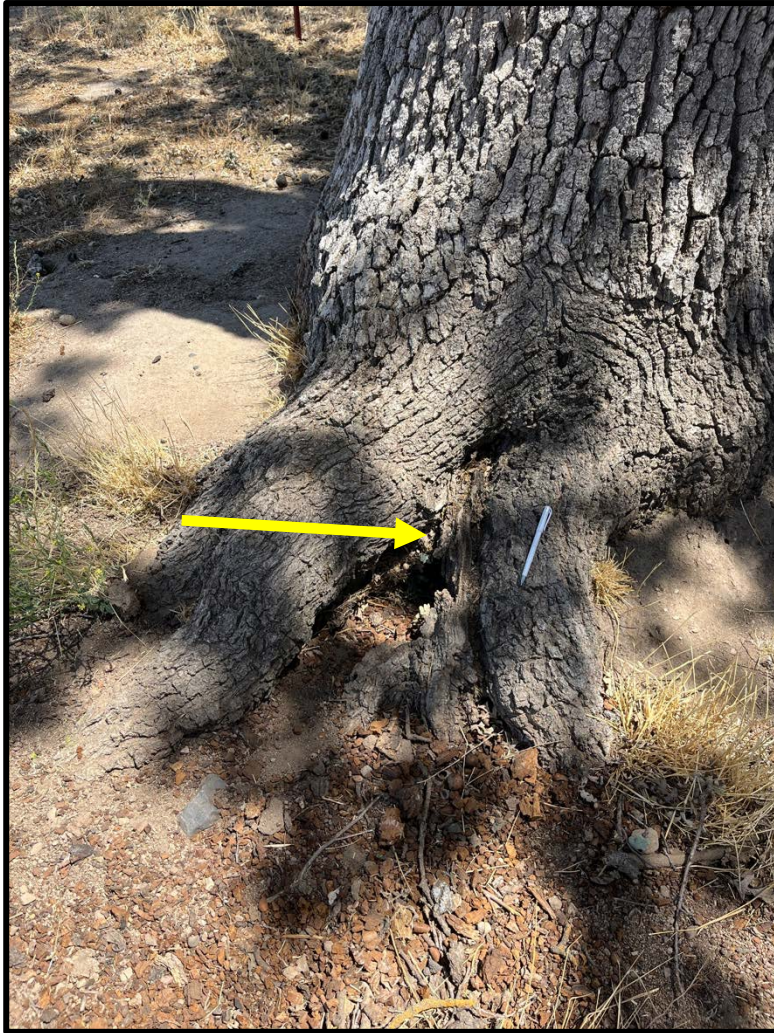
The highest risk rating for this tree was High and was associated with root and trunk failure. I found decay in one anchor root and significant decay was detected in the trunk. Buckling of trunk fibers was evident. Based on shell strength measurements, the likelihood of trunk failure was probable, due to lack of structural integrity. Root failure was Probable due to significant decay in the anchor root on the southwest side of the tree. Scaffold failure was also probable with a high likelihood of failure.

**Photo 2** - Tree 1 with decayed anchor root on southwest side, indicated by arrow. Ink pen provided for scale

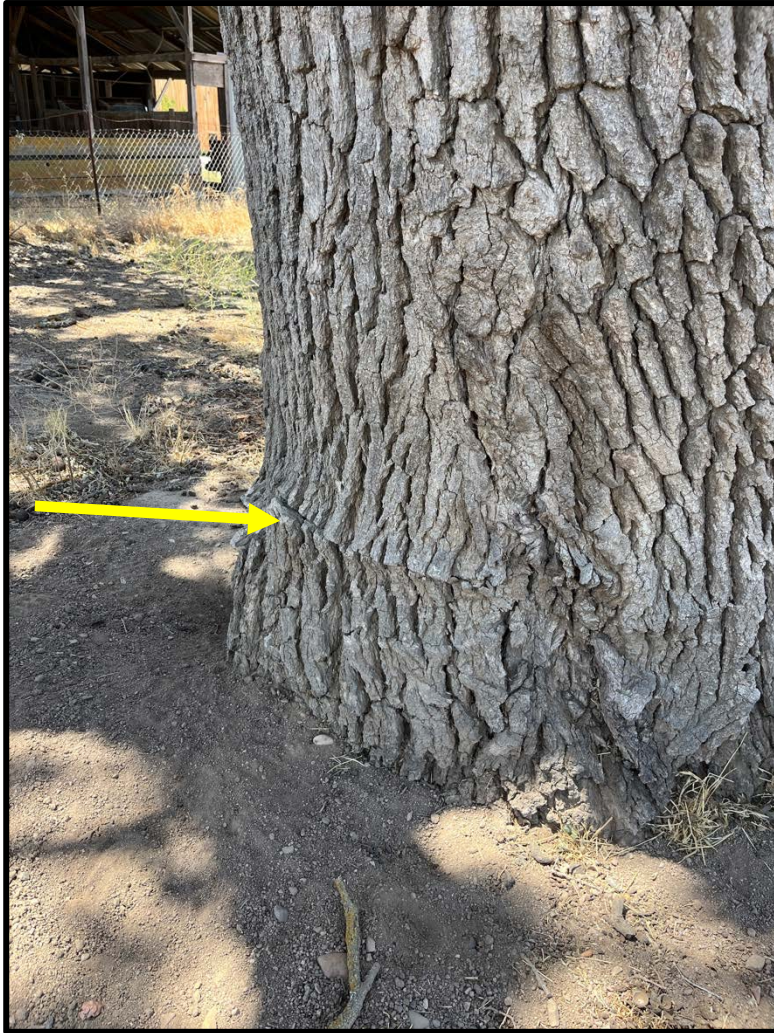
Based on the Resistograph results, it was apparent that the interior wood of the trunk was significantly decayed. The evidence of compression bulges showed that the trunk is losing structural integrity and leaning due to lack of supportive wood fibers.

**Photo 3** - Tree 1 with compression bulge east side of trunk indicated by arrow shows lack of structural support.

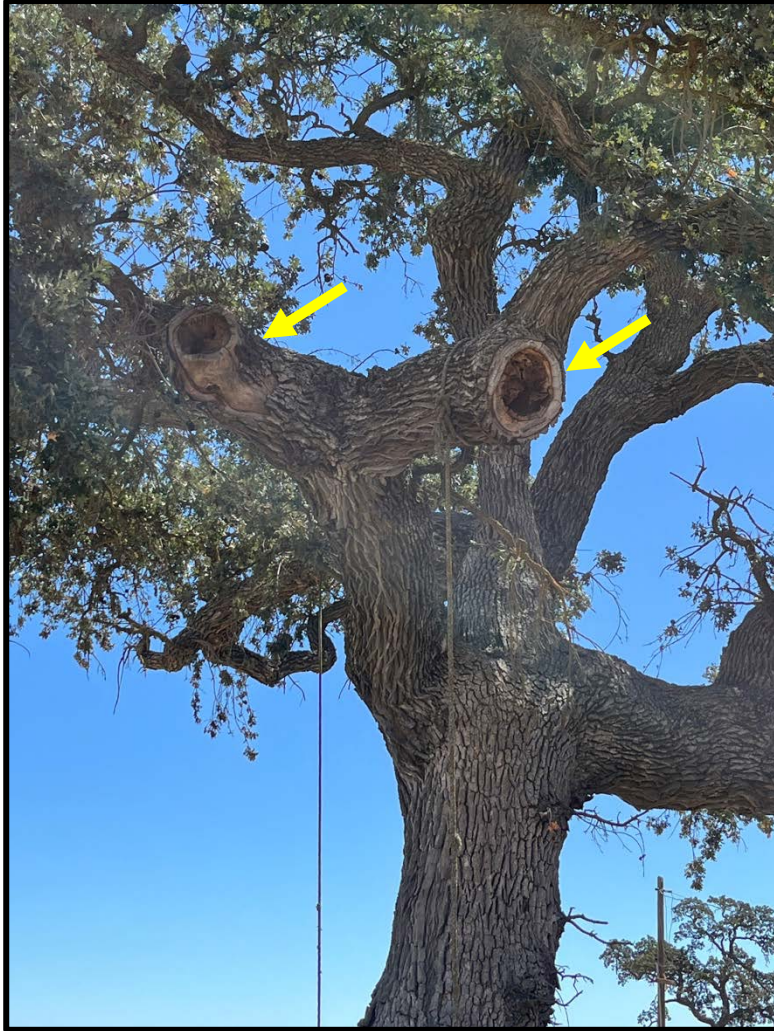
This tree had drought stress which was indicated by dead wood in the canopy. It also had decay throughout its scaffold branches which was evident from the presence of decay cavities and woodpecker nests excavated in dead wood. See Appendix A - Photographs - Photos 1 & 4.

**Photo 4** - Tree 1 with decay in scaffold branches. indicated by arrows.

**Scaffolds** - Reducing the canopy through end weight reduction and removing decayed branches 2" diameter and larger would relieve some stress on remaining scaffold branches and reduce their risk to Moderate.

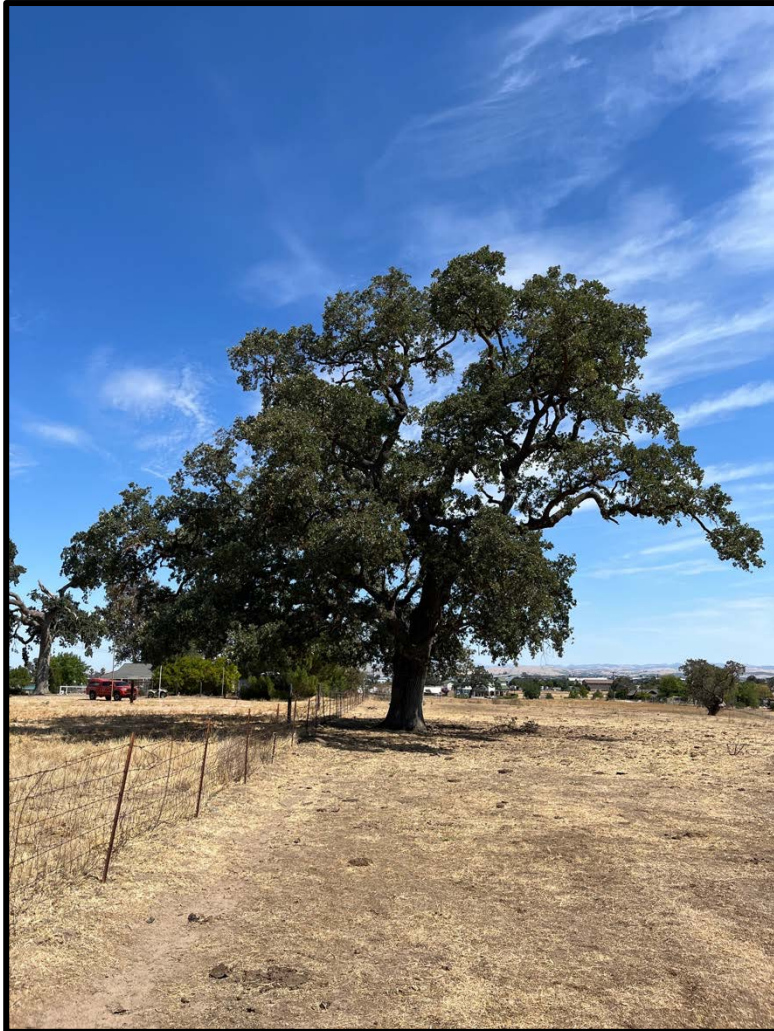
**Tree 2** – A 47" diameter valley oak was in Poor condition. See Appendix A - Photographs - Photo 5.

**Photo 5** - View of Tree 2 to north

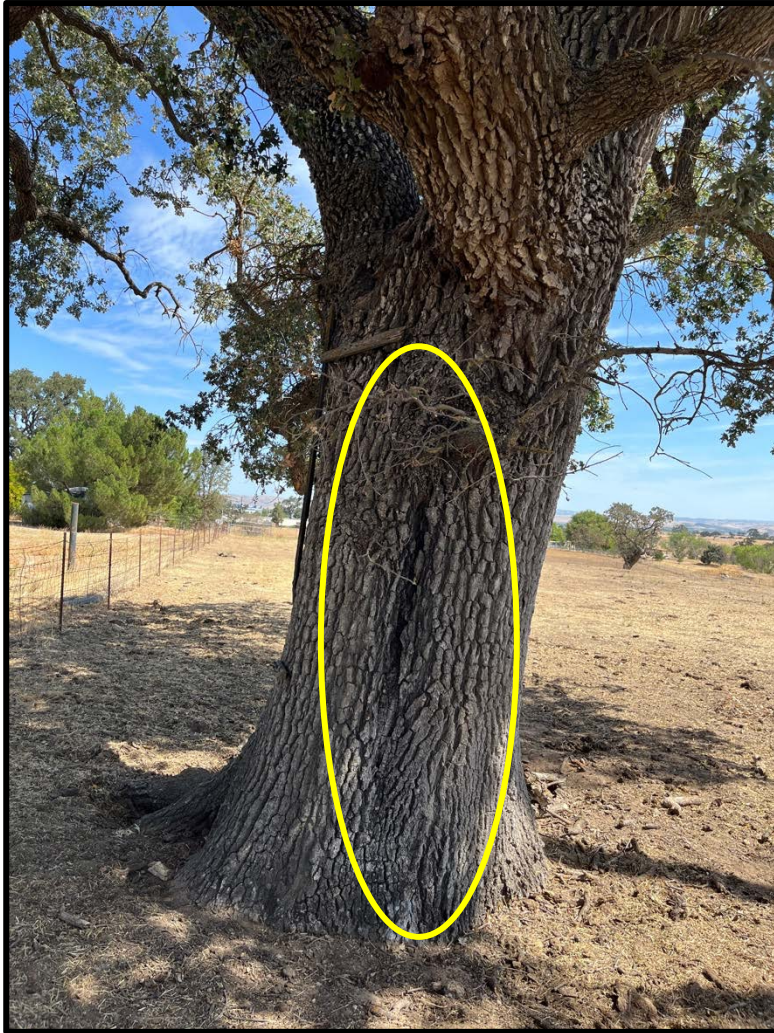
On the south side of the trunk there was a decay cavity originating at the root-crown and extending approximately 5.5' upward. When sounded with a rubber mallet on either side of the cavity, it resounded hollow. Moving around the trunk to the east side, I detected another hollow sounding area with my mallet at approximately 3.5' above ground. See Appendix A - Photographs - Photo 6. Like Tree 1, I suspect *Armillaria mellea* - Oak root fungus, is the cause of the rot.

**Photo 6** - Tree 2 with decay cavity south side of trunk. Length is approximately 5.5'.

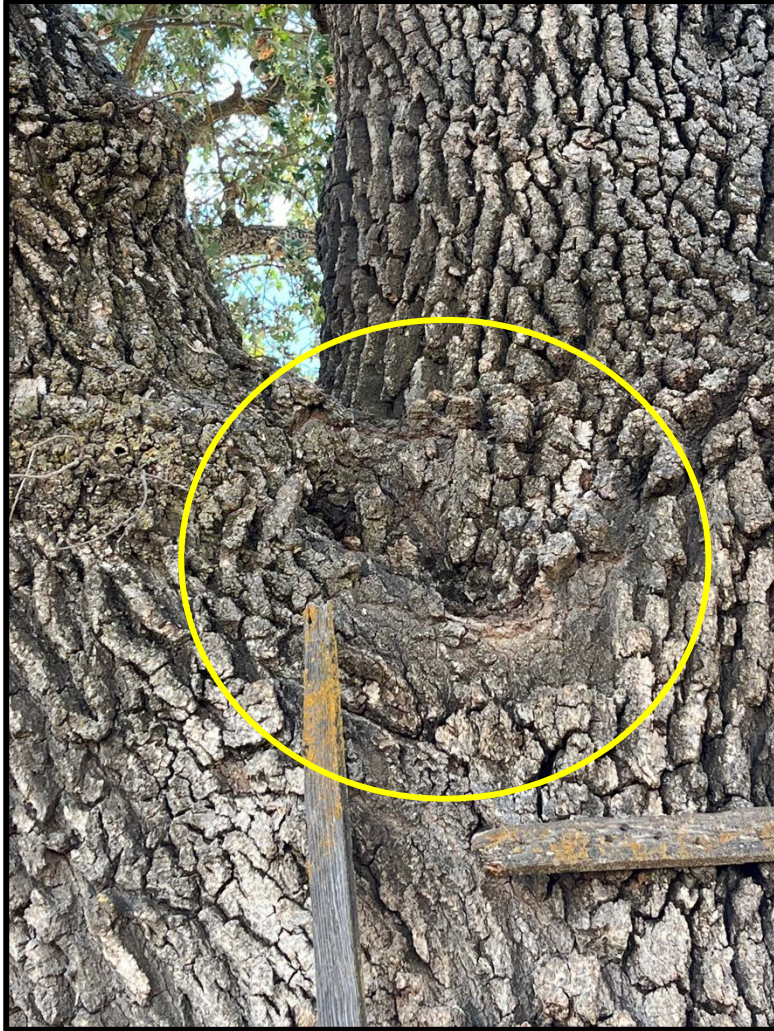
At approximately 8 feet above ground, on the southwest side of the trunk there was another decay area that was almost closed over with scar tissue. Although almost closed, I suspected a large area of decay behind the scar. See Appendix A - Photographs – Photo 7. There was a large scaffold branch attached to the trunk above the scar. It had a desiccated fungal fruiting body growing on it and cankers had killed strips of bark near the fungus. See Appendix A - Photographs – Photo 8. I identified the fungi genus to be that of *Inonotus*. Jessie A. Glaeser and Kevin T. Smith in the winter 2010 issue of *Western Arborist*, note this fungus to cause a white rot of heartwood in the trunk of living oaks and also decays strips or sections of sapwood, forming elongate cankers and killing the cambium. According to Swiecki, T. J.; Bernhardt, E. A. 2006, *A Field Guide to Insects and Diseases of California Oaks*, "*Inonotus dryophilus* is one of the most serious pathogens of living oaks in California associated with decline, failure, and mortality". In this tree, the weakened trunk area at the scar combined with the heavy, decayed scaffold branch make this section of the tree likely to fail.

**Photo 7** - Tree 2 with decay cavity at scaffold union approx. 8' above ground on southwest side of tree.

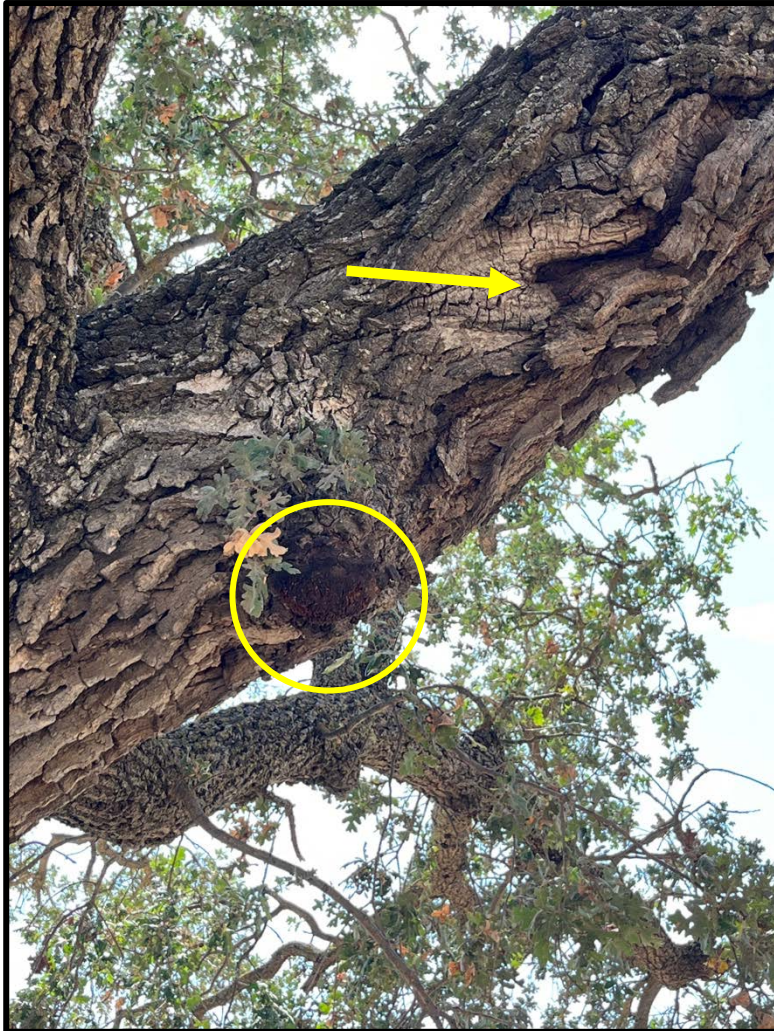
**Photo 8** - Tree 2 with fungal fruiting body circled and decay in south scaffold branch indicated by arrow.

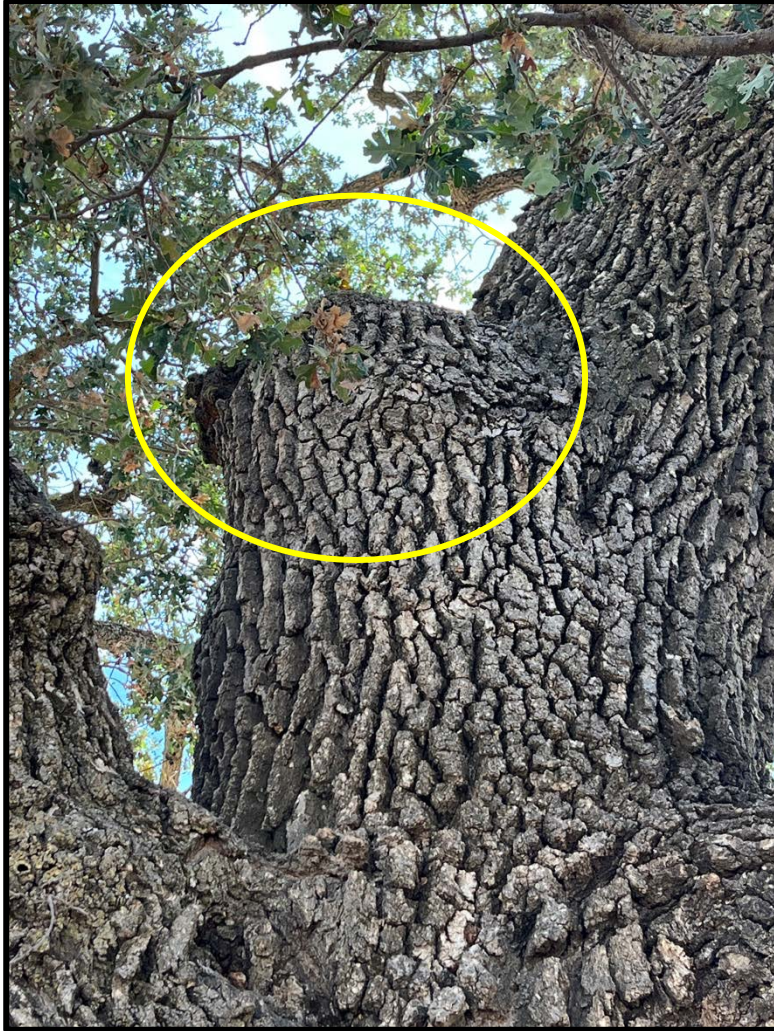
In the upper canopy at approximately 14' above ground there was another decay cavity in the center of the canopy, where a large scaffold branch had failed many years ago. I suspected advanced decay in the trunk at this location. See Appendix A - Photographs - Photo 9.

During the aerial inspection, I discovered that the opening of the decayed scaffold in the upper canopy was 13" in diameter. The depth of the cavity was 13'2" deep. When I measured the distance to the ground from the outside of the cavity, it was 14'3", which illustrated that the entire trunk of the tree was hollow. See Appendix A - Photographs – Photos 9 -14.

**Photo 9** - Tree 2 with decay cavity formed by failed scaffold circled at center of tree, approximately 14 feet above ground.

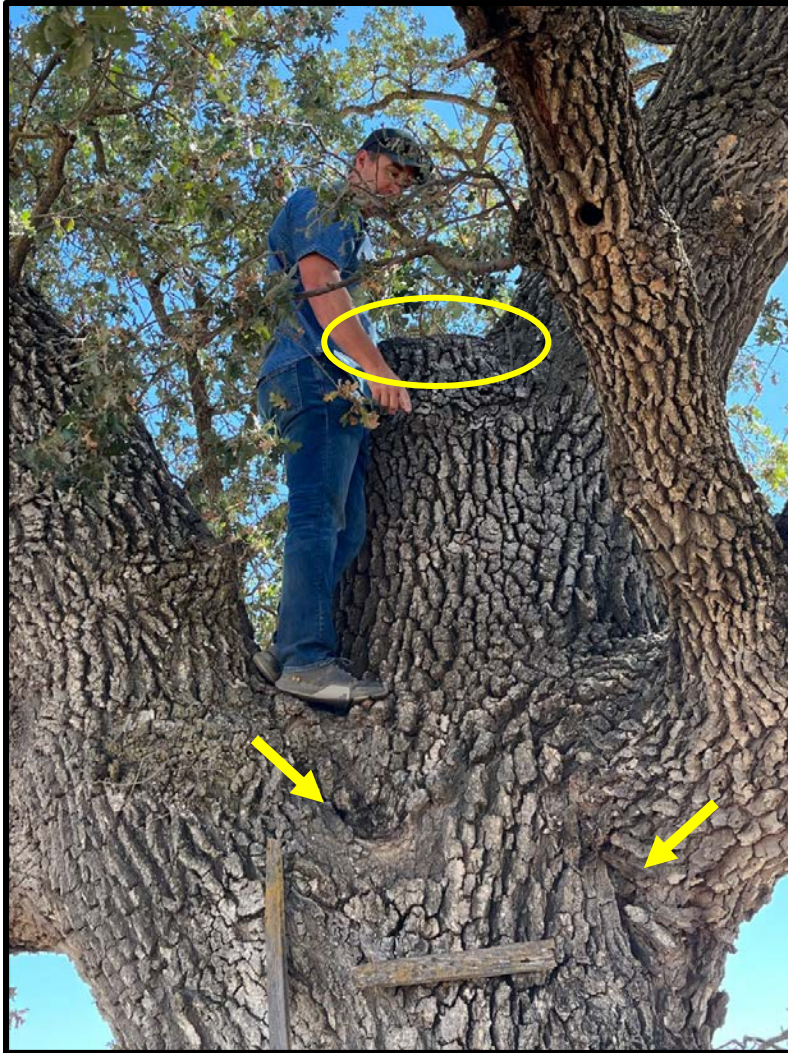
**Photo 10** - Tree 2 perspective view of decay cavity formed by failed scaffold circled at center of tree. Cavity is circled. Other decay points below the open cavity are indicated by arrows.

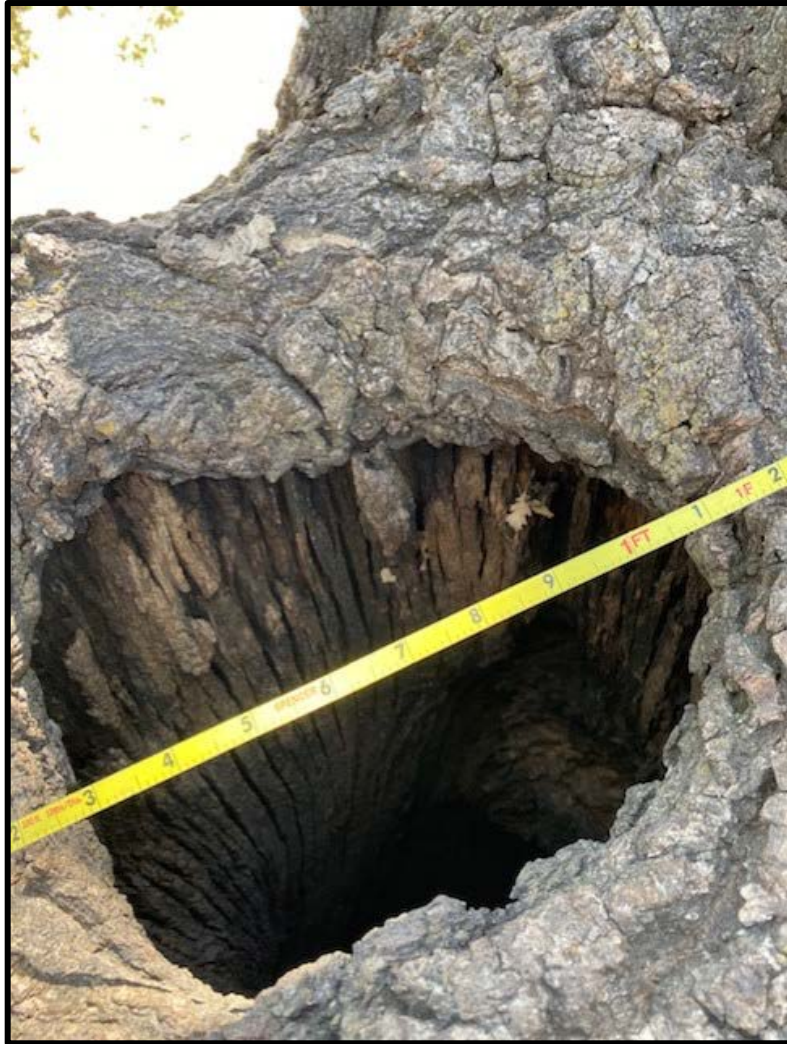
**Photo 11** - Tree 2 view of decay cavity formed by failed scaffold. Opening measures 13"

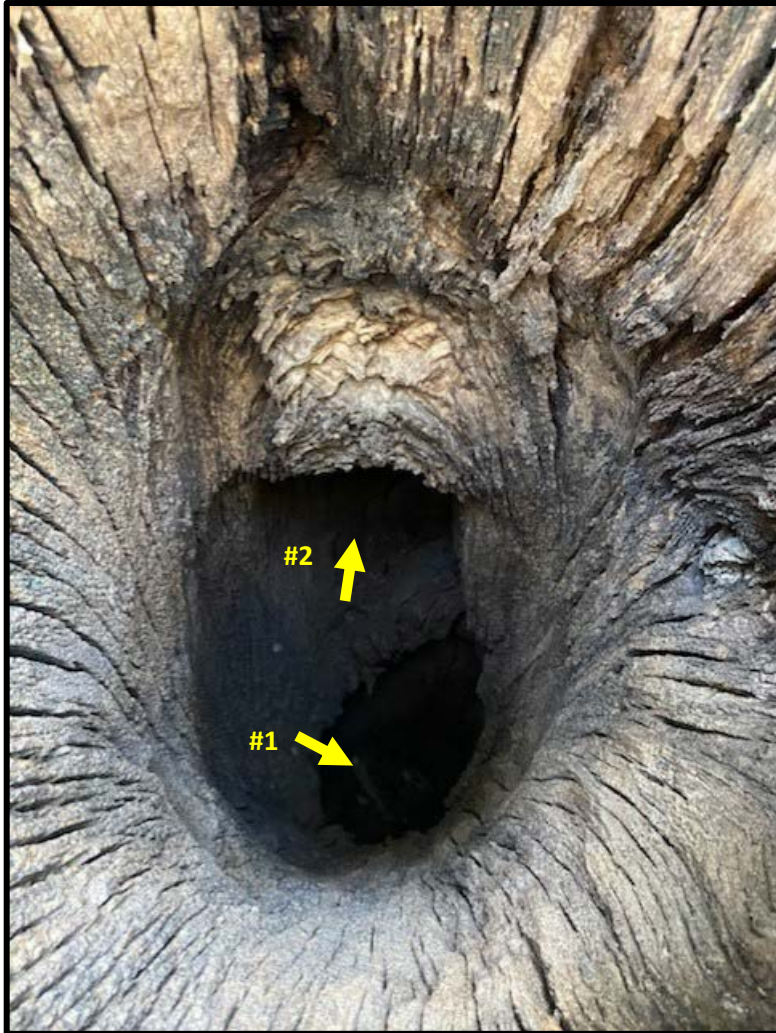
From the cavity opening, the decay continued upward into the scaffold branch growing east. This scaffold is very likely to fail due to weak trunk structure. See Appendix A - Photographs – Photo 12.

**Photo 12** - Tree 2 view of interior decay cavity formed by failed scaffold. Arrow 1 shows depth of cavity down to roots of tree. Arrow 2 shows decay that has advanced into eastern scaffold branch.

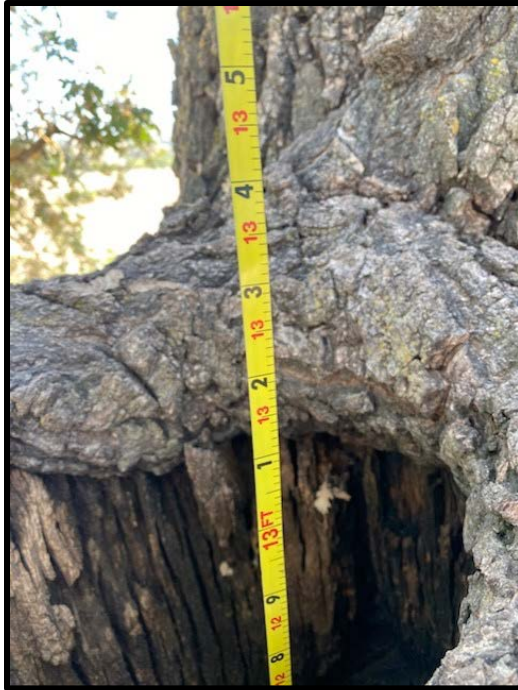
**Photo 13** - Tree 2 measurement of interior depth of decay cavity formed by failed scaffold. 13' 2"

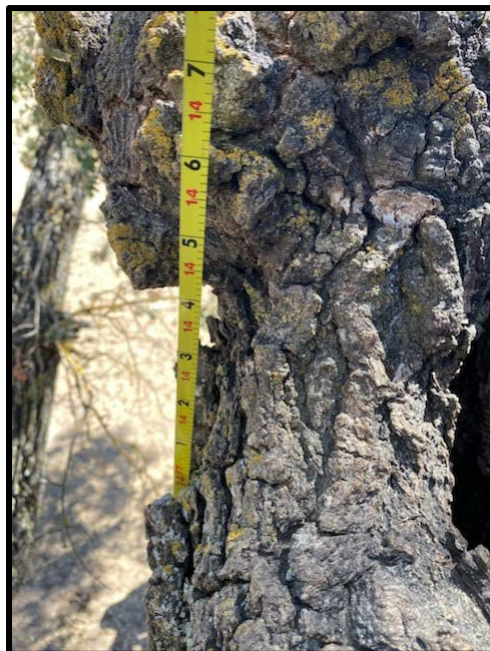
**Photo 14** - Tree 2 measurement of exterior depth of decay cavity formed by failed scaffold. 14' 3"

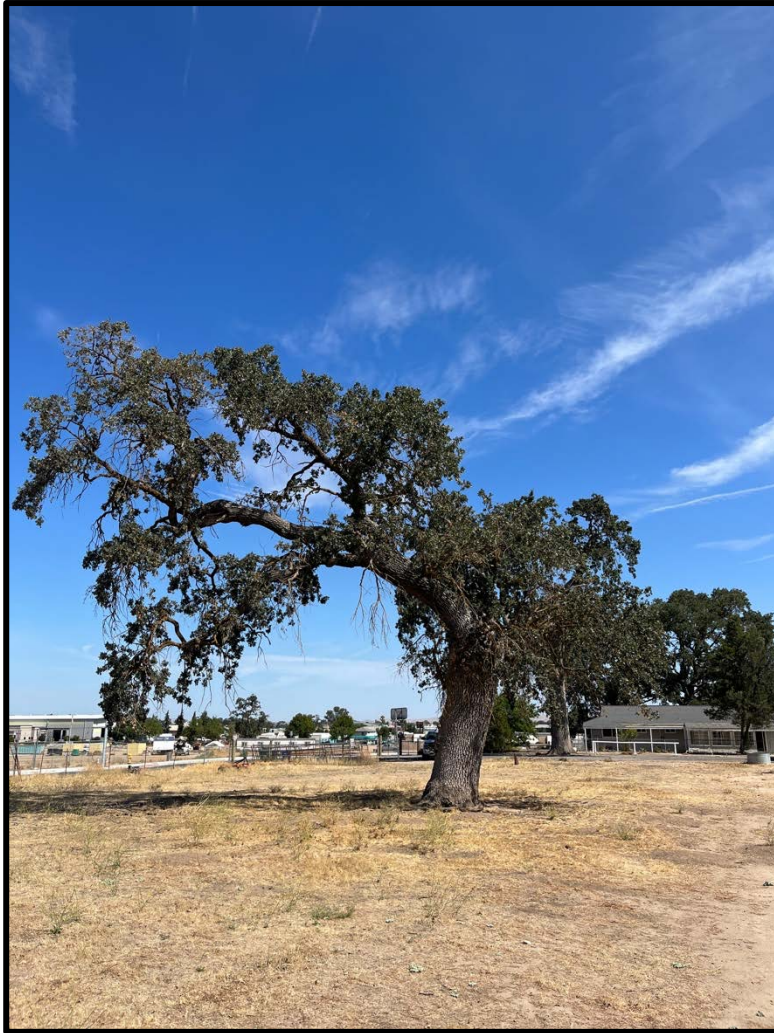
**Tree 3** – A 47” diameter valley oak was in Very Poor condition. When I sounded the trunk with a rubber mallet, it resounded hollow on the southwest side. A large wound left by a scaffold branch failure in the crown of the tree has since decayed and left a 3’x 4’ hollow at approximately 14’ above ground on the east side of tree. Another decay cavity on the north side of the tree at the same height as the previous, measured approximately 2’ in diameter. Remaining scaffold was overextended and attached to the decaying trunk. The remaining parts of this tree have a high likelihood of failure. See Appendix A - Photographs – Photos 15 & 16.

**Photo 15** - View of Tree 3 to north. Overextended scaffold to west. Large decay cavity at connection to trunk.

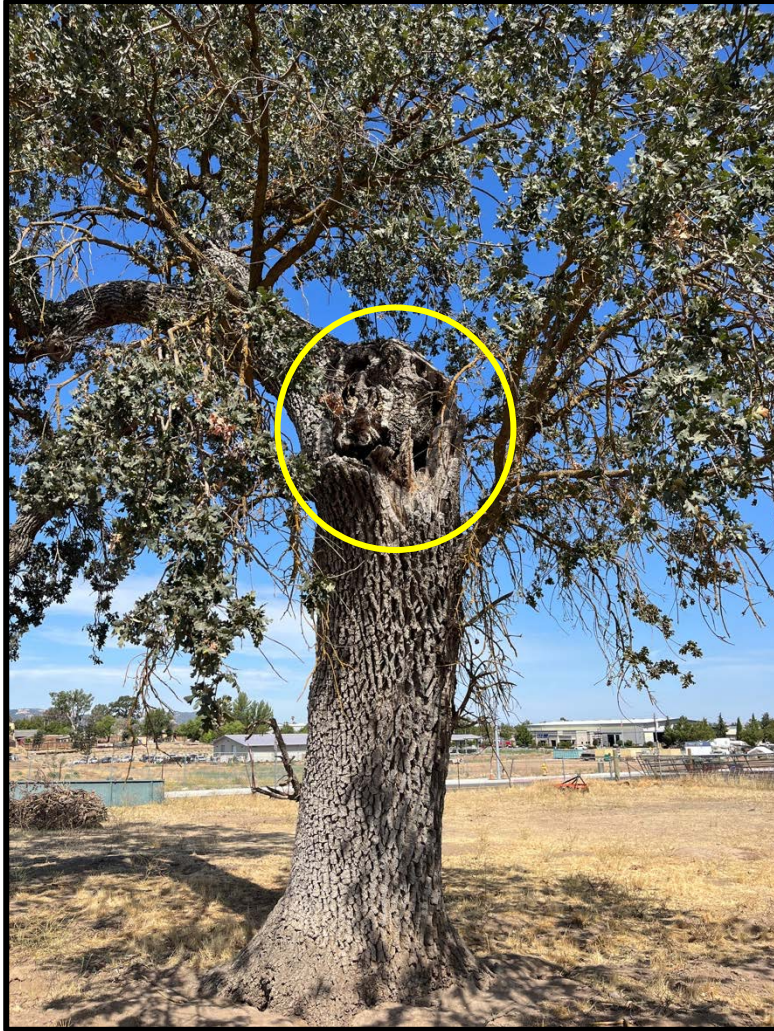
**Photo 16** - Tree 3 with large decay cavity at scaffold connection to trunk.

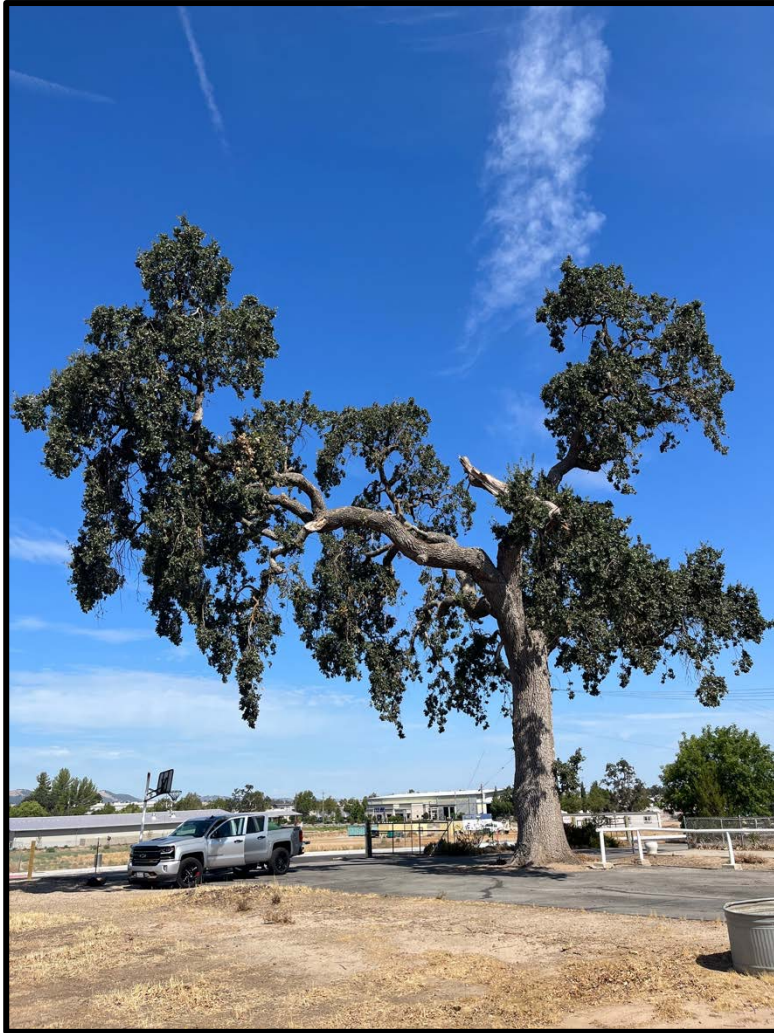
**Tree 4** – A 52” diameter valley oak was in Very Poor condition. The tree was growing off-site but had critical root zone (CRZ) and crown encroachments into your proposed construction area. This tree has had several large scaffold branch failures. At the failure points, significant decay was visible. The remaining scaffolds were overextended and potentially had similar internal decay and had a high likelihood of failure. See Appendix A - Photographs – Photo 17.

**Photo 17** - View of Tree 4 with to northwest. Numerous failed scaffold branches due to overextension and internal decay.

**Mitigation:** I highly recommend removal of this tree due to the advancement of decay in the scaffold branches which is compromising their structural integrity. Crown reduction needed to reduce the risk of scaffold branches failing would take up to 50% of the live canopy and jeopardize the tree’s health. Because this tree is off site, you will need to coordinate with the owner regarding removal.

At minimum this tree should have all overextended branches reduced to help prevent further failures and protect any buildings or other targets you may place on your property within striking distance of the tree. If the owner of the tree chooses to retain it, you will need to design buildings, service and loading zones outside of the CRZ.

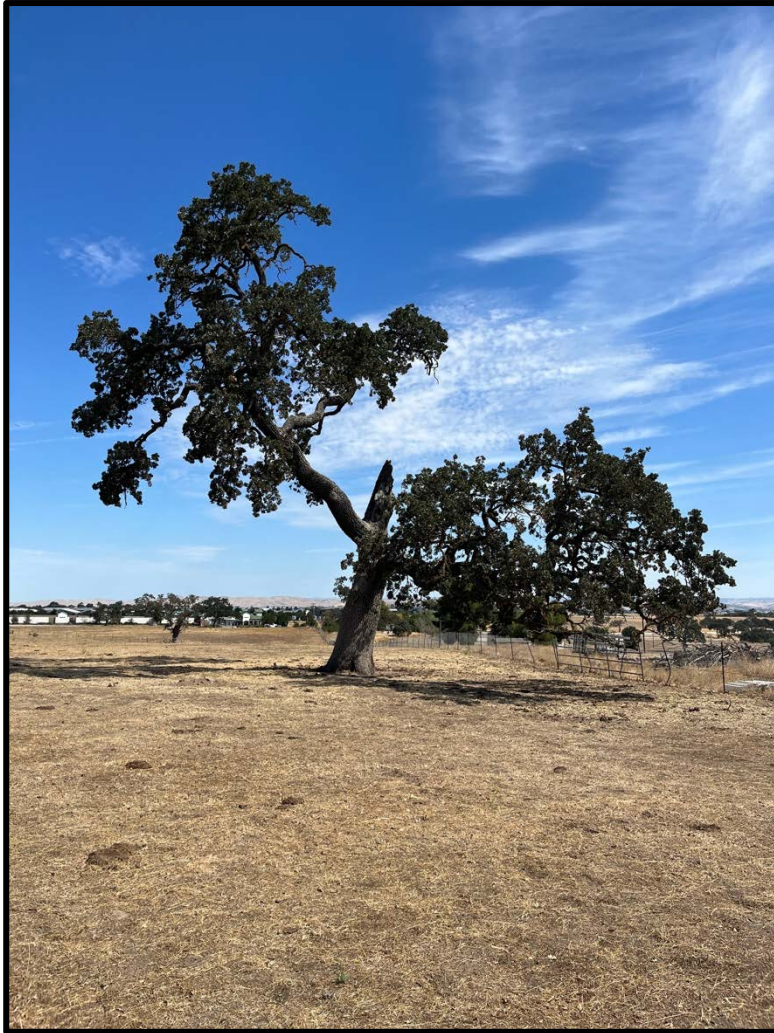
**Tree 9** – A 51” diameter valley oak was in Very Poor condition. Multiple large scaffold branches had failed. Extensive decay was present at branch failure points. Only 2 overextended scaffold branches remain, and they are connected to a decaying trunk.

When I sounded the trunk with a rubber mallet, it resounded hollow. A 3’ long by 10” wide decay cavity was on the northeast side of trunk. This tree has a high risk of complete failure. See Appendix A - Photographs – Photos 18 & 19.

**Photo 18** - View of Tree 9 to north. Numerous failed scaffold branches due to overextension and internal decay.

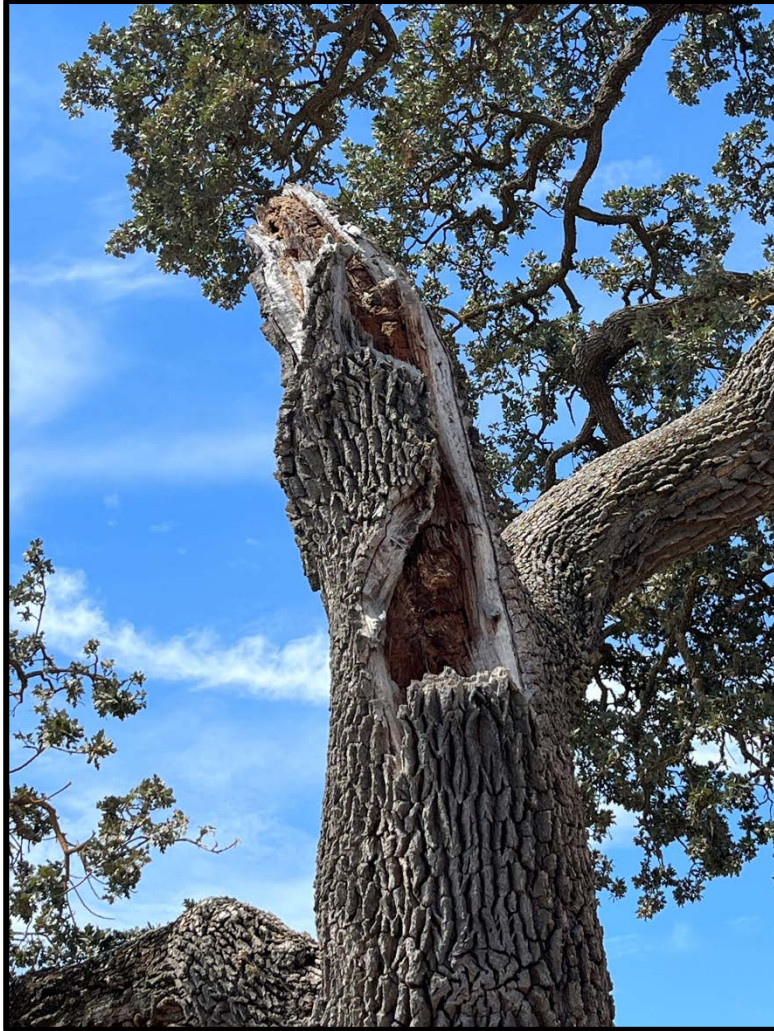
**Photo 19** - Tree 9 close-up of failed scaffold branch with internal decay.

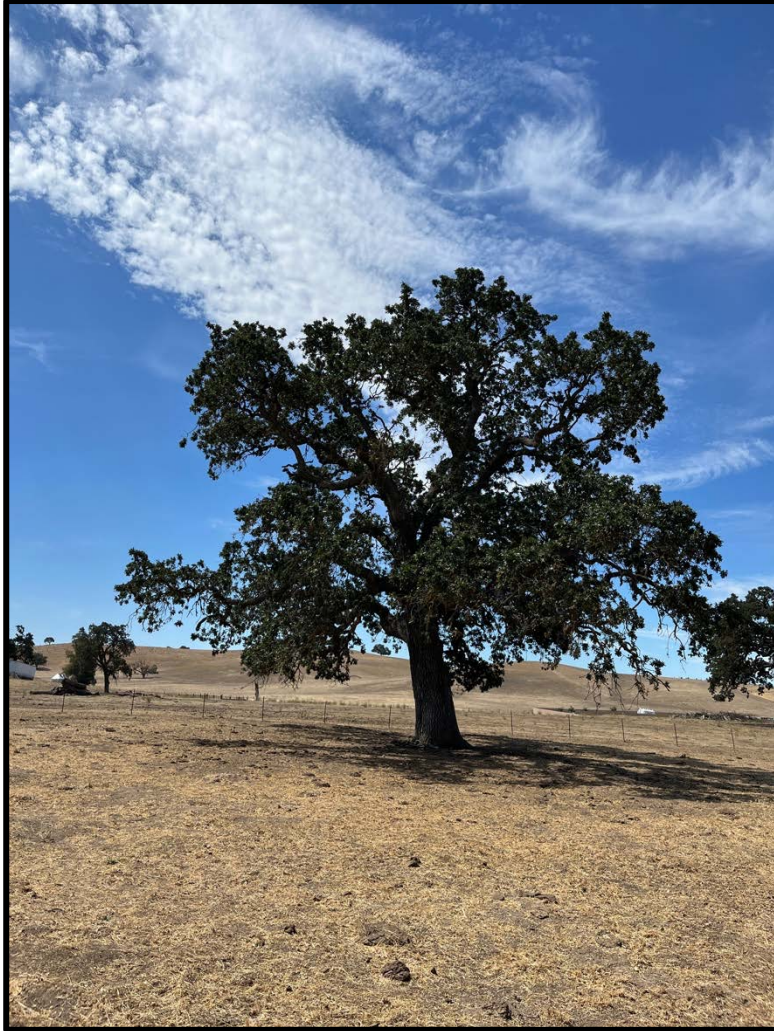
**Tree 10** – A 51” diameter valley oak was in Good condition. The trunk of the tree resounded solid when sounded with a rubber mallet. Tree form was good, but there was some large dead wood and decaying scaffolds. This tree can be retained, but it should have maintenance pruning performed prior to commencement of your project. See Appendix A - Photographs – Photos 20 & 21.

**Photo 20** - View of Tree 10 to south.

**Mitigation:** Reduce end-weight up to 25% on overextended scaffold branches. Remove dead wood 2" diameter and larger. Remove decayed and structurally unsound scaffold branches. Supervision of pruning work by the Project Arborist shall be required.

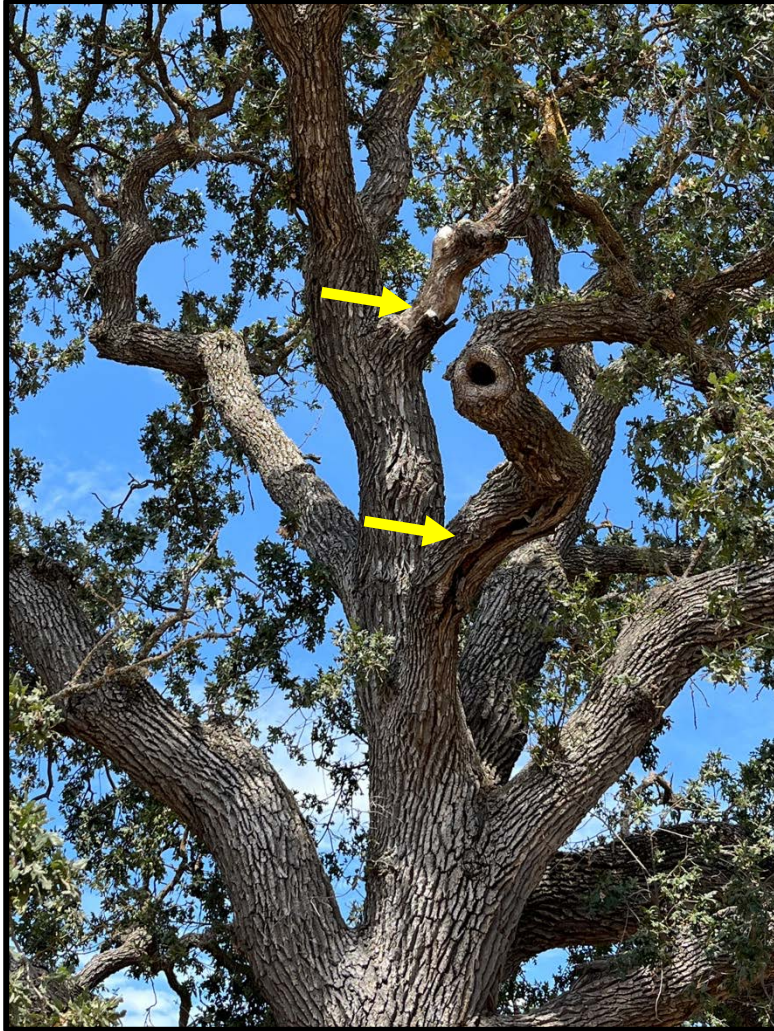
**Photo 21** - Tree 10 with decayed scaffold branch indicated by yellow arrows.

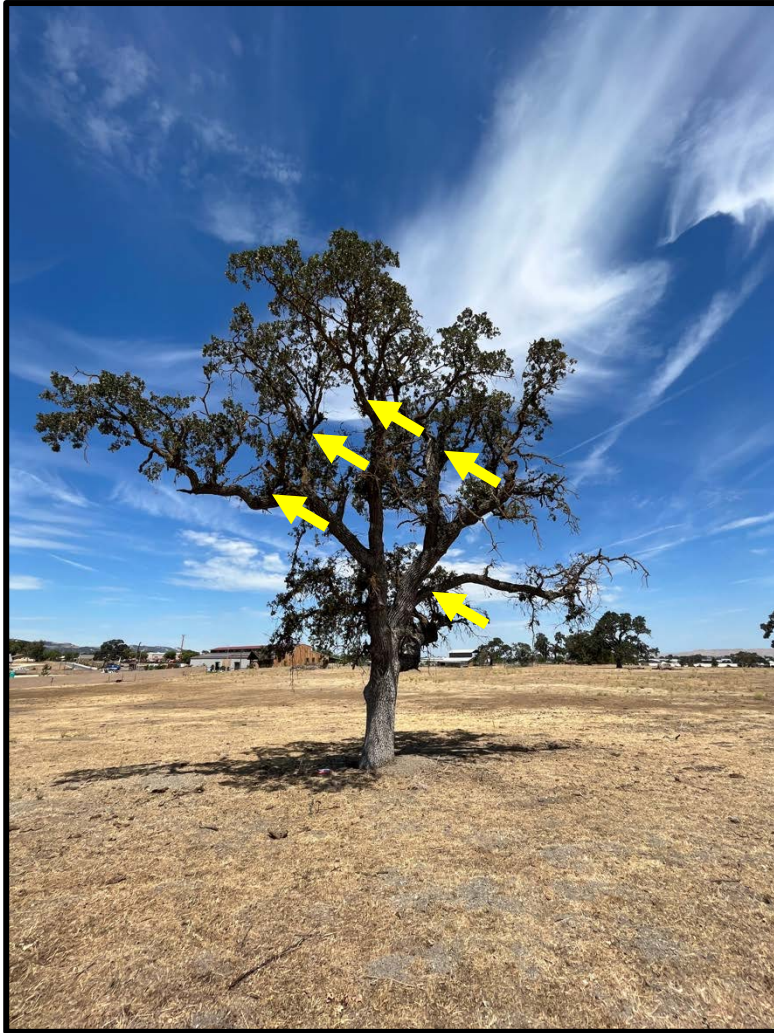
**Tree 11** – A 30" diameter valley oak was in Very Poor condition. The tree was in severe decline due to drought stress and root disease. Many of the smaller branches had died. I detected decay at the root crown on the southwest side of the tree. I found an ant nest at the root-crown decay area indicating ants are excavating and nesting in dead roots and root crown. The dead roots contribute to the decline of the canopy and compromise the stability of the tree. At least five, 12" average diameter scaffolds had extensive decay on the east side of the tree. To reduce scaffold failure risk, up to 50% of the live canopy would need to be removed, which would compromise the health of an already unhealthy tree. See Appendix A - Photographs – Photos 22-24.

**Photo 22** - View of Tree 11 to north. At least 5 decayed scaffold branches would be removed which would reduce the tree at least 50%. Arrows indicate branch removal points.

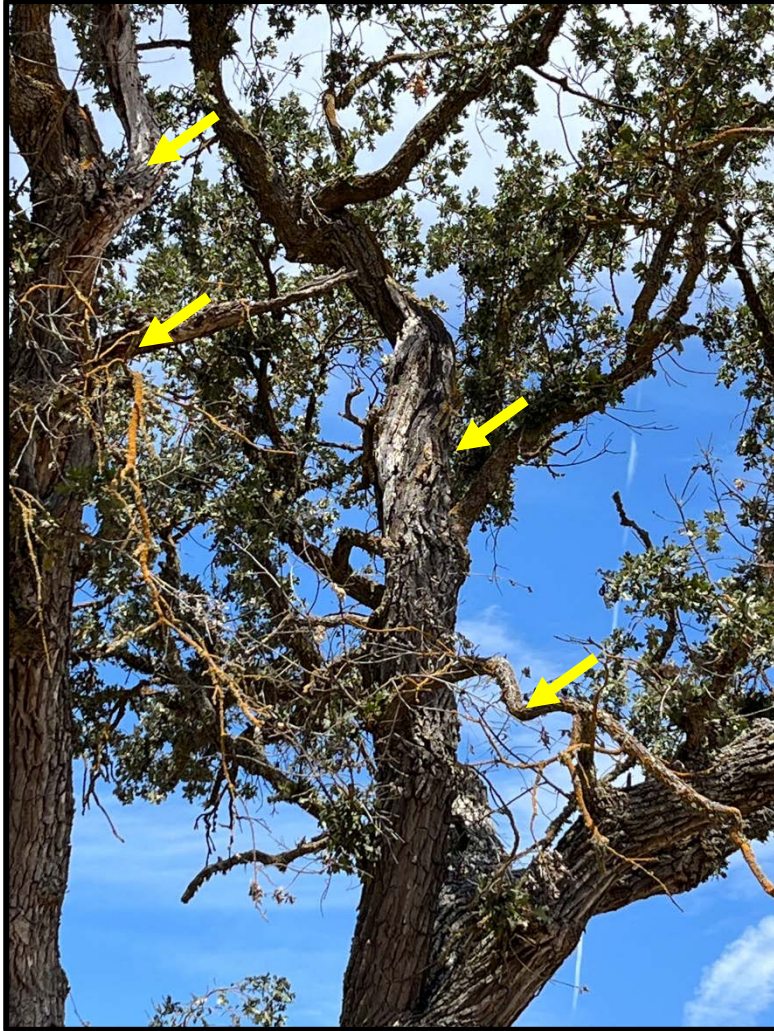
**Photo 23** - Tree 11 close up of declining canopy, decayed branches, and dead wood indicated by arrows.

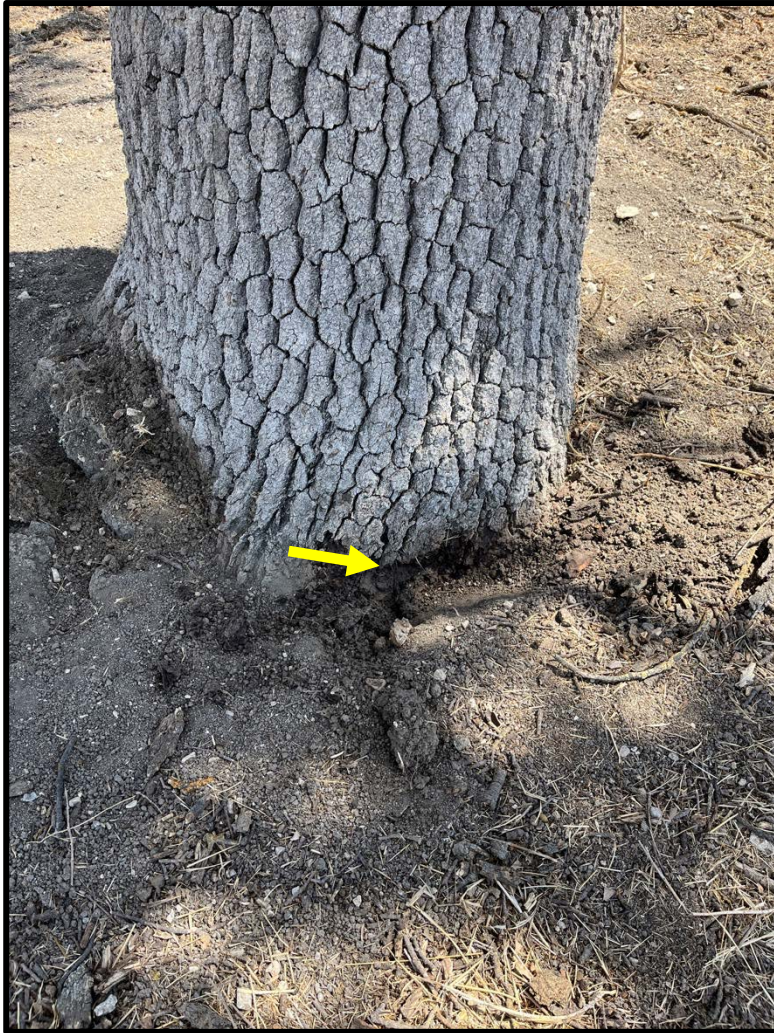
**Photo 24** - Tree 11 close up of root crown decay at southwest side of tree indicated by yellow arrow. Ant nest discovered here which indicates dead and rotting wood.

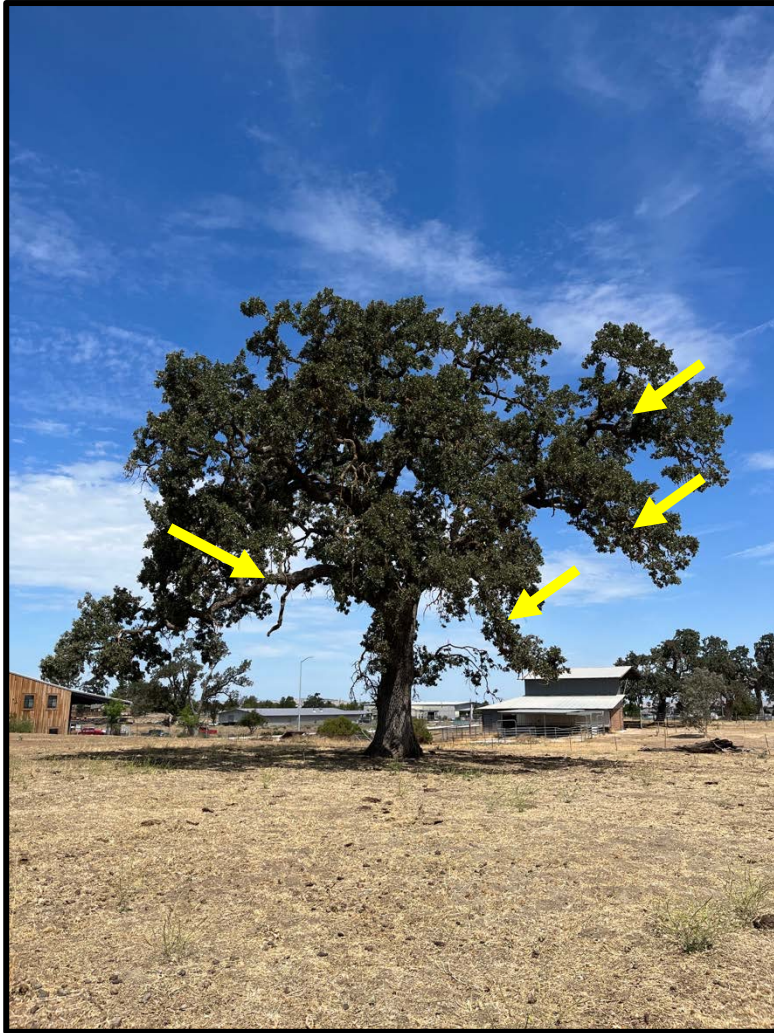
**Tree 13** – A 42" diameter valley oak was in Poor condition.

**Photo 25** - View of Tree 13 to north. Note overextended scaffold branches indicated by arrows.
