# Exhibit B

October 21, 2022

**Re:** Oak Tree Impact and Protection report for Ardmore Road Project, 2930 Union Rd, Paso Robles, CA 93446

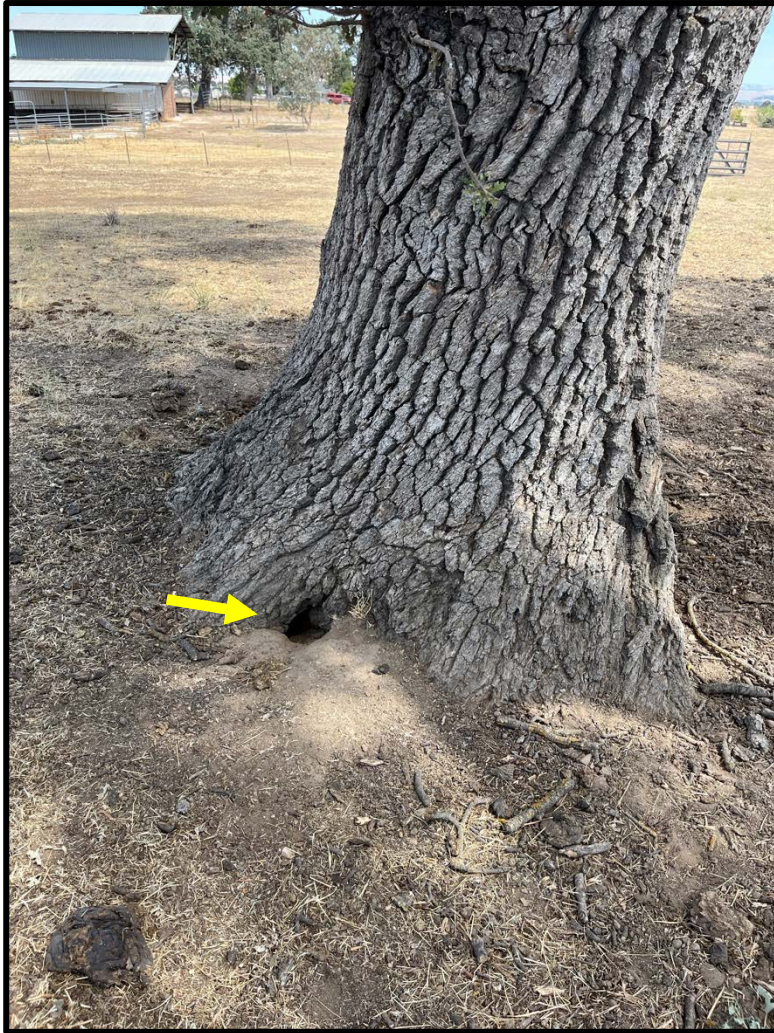
**Photo 26** - Tree 13 with root decay cavity on south side of tree indicated by arrow.

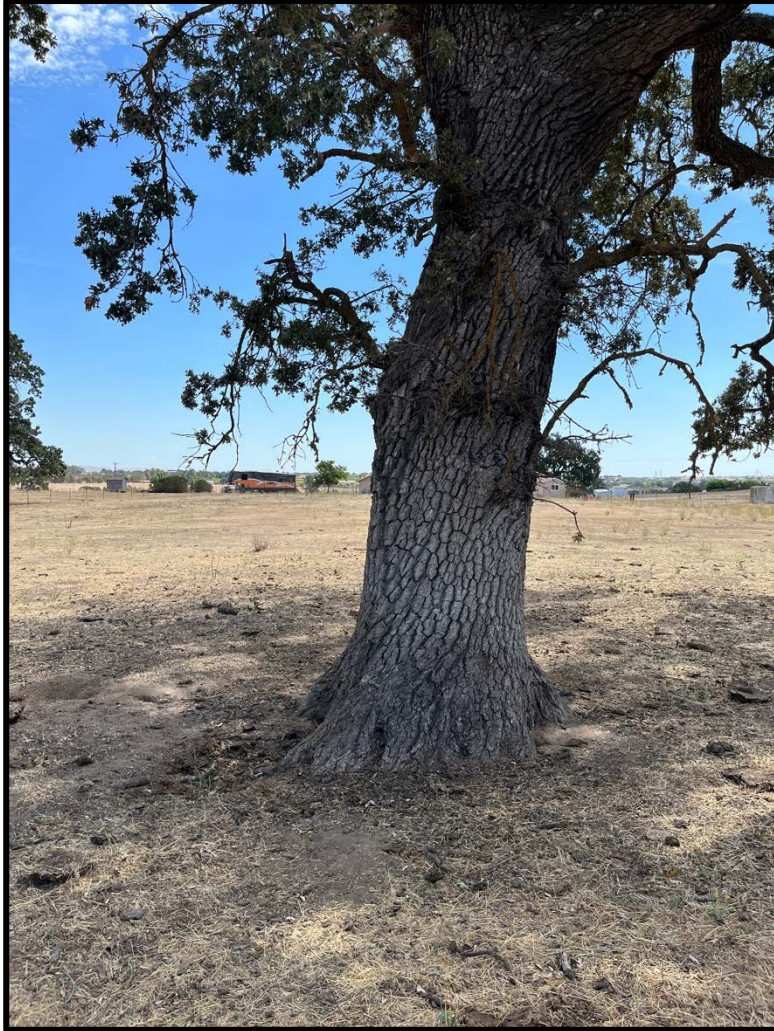
**Photo 27** - Tree 13 with bulging root-crown indicating possible butt-rot.

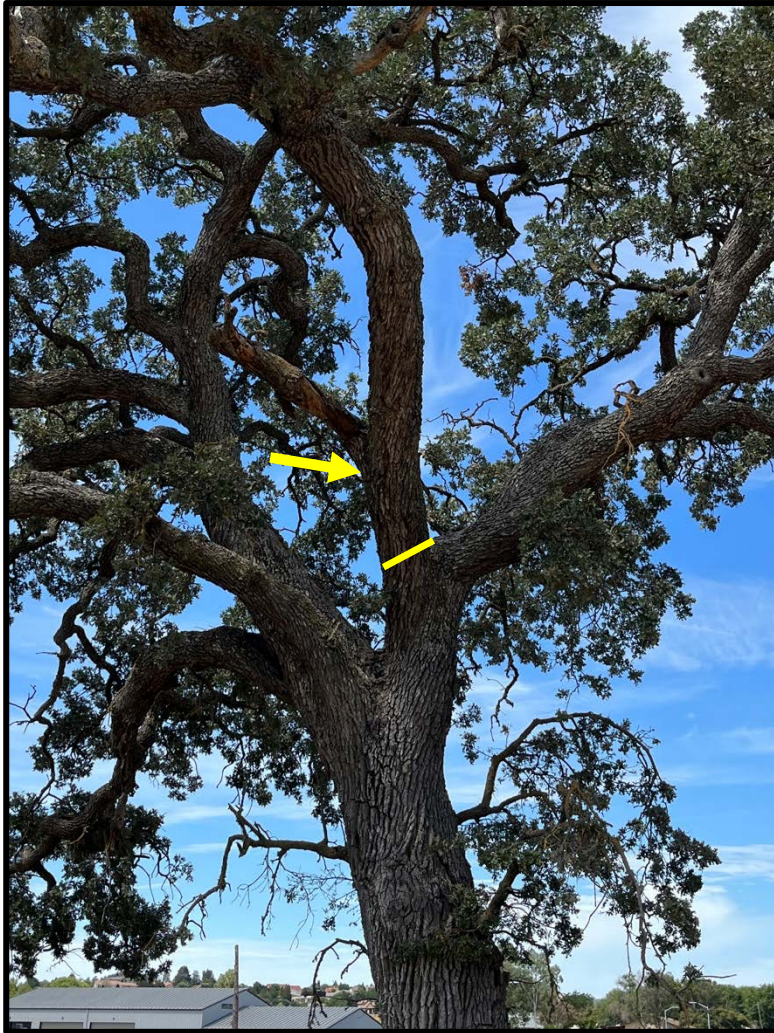
**Photo 28-** Tree 13 with decaying scaffold branch east side of canopy indicated by arrow. Line indicates locations for removal

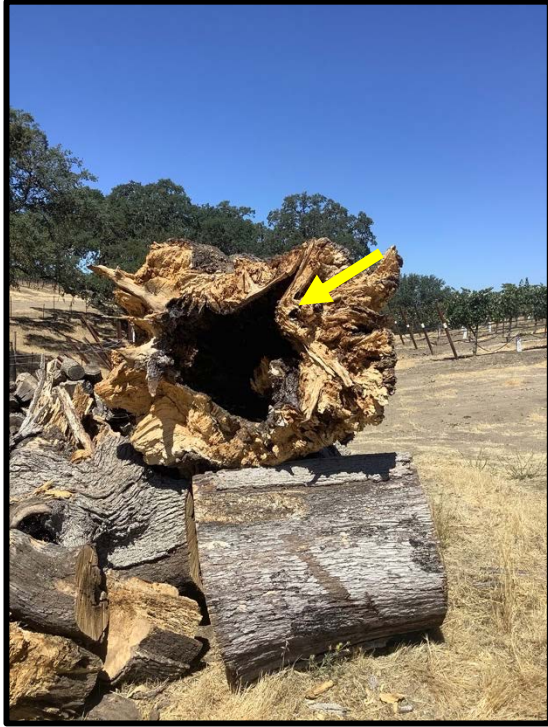
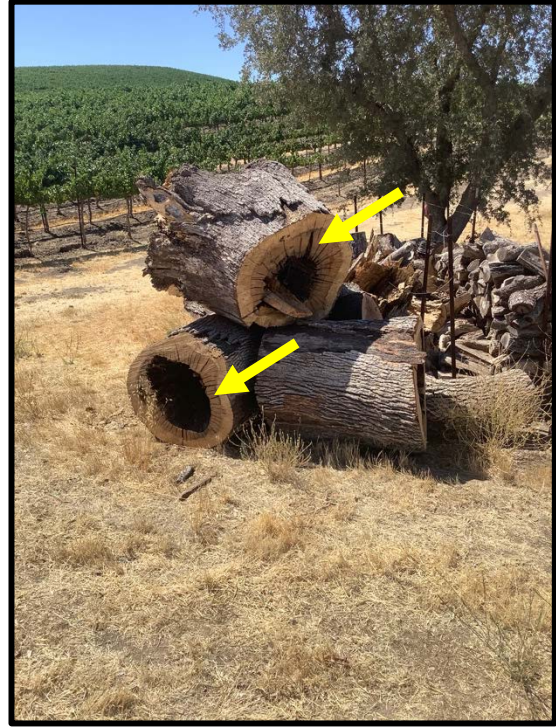
*Armillaria mellea*, a.k.a. Oak root fungus is a common disease in valley oaks and is likely the cause of the decay in the roots and the trunk. Christopher J. Luley in his guide *Wood Decay Fungi* calls this fungus *Number one of the "Big Three" of the important decay fungi*. Again, according to Mr. Luley, "Armillaria is a root and butt rot fungus that increases the risk of tree failure and is a pathogen capable of killing cambium of roots and lower trunk of stressed trees". See Appendix A - Photographs - Photos 29 & 30 for example of failed oak due to root and butt rot.

**Photos 29 & 30** - Example of oak tree that failed due to root and butt-rot. Photo 29 shows failed roots. Photo 30 shows internal decay of trunk.
