Exhibit C

July 31, 2025

Per your request, the following memo is an update of recommendations regarding two (2) native oaks at your Ardmore Project located at 2930 Union Road, in Paso Robles, California.

Tree Assessment Updates

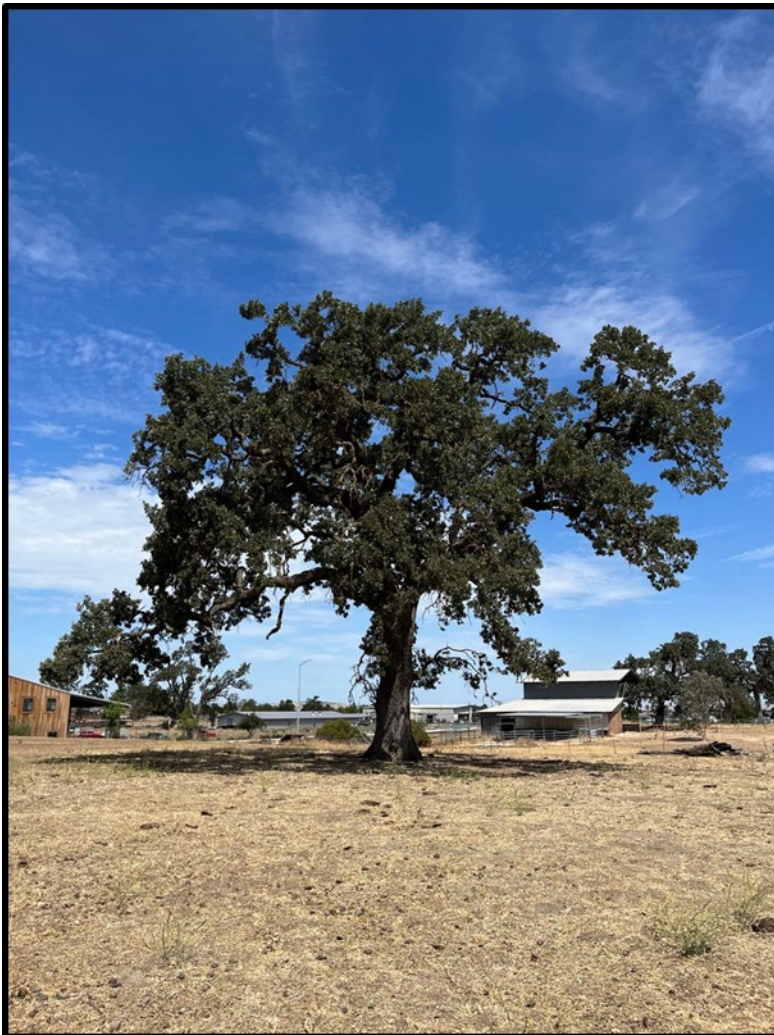
The tree had a diameter of 42 inches. The outer shell, live wood thickness of the trunk measured by the Resistograph showed a substantial loss of internal wood that provides structure to the tree. Sample 5 was the thinnest sample measured at 3.5' above ground.

At this location there was an approximate 77% radial loss of wood. Samples 2 and 3 were the thickest samples measured at 3.5' above ground, at these locations there was an approximate 60% radial loss of wood. Essentially all that is left of the trunk is a hollow tube that is supporting multiple tons of canopy weight.

In my report dated October 19, 2022, I concluded through a tree risk assessment, that the risk of Tree #13 failing at the trunk due to advanced internal decay was HIGH.

Photo 1 – Tree 13 with view to northeast. Outwardly, the tree appears to be healthy but internal rot makes it structurally unstable.

I recommend to the City of Paso Robles planning department that Tree 13 be removed based on the risk of it failing and potentially severely injuring residents of the development.

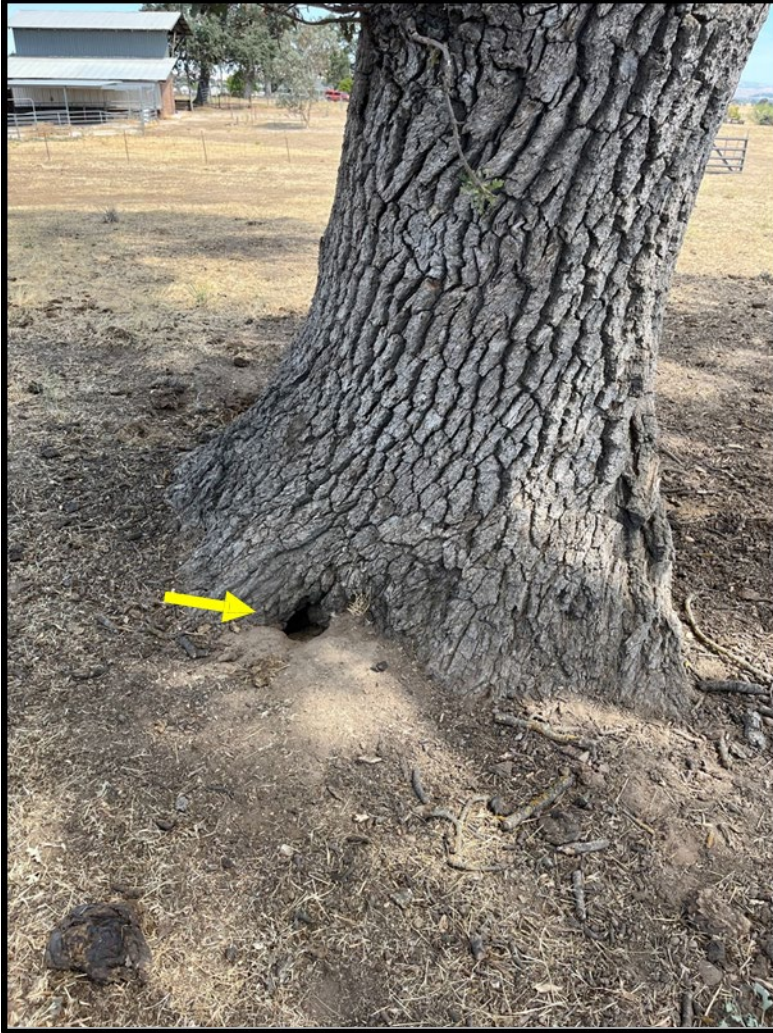
Photo 2 – Tree 13 with root decay cavity on south side of tree indicated by arrow.

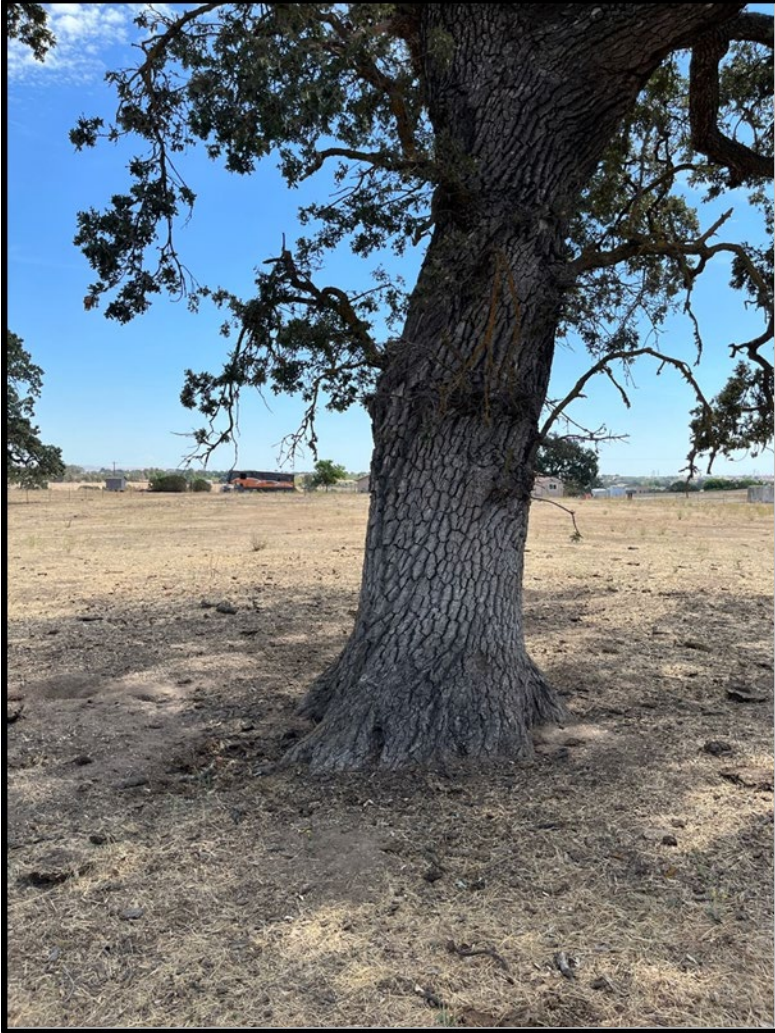
Photo 3 – Tree 13 with bulging root-crown indicating possible butt-rot.

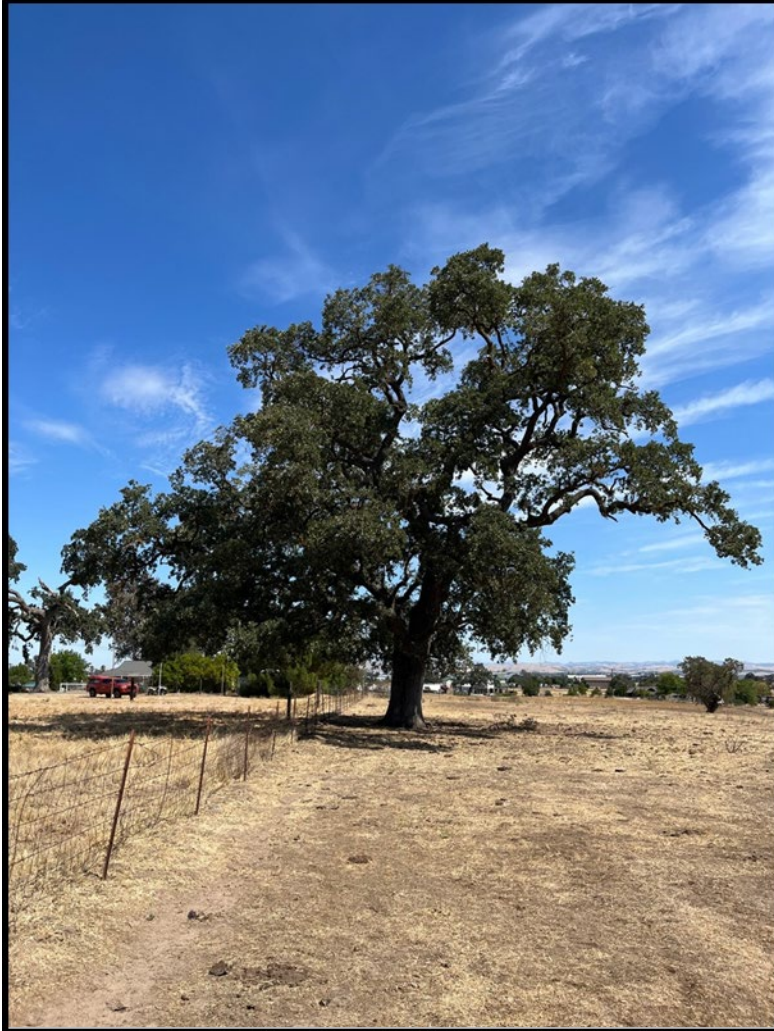
Photo 4 – Tree 2 in 2022. Outwardly, the tree appears to be healthy but internal rot makes it structurally unstable.

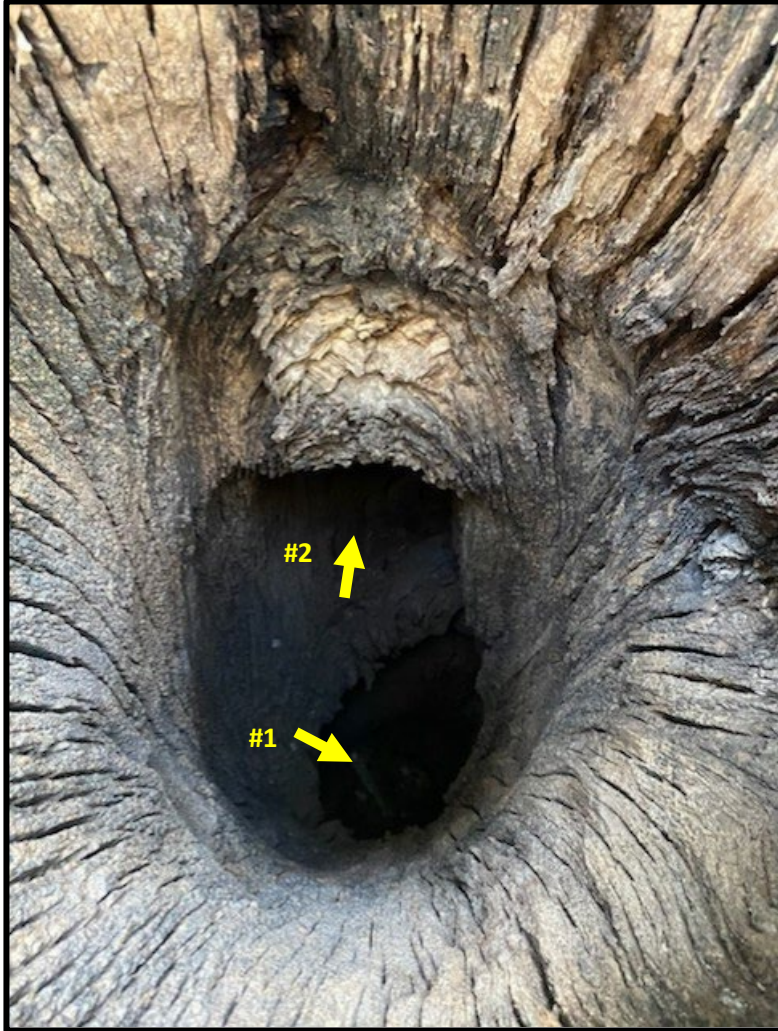
Photo 5 – Tree 2 in 2022. View of interior decay cavity formed by failed scaffold. Arrow 1 shows depth of cavity down to roots of tree. Arrow 2 shows decay that has advanced into eastern scaffold branch. The tree has high potential to fail due to internal decay.

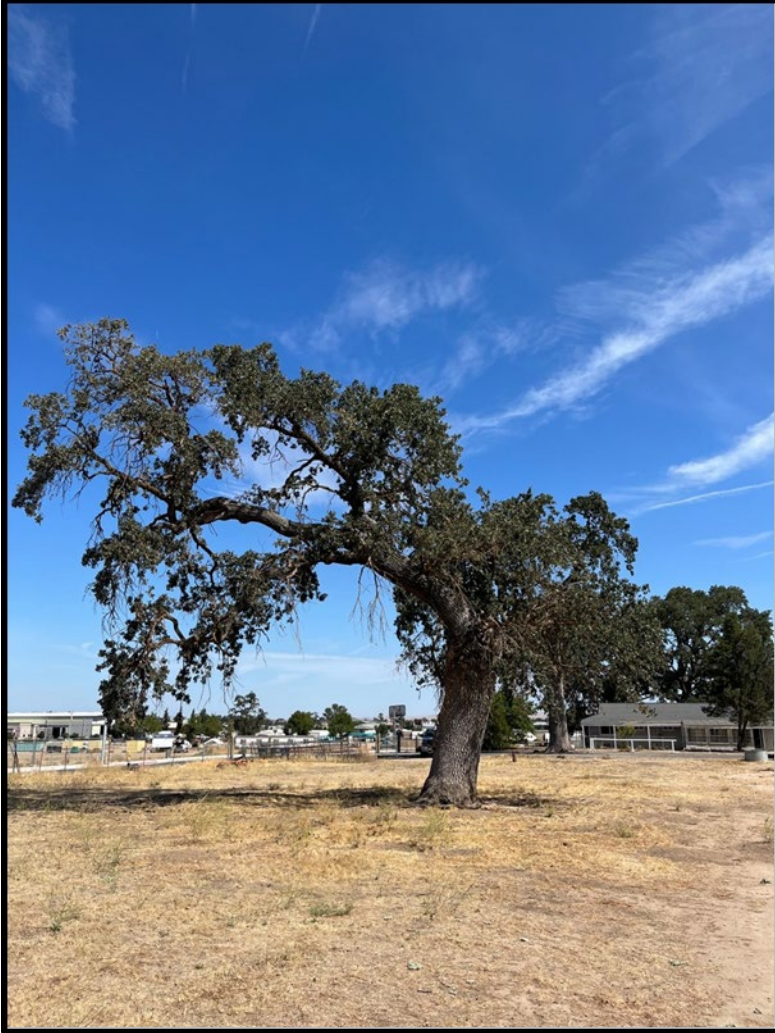
Photo 6 – Tree 3 in 2022. Outwardly, the tree appears to be moderately healthy but internal rot made it structurally unstable.

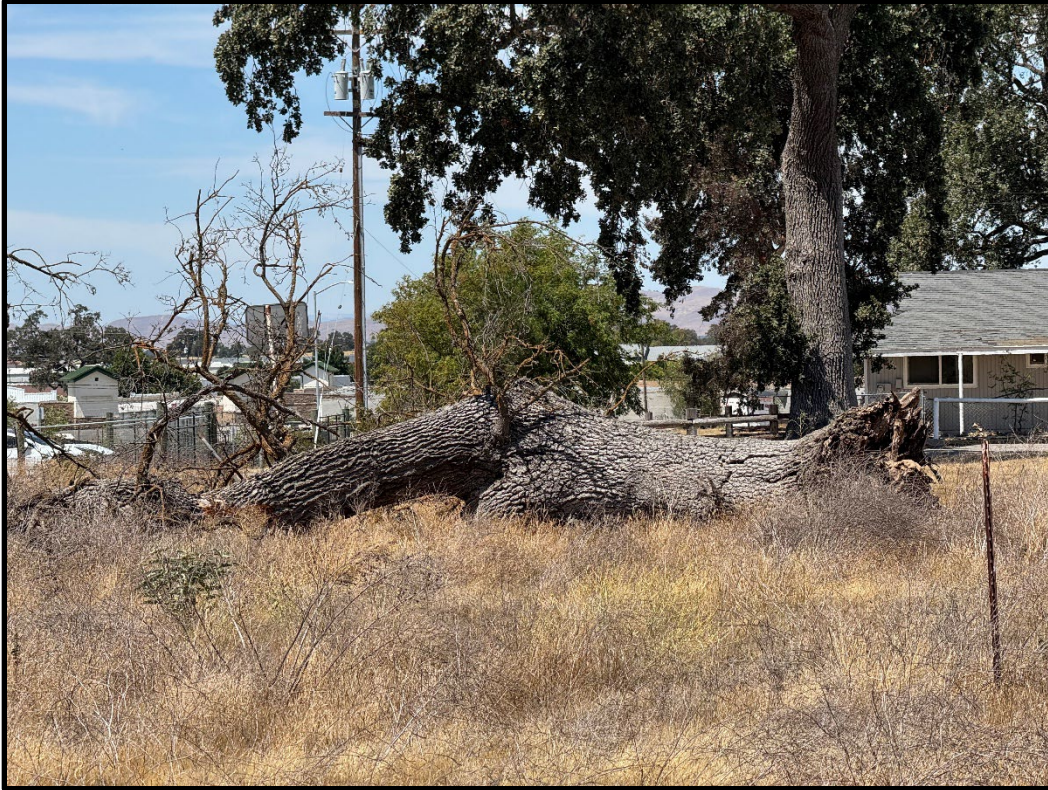
Since my original report was submitted to you in October of 2022, Tree #3 has failed to internal decay and root rot that affected its structural integrity. In my original report, I noted that the tree had several decay cavities throughout the trunk as well as in one scaffold branch. My recommendation at the time was for the tree's removal. Now that the tree has failed, this tree should be eliminated from the survey. The failed tree should not count toward the oak tree mitigation replacement calculation since it is no longer alive or standing. See Appendix A- Photographs – Photo 7.

Photo 7 – Tree 3 – July 2025. The tree has died due to root rot and failed because of internal decay and root rot.
