## A&T Arborists and Vegetation Management

Angel Cabrera  
1517 Olive Street  
Paso Robles, CA 93466

### ASSIGNMENT AND SUMMARY OF FINDINGS

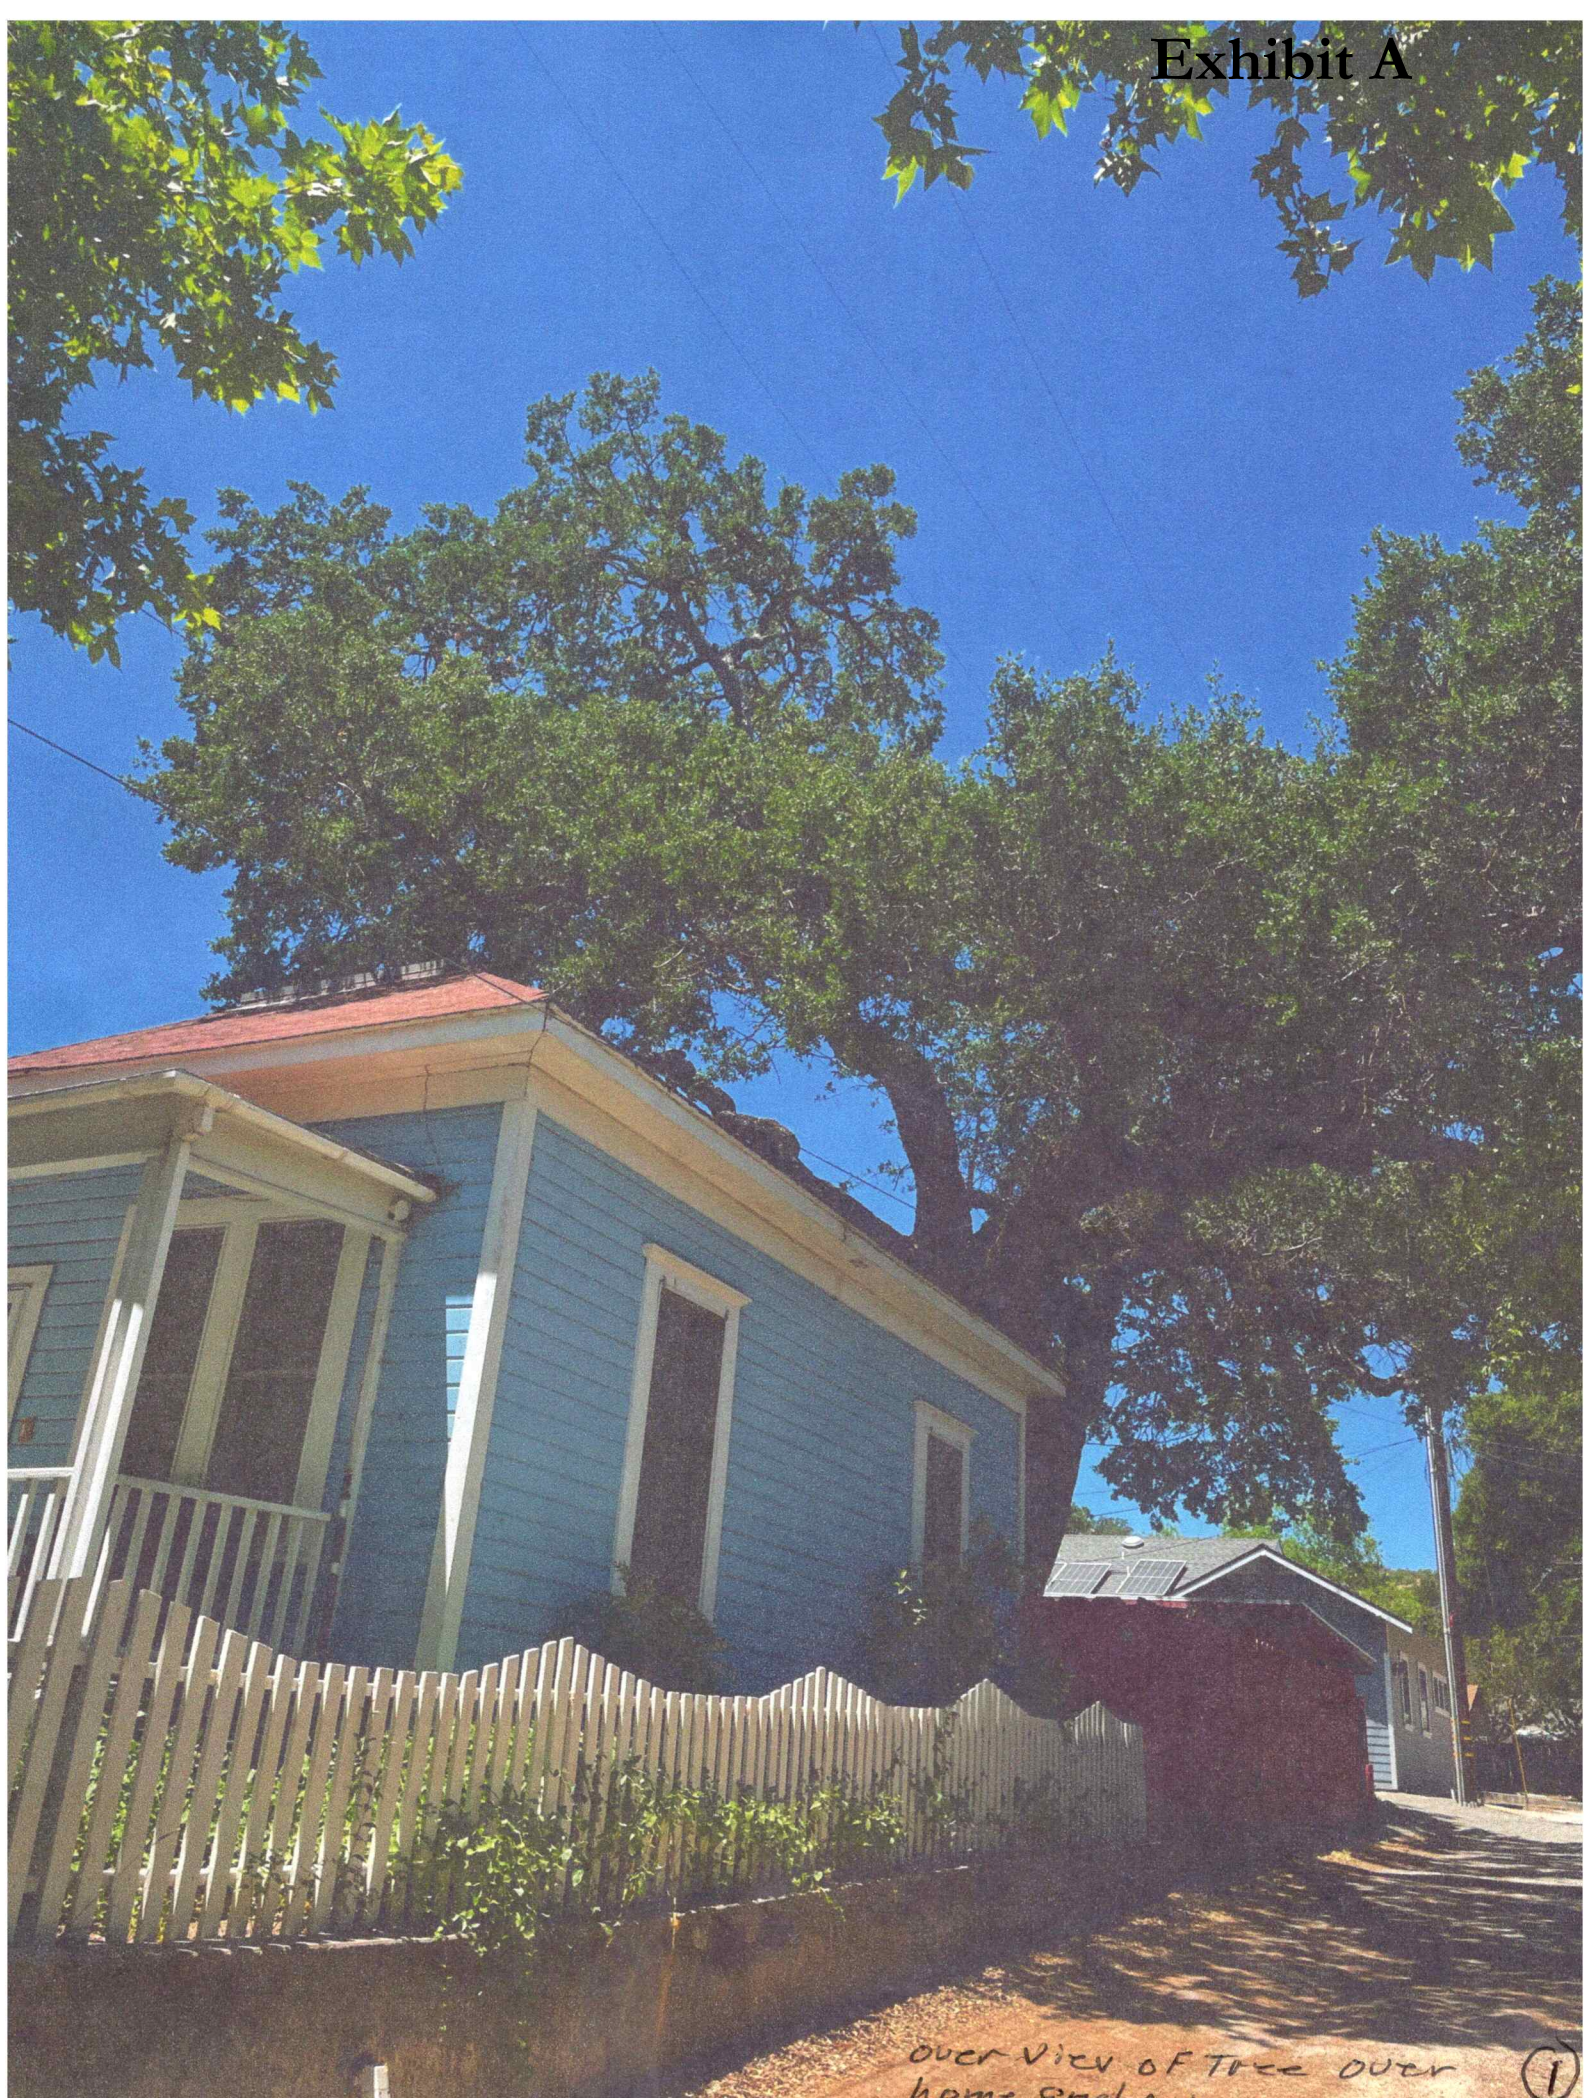
OVER VIEW OF TREE OVER  
HOME ENCLAVE

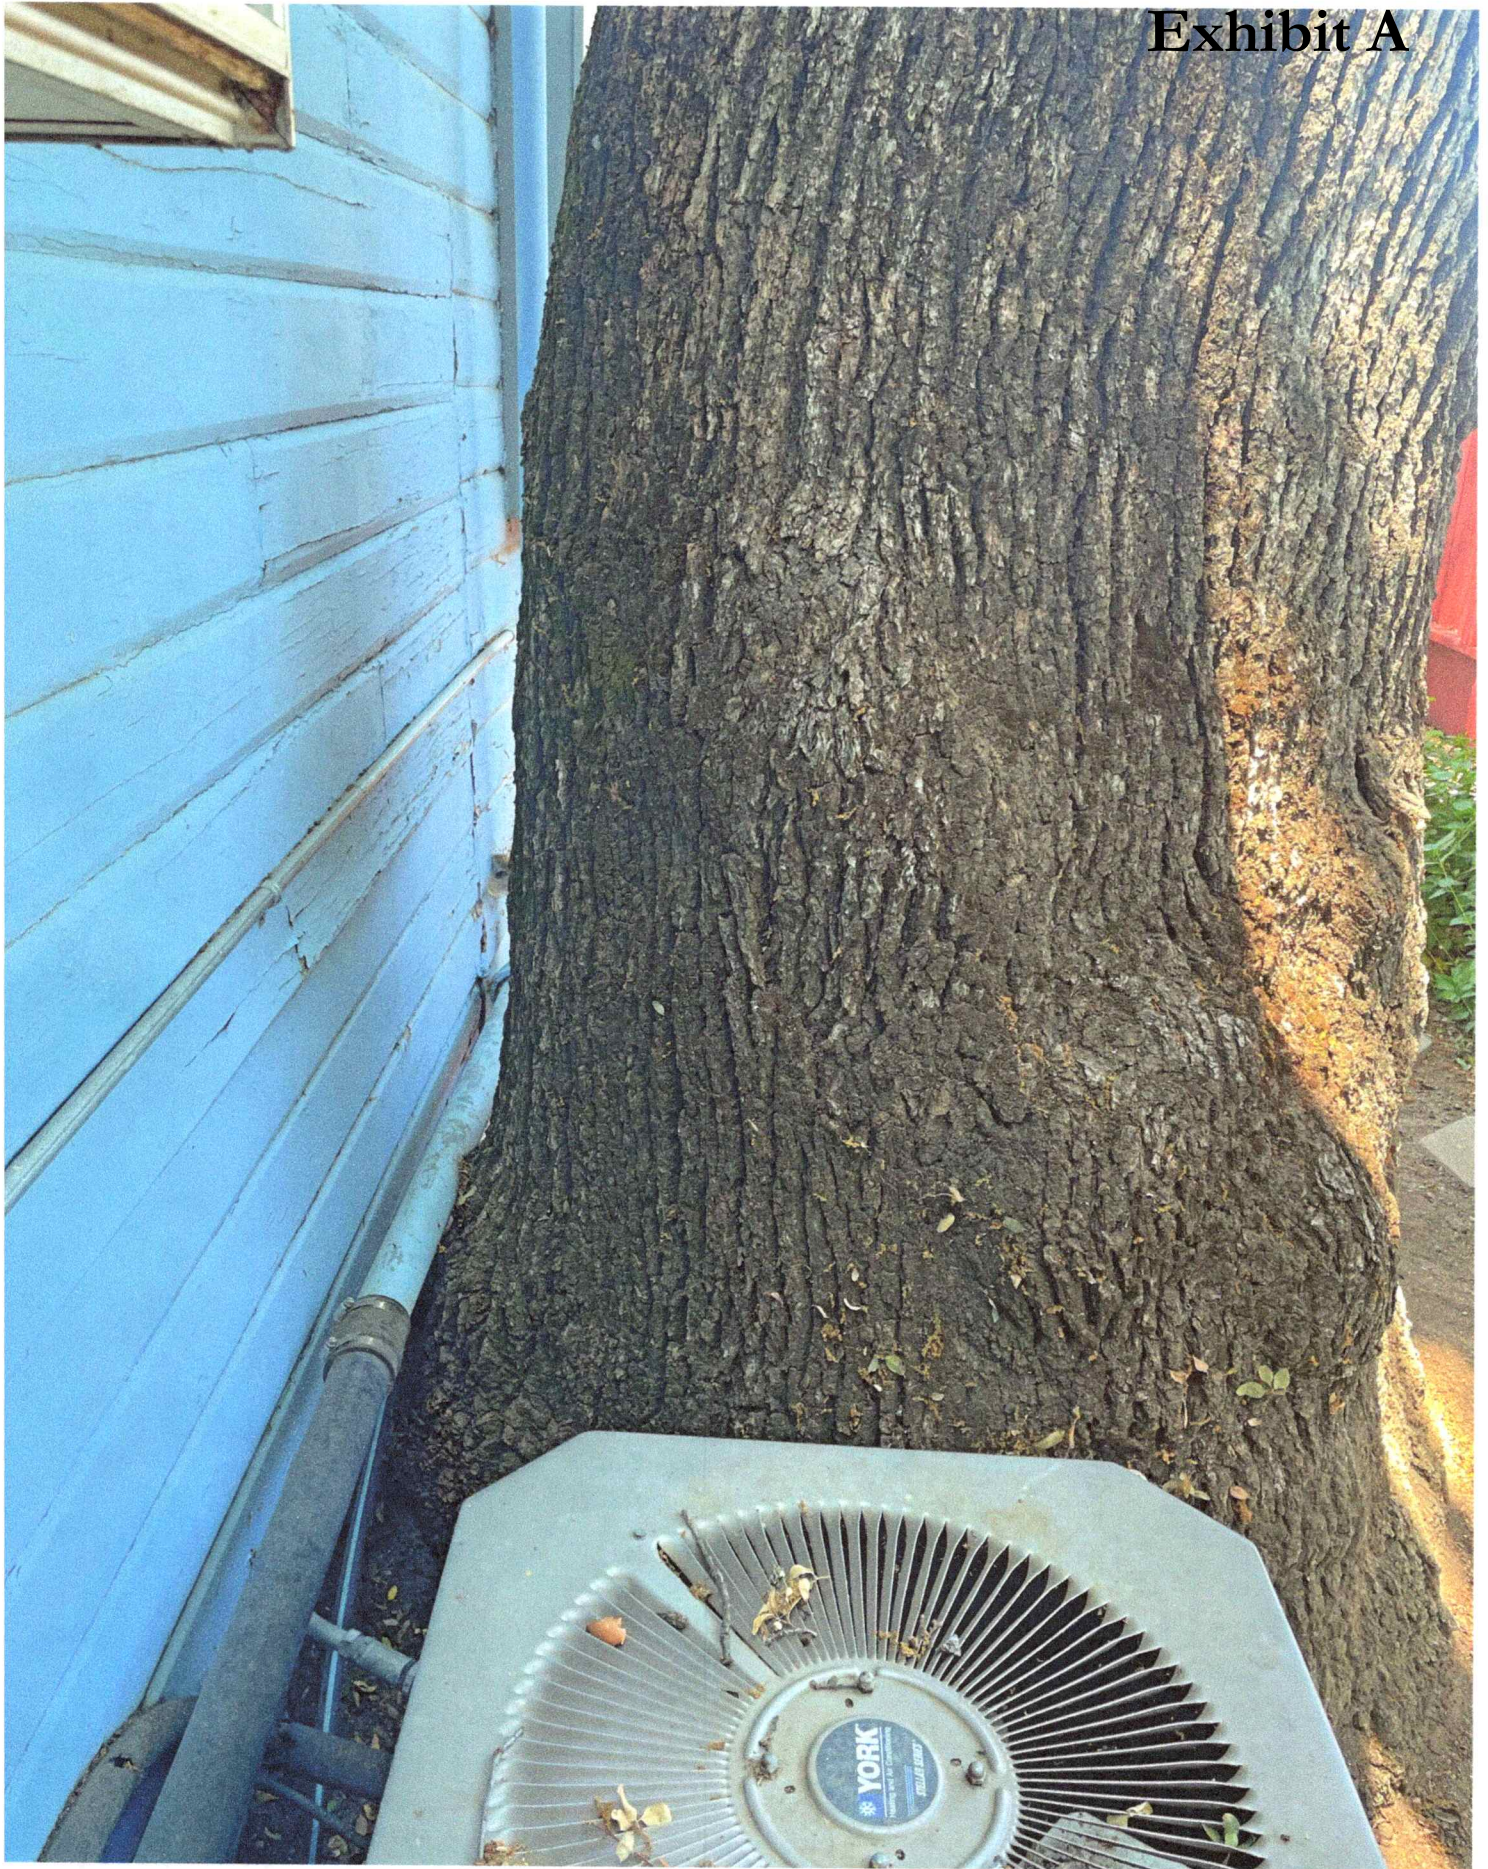
View of 40" Trunk TDBH, shows closeness to utilities/home/  
Foundation

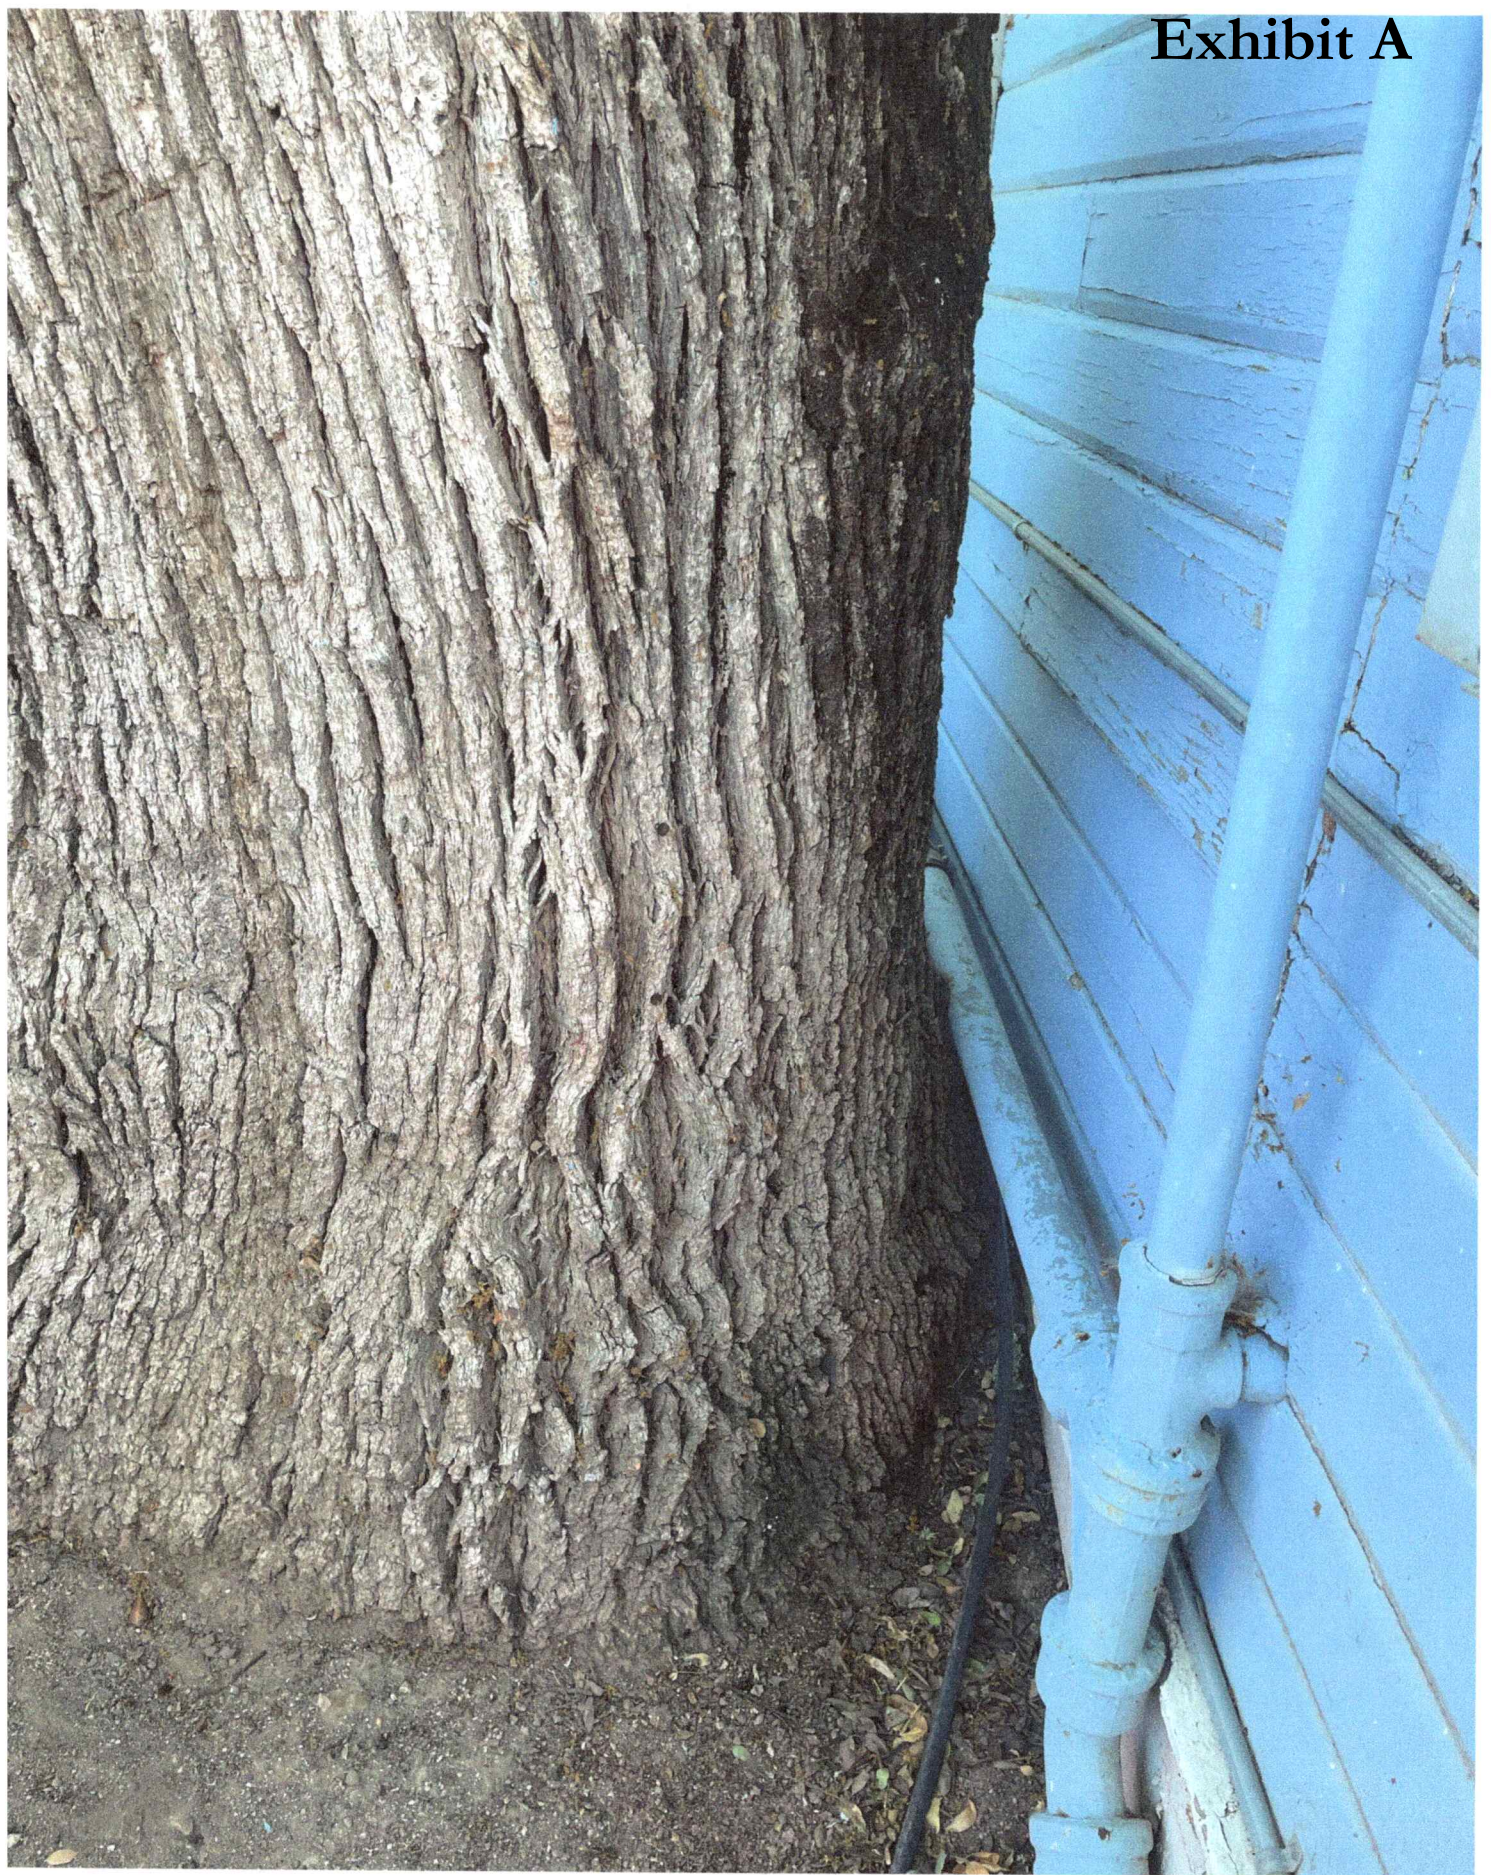
Other pic of Trunk near home and utilities

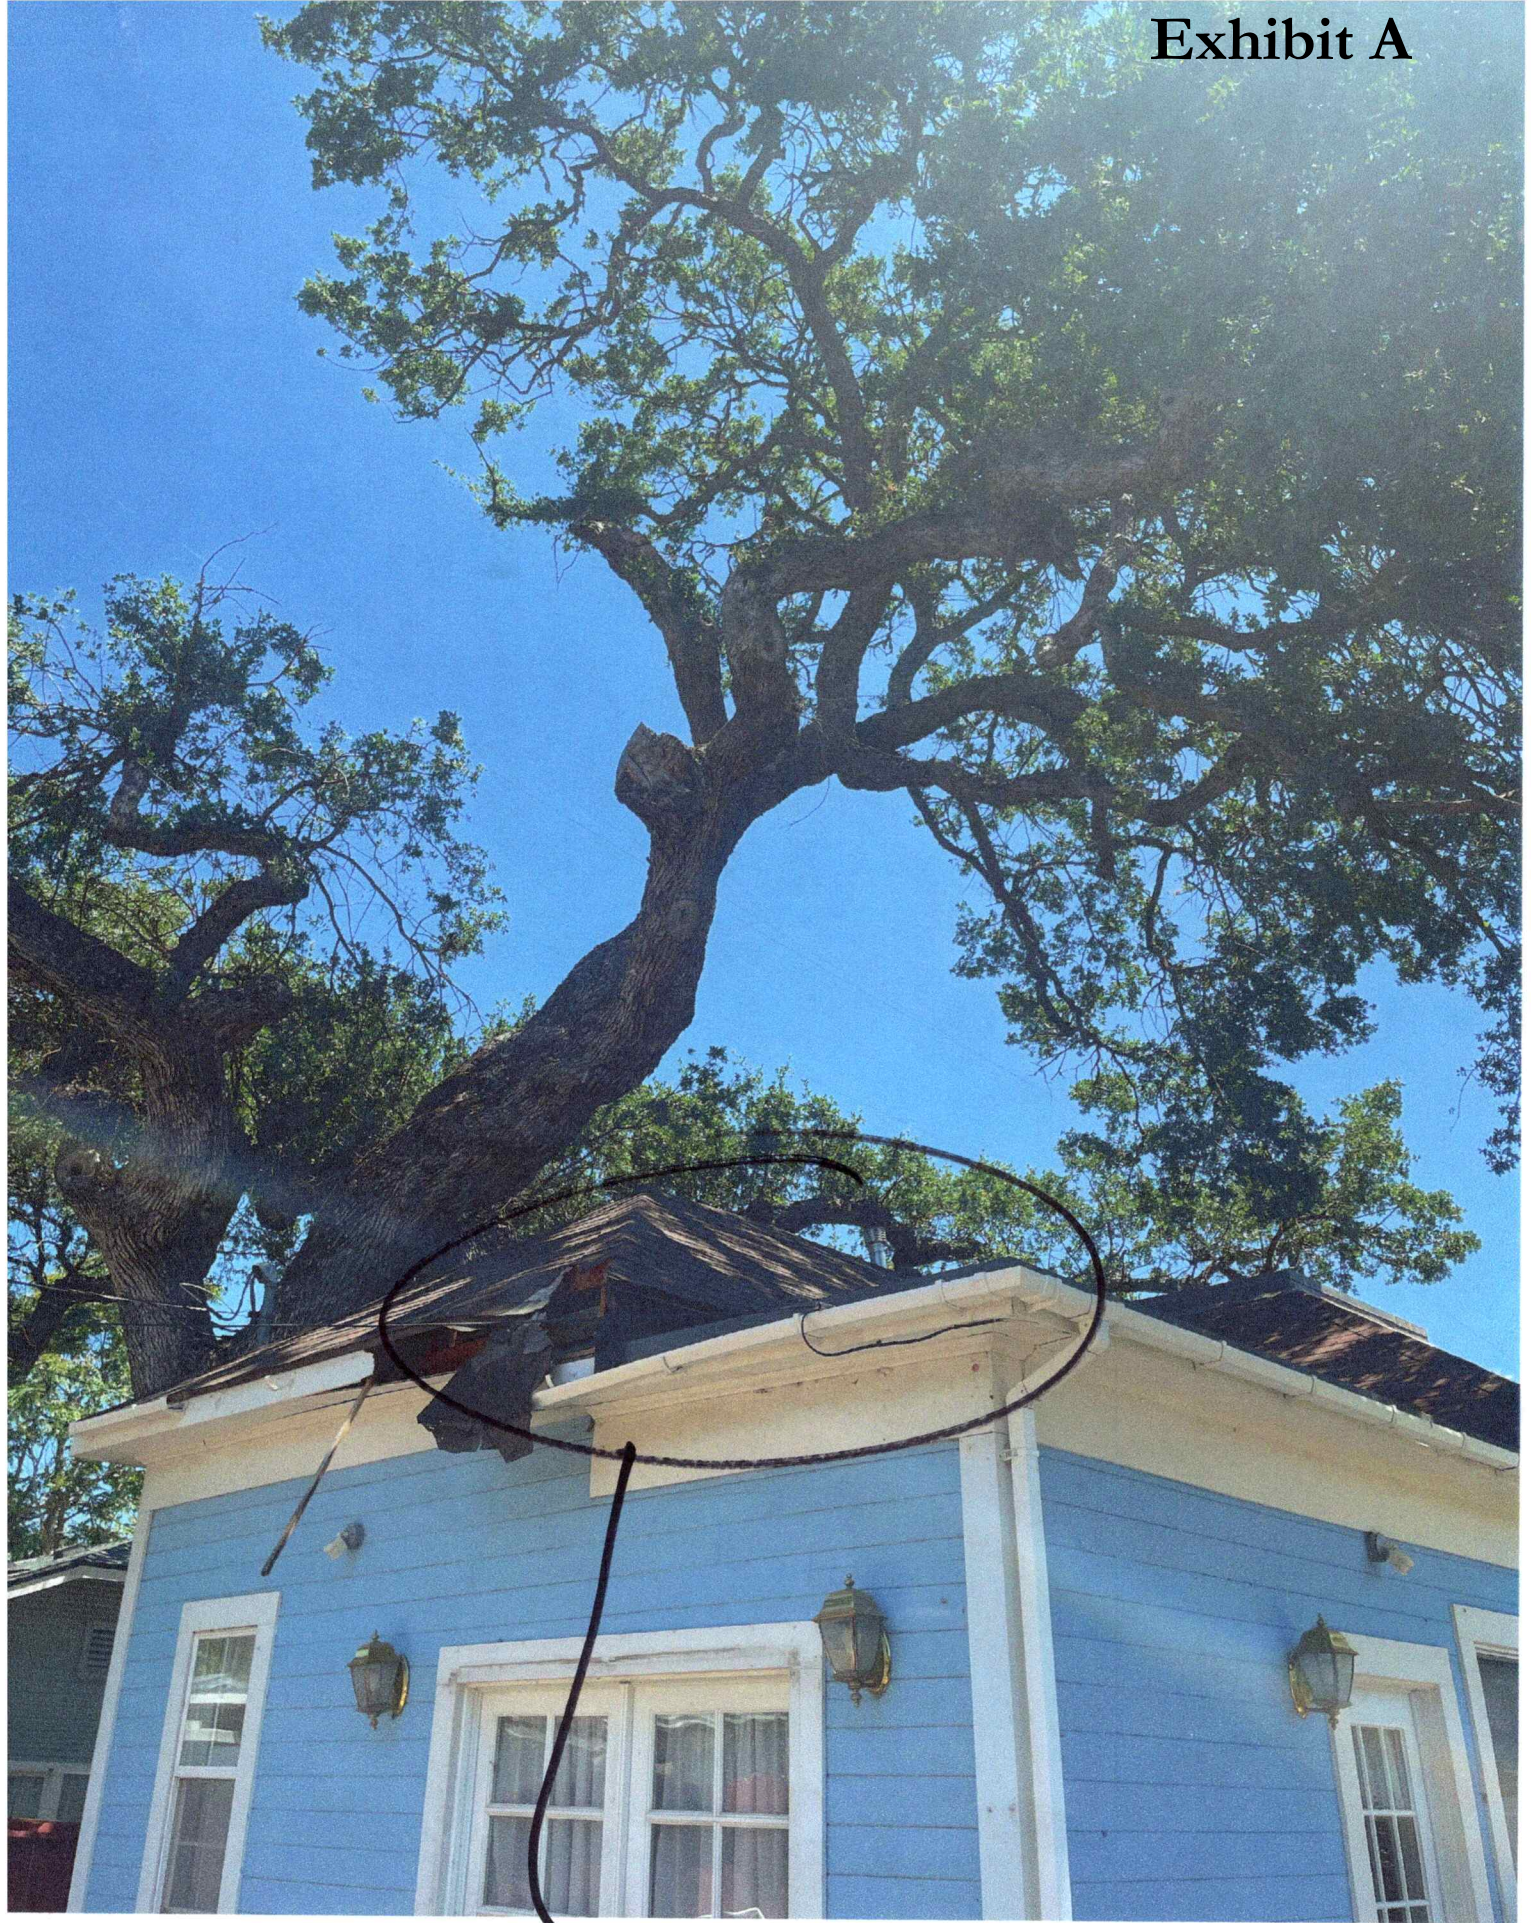
Recent Damage

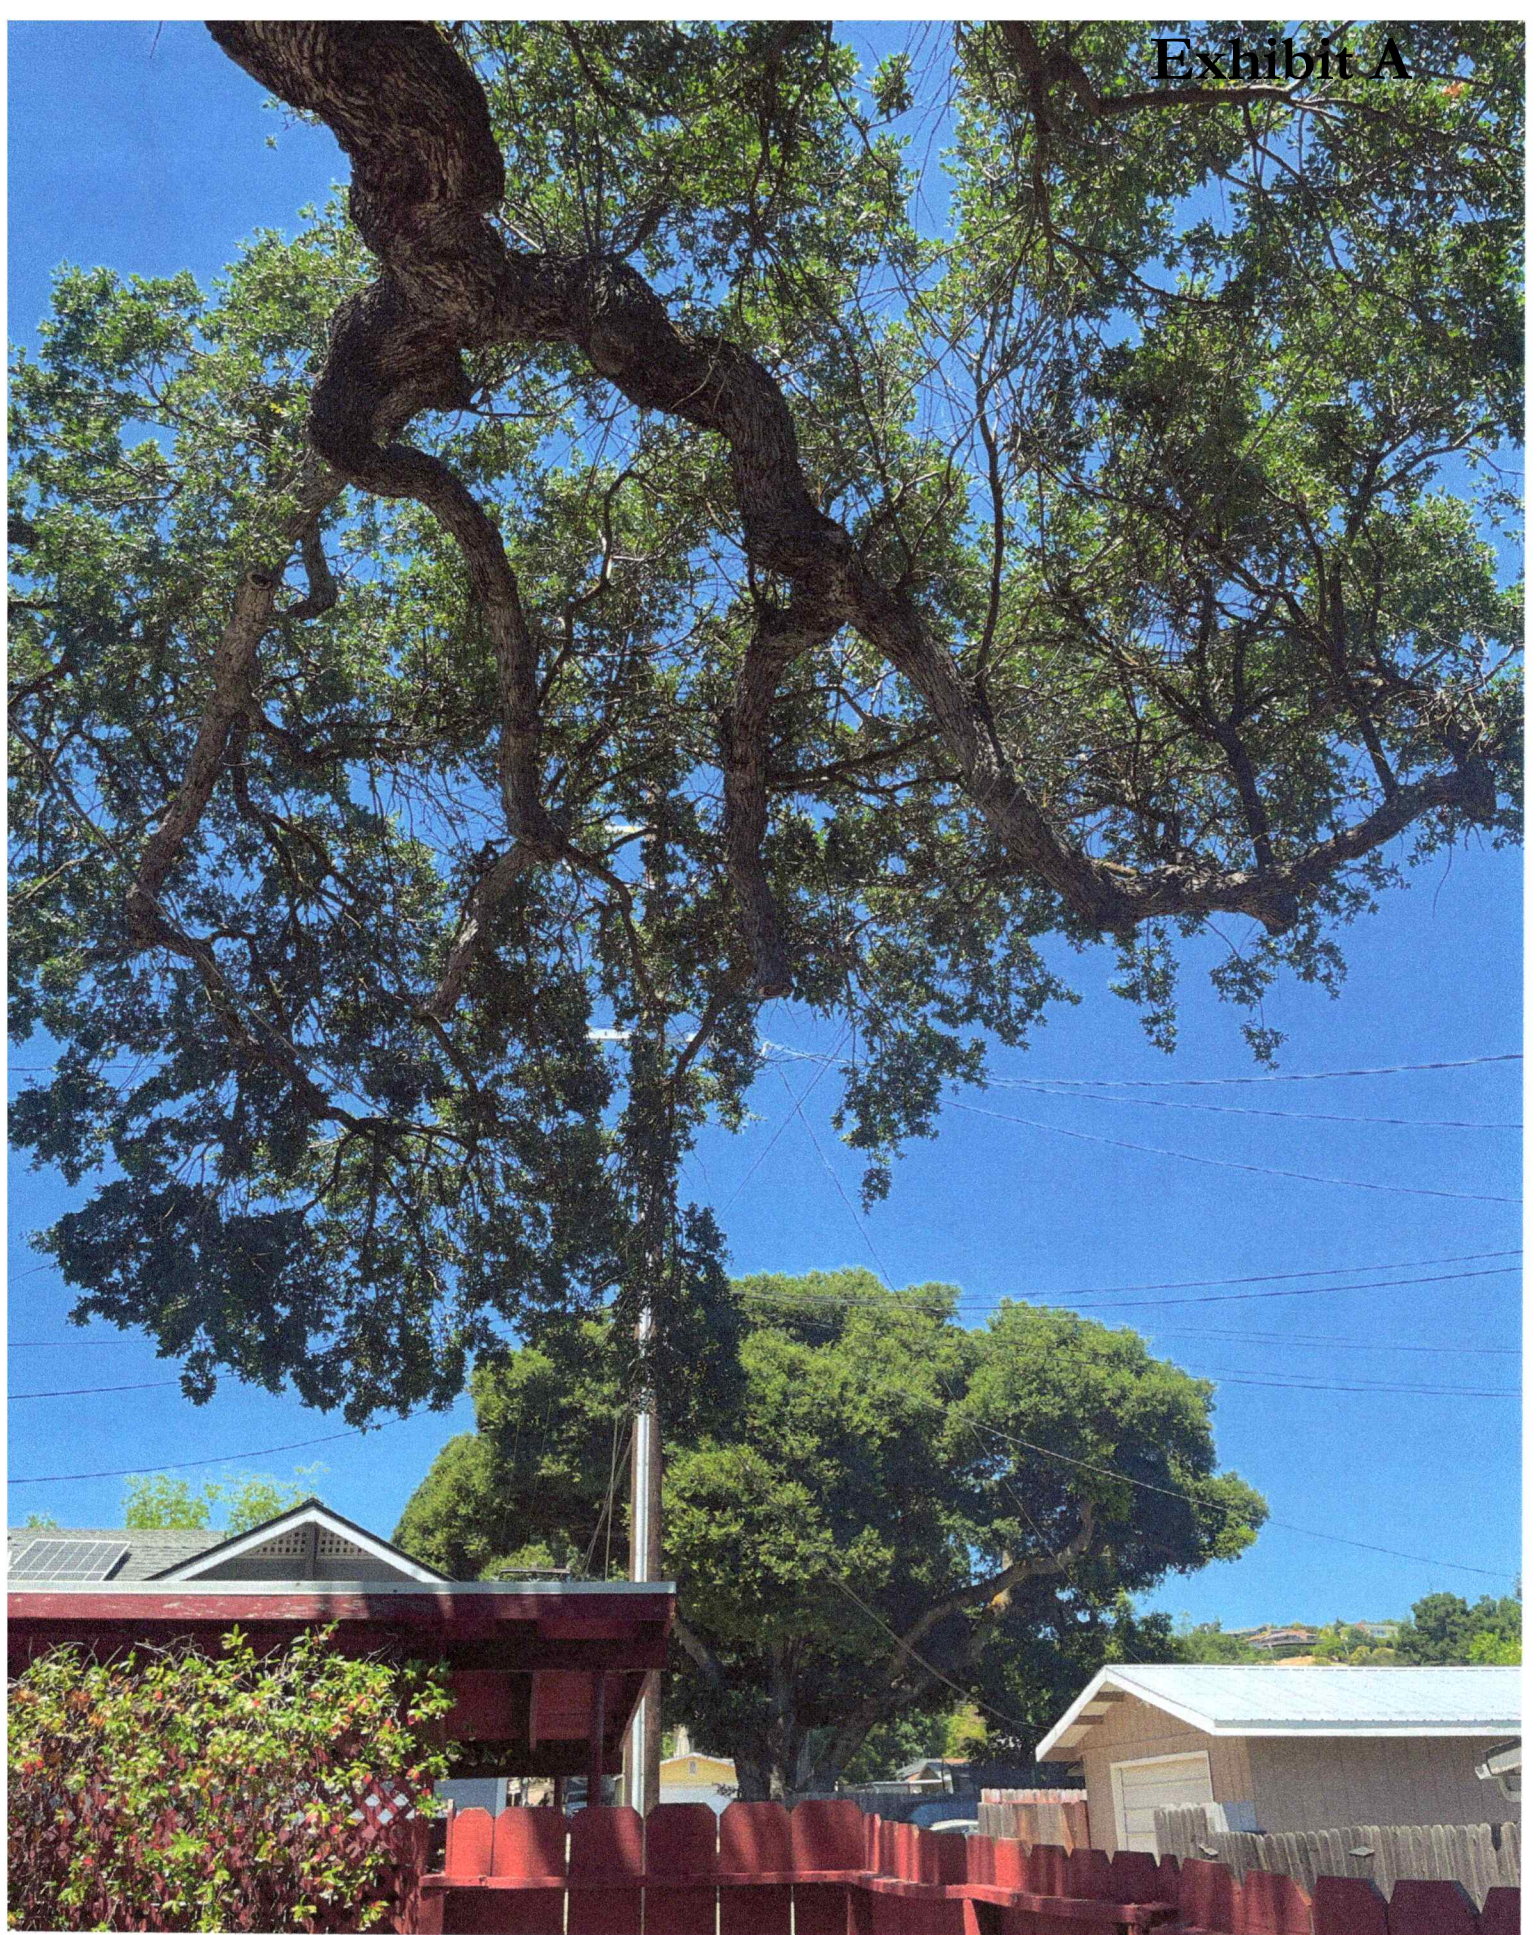
Large limb growing toward 8 way line service  
16

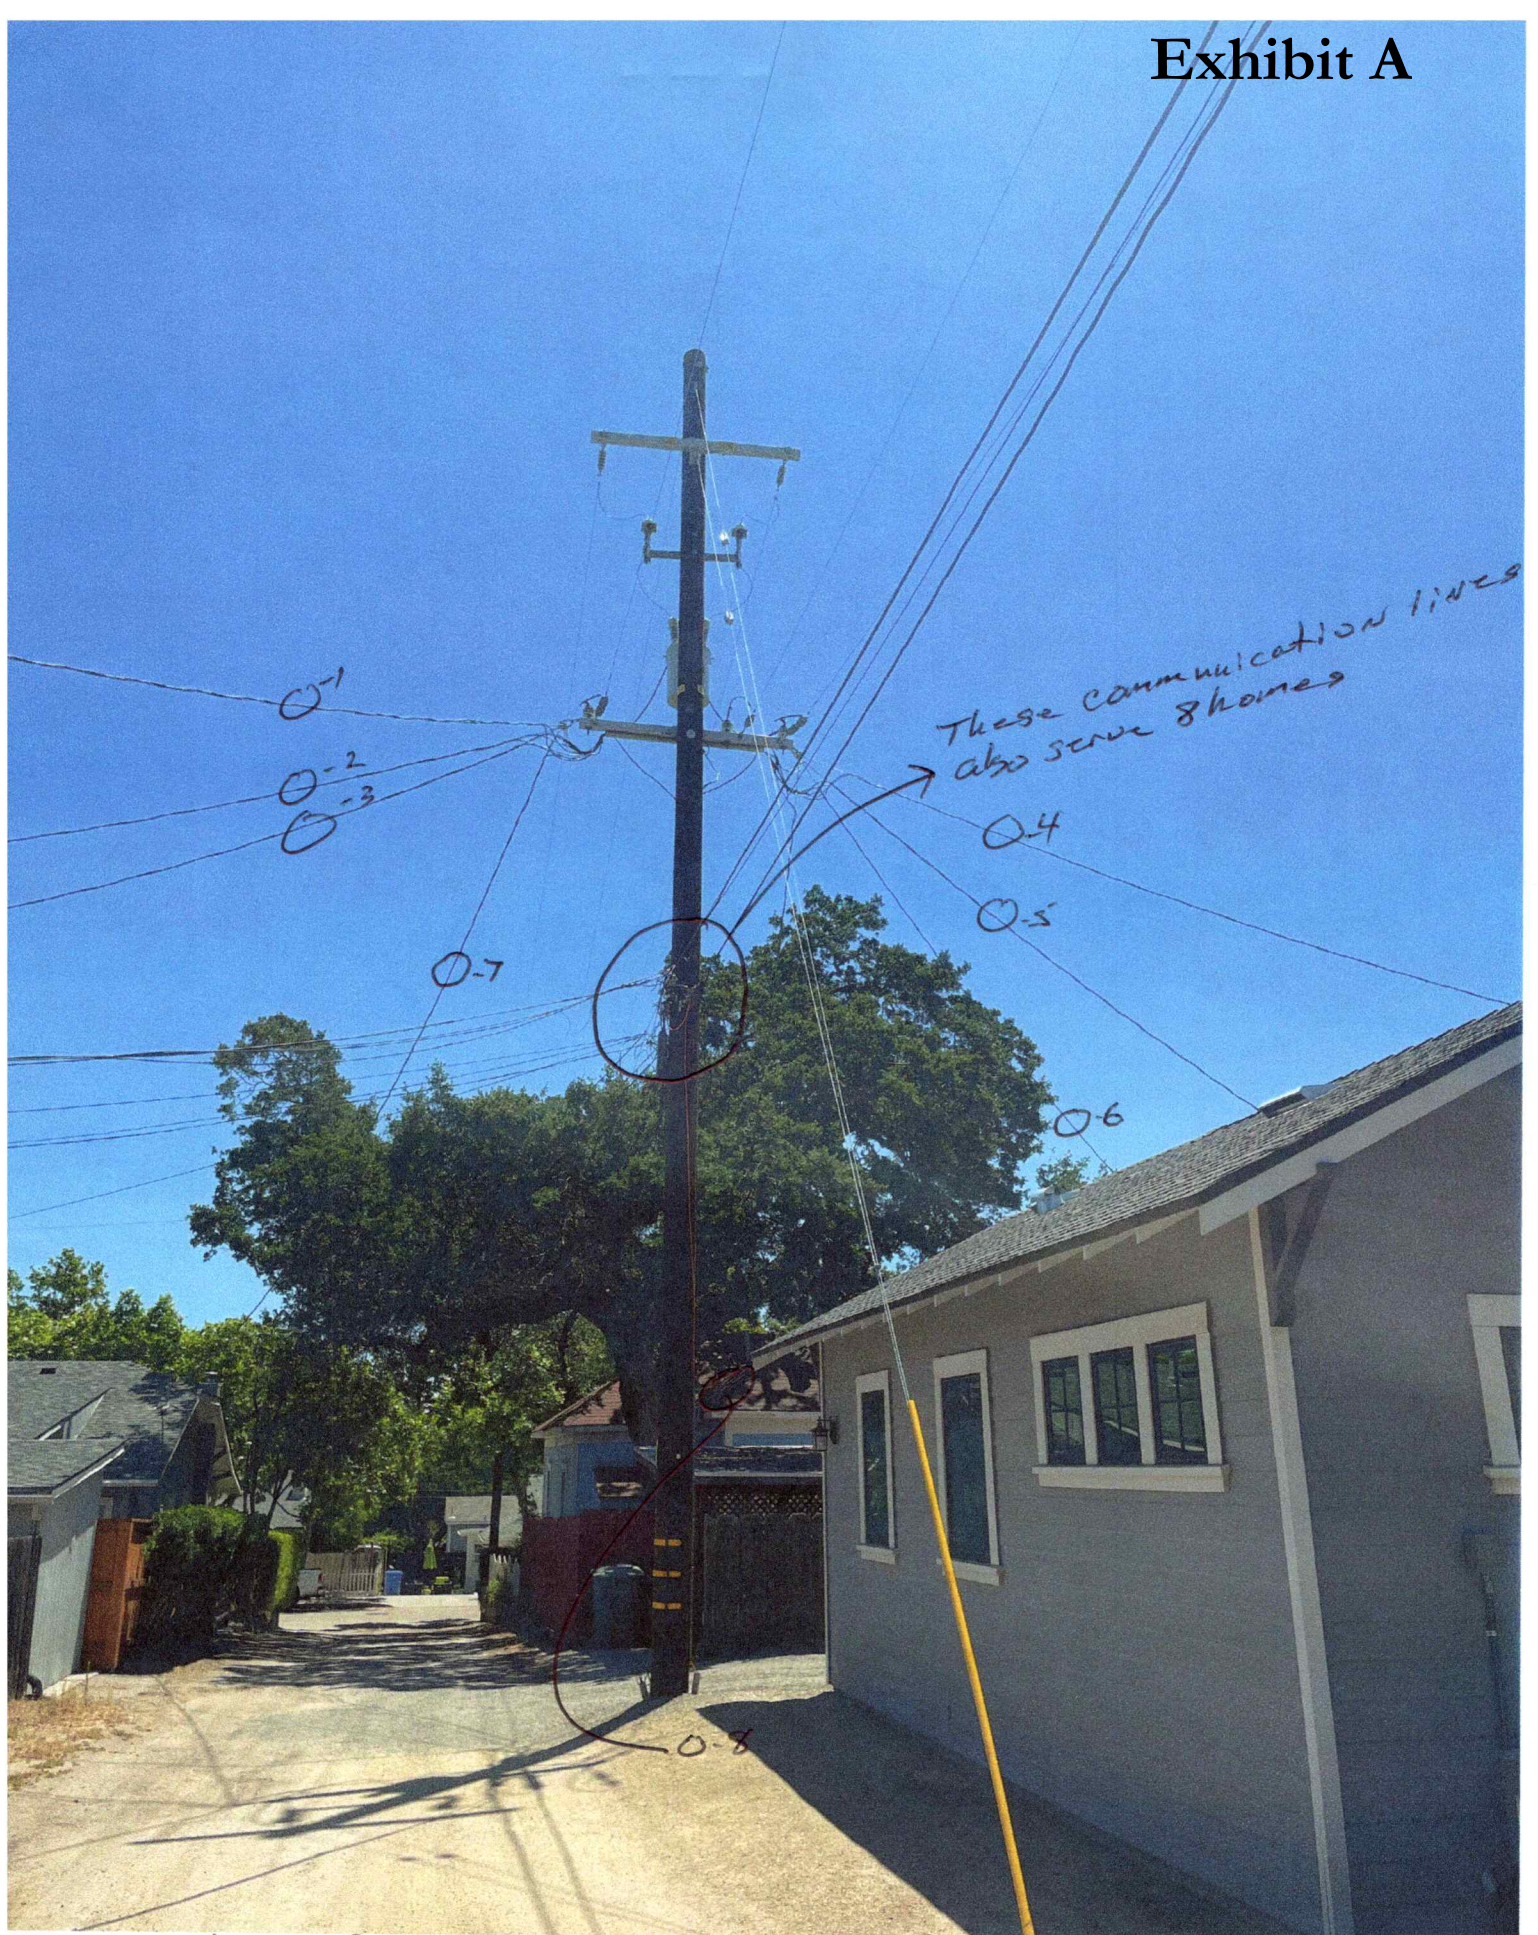
Overview of Subject Tree looking Toward Olive St in alley
