July 19, 2023

SUBJECT: VALLEY OAK TREE 1234 OLIVE STREET PASO ROBLES, CA 93446

This report includes an analysis of one (1) Valley Oak tree (*Quercas lobata*) located at 1234 Olive Street, Paso Robles, CA 93446 (APN 009-034-004). The report is intended for use by High End Construction, the City of Paso Robles and the property owner.

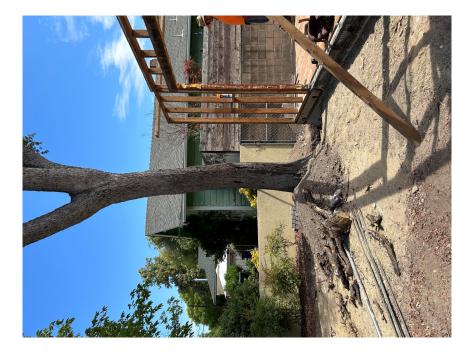
The subject tree is located in the front yard of a residential lot. It is adjacent to the left corner of the residence and is in close proximity to the existing house foundation [see Figure 1 attached]. It overhangs the roof of the existing residence as well as a portion of the neighbor to the left of the subject property [see figures 2 & 3 attached]. The tree currently has full foliage to the extent possible given prior pruning. The tree is in okay health. The major leaders are well attached to the trunk and show no signs of necrosis or excess stress at attachment. The shape of the tree is good. There is evidence of bark fracture from grade to approximately 5' up the trunk [see Figure 5 attached]. The root ball near the existing foundation has been excavated per the approved construction plans. Multiple roots, approximately 1/3 of the root system, have been removed during the excavation. The root ends have been cleanly cut leaving no frayed edges at this point [see Figure 4 attached].

The location of the tree is clearly problematic. Its' proximity to the existing structures foundation, overhang on both existing and adjacent structures and degradation of the root ball /root system indicates a possible future danger if there was a failure. Due to prior activity with the tree, structural pruning will not mitigate the threat of failure and possible harm to persons and property.

Given the location, health and construction impacts the tree has undergone, the logical conclusion is to remove the tree. The loss of 21.5" of dsh can be mitigated with a combination of on-site and off-site planting of like kind Valley Oaks in the ratio as described in the Paso Robles Oak Tree Ordinance {PRMC Section 10.01.030}.

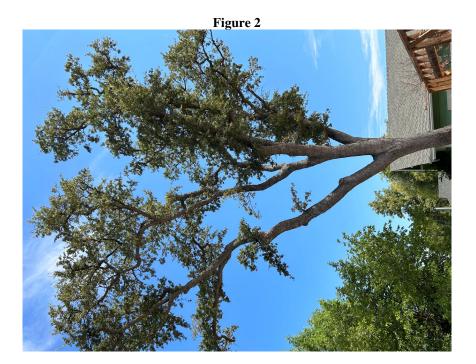
Valley Oak tree [see figures 1 - 5] DSH (diameter at standard height [ 4.5']): approximately 21.5" Height: +/- 60 feet Spread: +/- 40 feet Age: Mature Health: Okay
