August 17, 2022

Re: Oak Tree Assessment report for Ardmore Road Project, 2930 Union Rd, Paso Robles, CA 93446

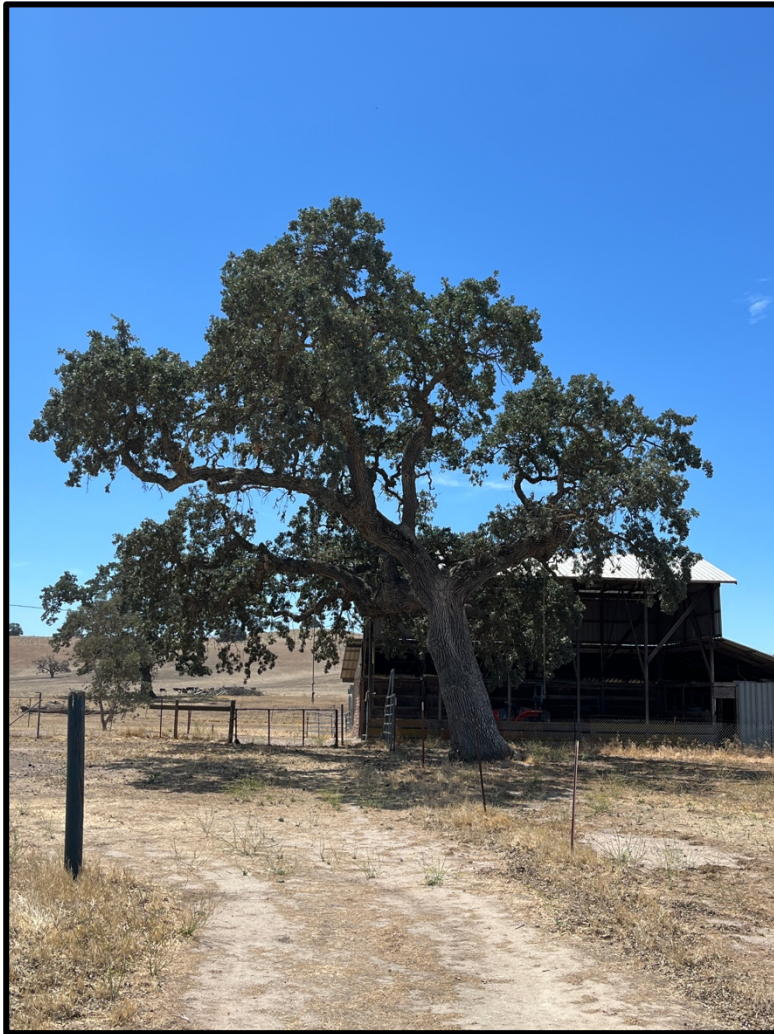
Tree 1 – A 43” diameter valley oak was in Very Poor condition. See Appendix A - Photographs - Photo 1

This tree had drought stress which was indicated by dead wood in the canopy. It also had decay throughout its scaffold branches which was indicated by decay cavities and woodpecker nests excavated in dead wood. See Appendix A - Photographs - Photos 1 & 4.

The trunk had an approximate lean to the east of 10 degrees. It also had a horizontal compression bulge on the east side of its trunk approximately 1’ above ground. Compression bulges or wrinkles, indicate that wood fibers are being crushed by the weight of the canopy and trunk due to lack of supportive structure in the trunk. Further the tree had a large, decayed, anchor root on its southwest side. The root was on the opposing side of the lean of the tree and is likely to fail as decay advances and stress from the weight of the canopy continues to build. See Appendix A -Photographs - Photos 1-3.

Photo 1 - View of Tree 1 to south. Note lean to east.

Roots and Trunk - Reducing the canopy through end weight reduction would relieve some stress on the trunk but not enough to offset the overall stress being exerted on the buckling area on the north side of the tree. No structural support or bracing will help the stability of the tree's trunk or roots. Significant decay has been detected in the roots as well as the trunk. Based on shell strength measurements, lean of the tree and buckling of wood fibers on the east side of the trunk made failure likely due to lack of structural integrity. I recommend removing the tree before commencement of construction.

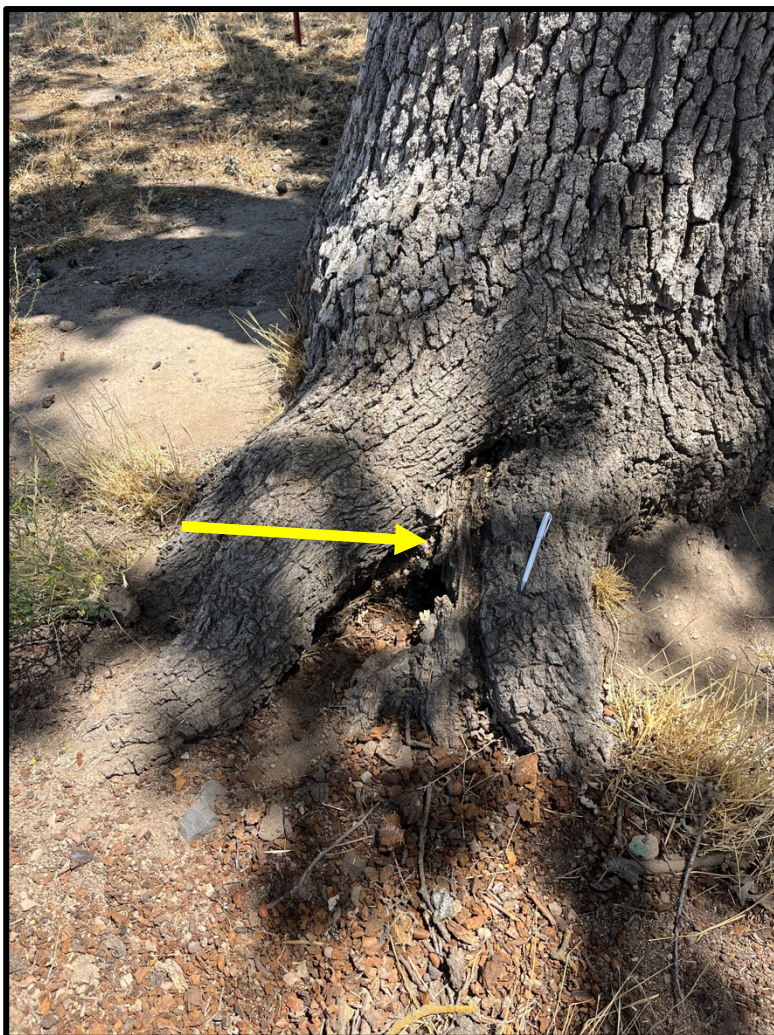
The highest risk rating for this tree was High and was associated with root and trunk failure. I found decay in one anchor root and significant decay was detected in the trunk. Buckling of trunk fibers was evident. Based on shell strength measurements, the likelihood of trunk failure was probable, due to lack of structural integrity. Root failure was Probable due to significant decay in the anchor root on the southwest side of the tree. Scaffold failure was also probable with a high likelihood of failure.

Photo 2 - Tree 1 with decayed anchor root on southwest side, indicated by arrow. Ink pen provided for scale

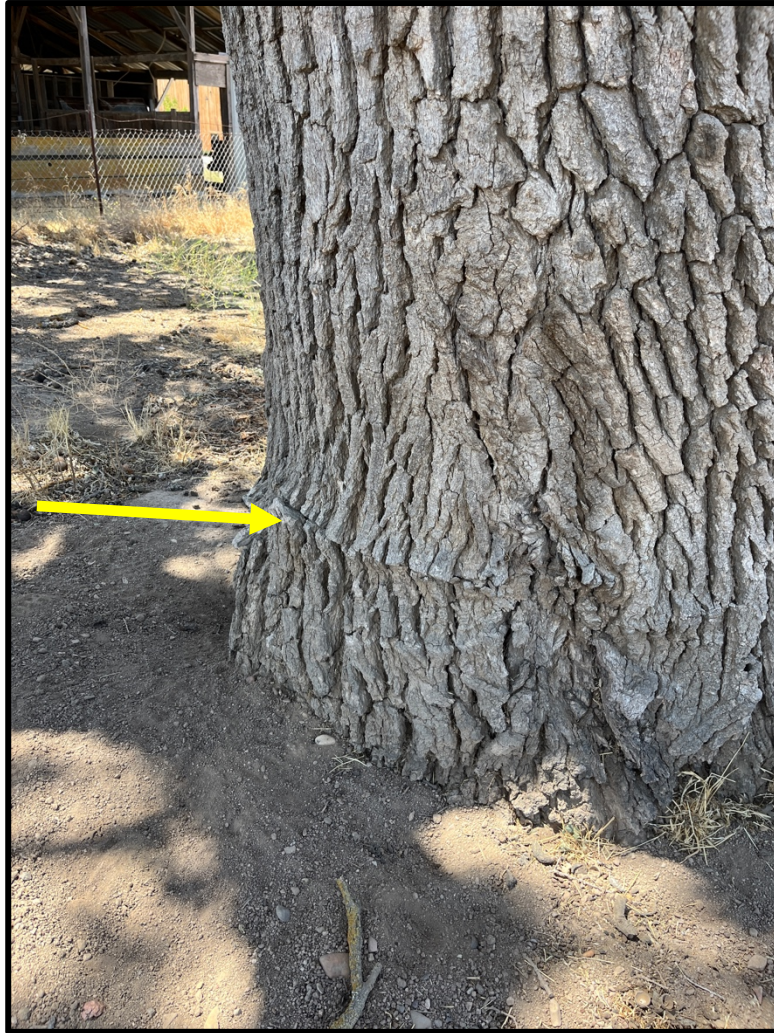
Based on the Resistograph results, it was apparent that interior wood of the trunk is significantly decayed. The evidence of compression bulges showed that the trunk is losing structural integrity and leaning due to lack of supportive wood fibers.

Photo 3 - Tree 1 with compression bulge east side of trunk indicated by arrow shows lack of structural support.

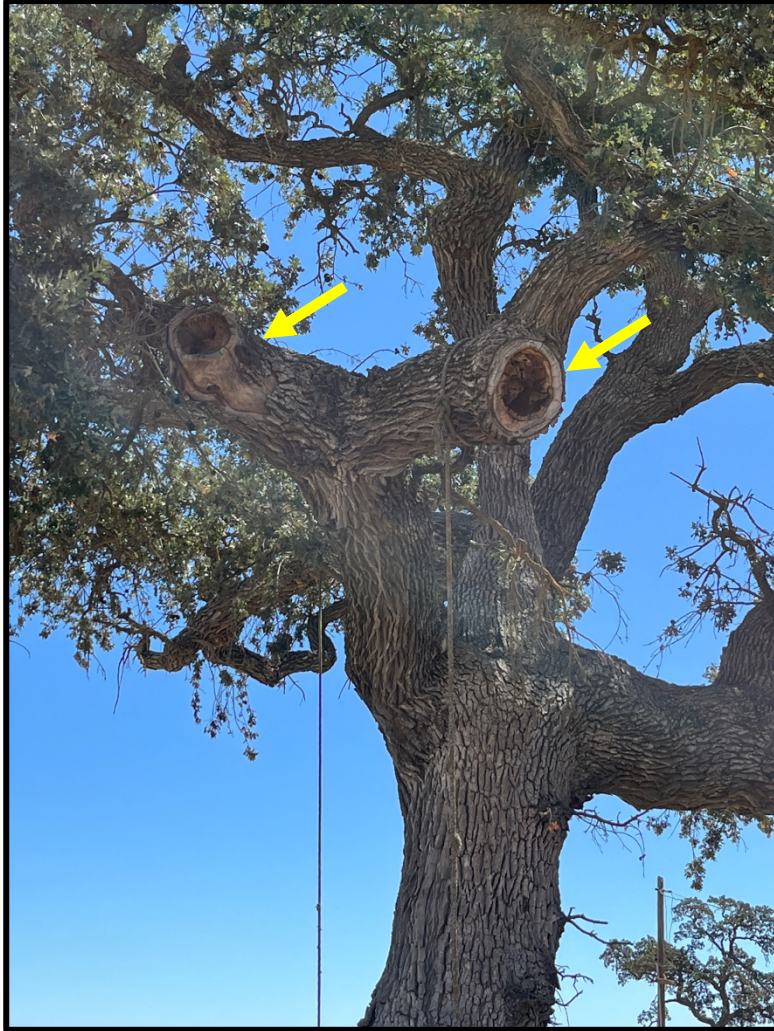
Photo 4 - Tree 1 with decay in scaffold branches. indicated by arrows.

Scaffolds - Reducing the canopy through end weight reduction and removing decayed branches 2" diameter and larger would relieve some stress on remaining scaffold branches and reduce their risk to Moderate.

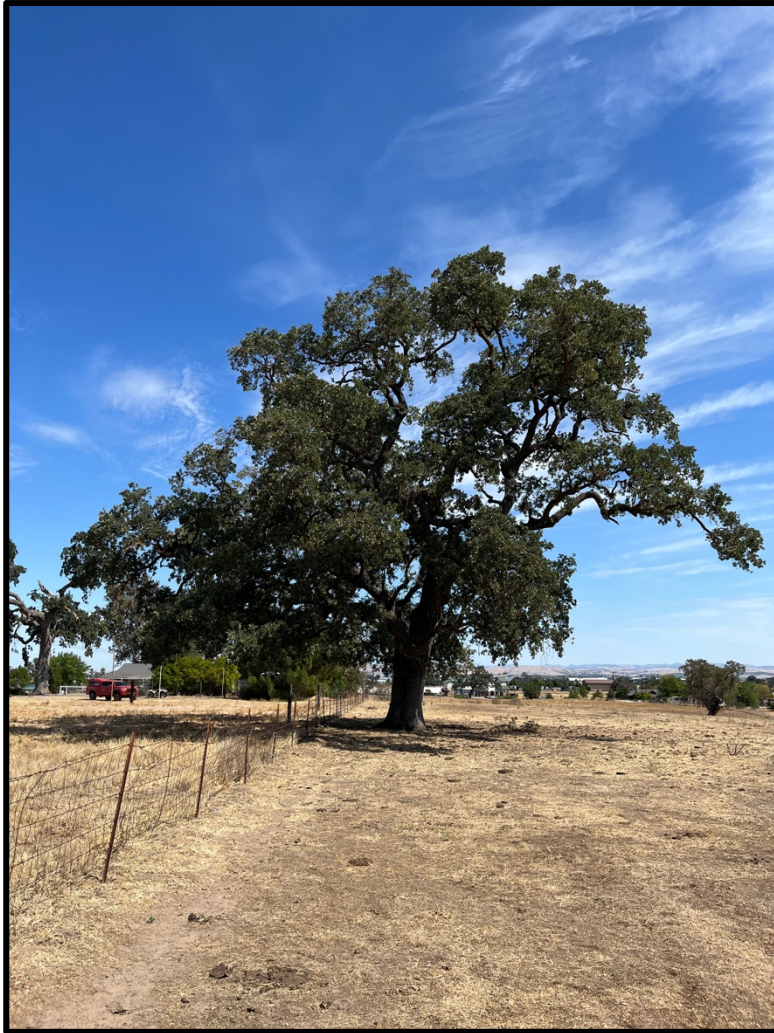
Tree 2 – A 47" diameter valley oak was in Poor condition. See Appendix A - Photographs - Photo 5.

Photo 5 - View of Tree 2 to north

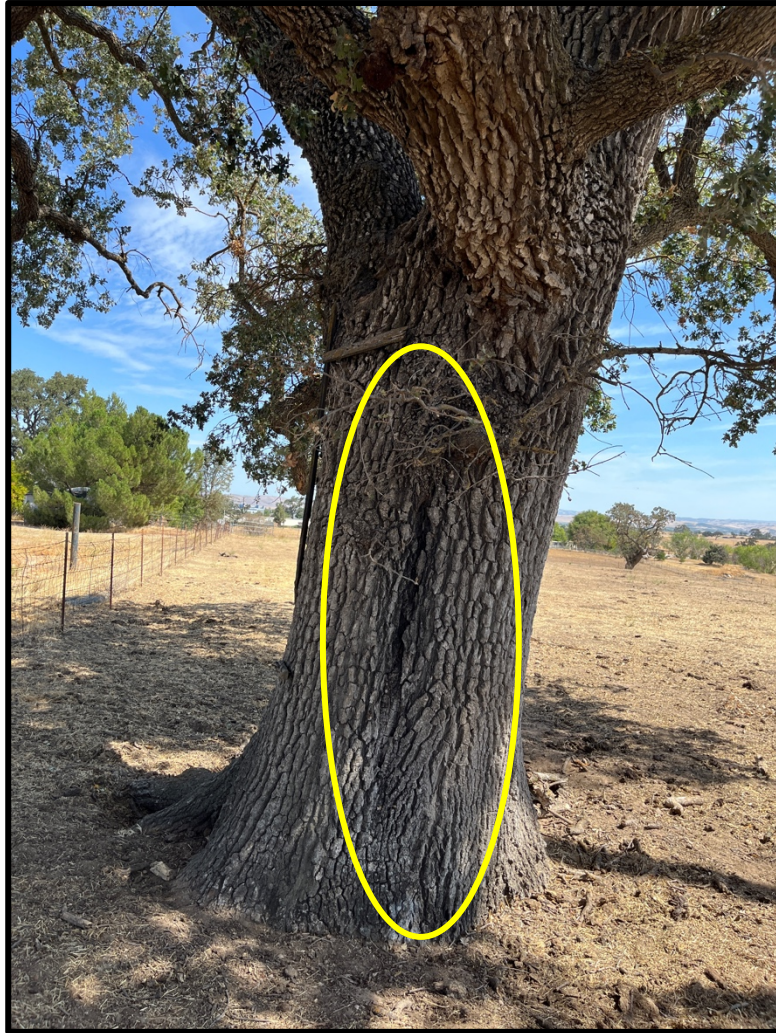
On the south side of the trunk there was a decay cavity originating at the root-crown and extending approximately 5.5' upward. When sounded with a rubber mallet on either side of the cavity, it resounded hollow. Moving around the trunk to the east side, I detected another hollow sounding area with my mallet at approximately 3.5' above ground. See Appendix A - Photographs - Photo 6. Like Tree 1, I suspect *Armillaria mellea* - Oak root fungus, is the cause of the rot.

Photo 6 - Tree 2 with decay cavity south side of trunk. Length is approximately 5.5'.

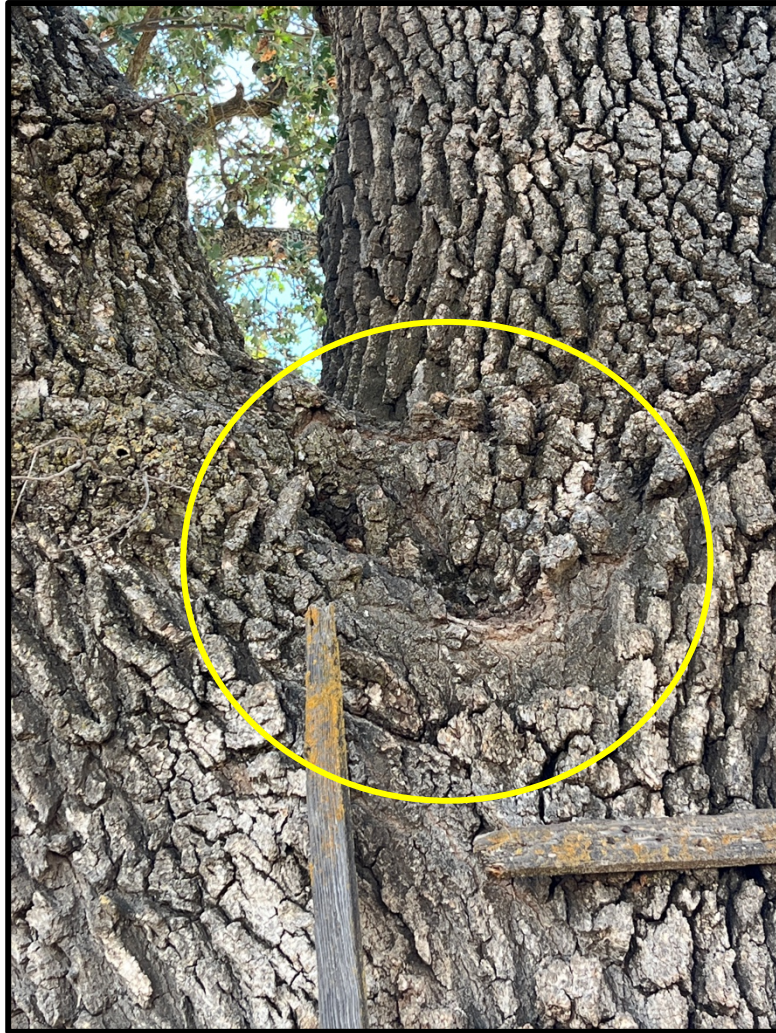
At approximately 8 feet above ground, on the southwest side of the trunk there was another decay area that was almost closed over with scar tissue. Although almost closed, I suspected a large area of decay behind the scar. See Appendix A - Photographs – Photo 7. There was a large scaffold branch attached to the trunk above the scar. It had a desiccated fungal fruiting body growing on it and cankers had killed strips of bark near the fungus. See Appendix A - Photographs – Photo 8. I identified the fungi genus to be that of *Inonotus*. Jessie A. Glaeser and Kevin T. Smith in the winter 2010 issue of Western Arborist, note this fungus to cause a white-rot of heartwood in the trunk of living oaks and also decays strips or sections of sapwood, forming elongate cankers and killing the cambium. According to Swiecki, T. J.; Bernhardt, E. A. 2006, A Field Guide to Insects and Diseases of California Oaks, "*Inonotus dryophilus* is one of the most serious pathogens of living oaks in California associated with decline, failure, and mortality". In this tree, the combined weakened trunk area at the scar combined with the heavy, decayed scaffold branch make this section of the tree likely to fail.

Photo 7 - Tree 2 with decay cavity at scaffold union approx. 8' above ground on southwest side of tree.

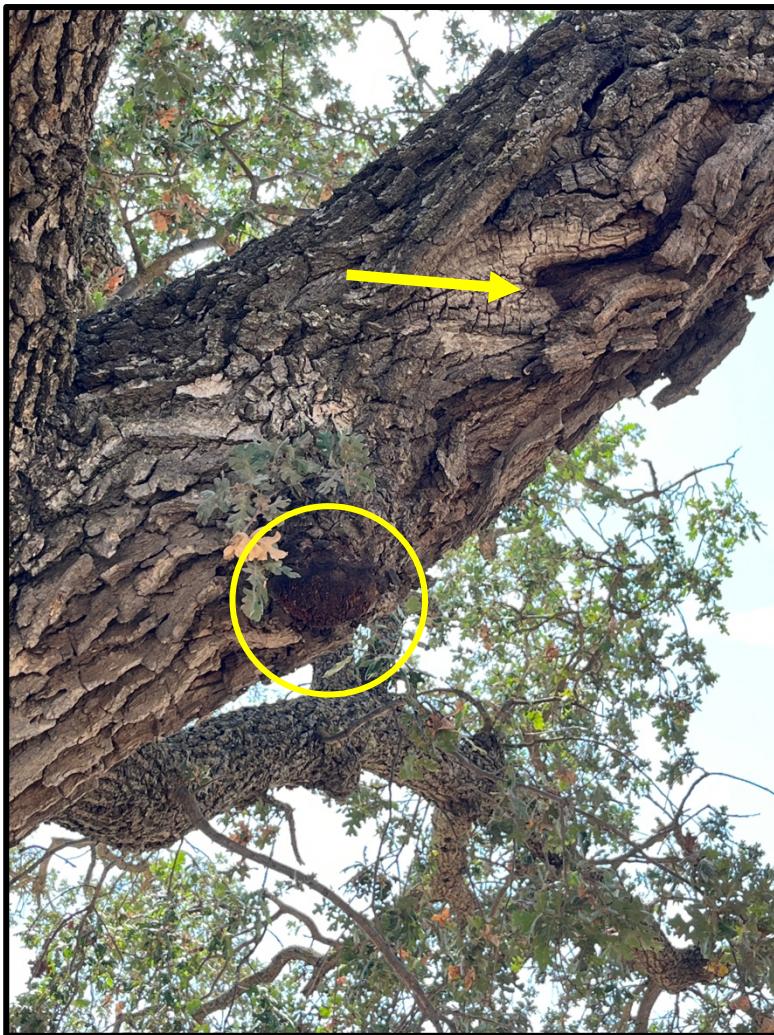
Photo 8 - Tree 2 with fungal fruiting body circled and decay in south scaffold branch indicated by arrow.

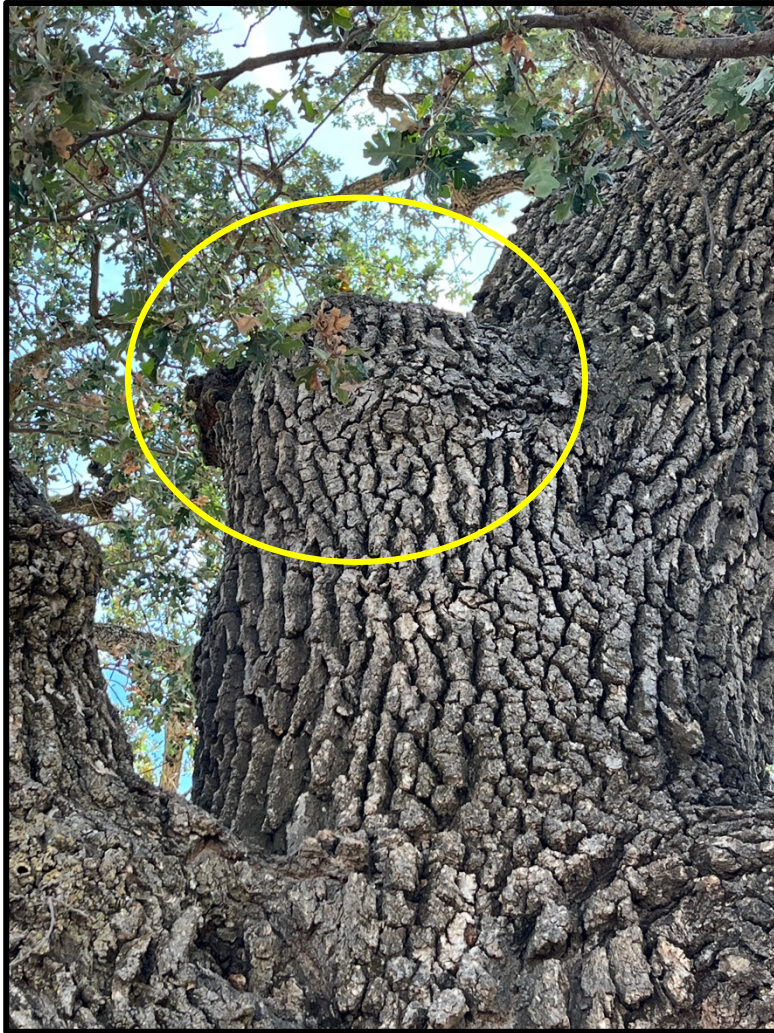
In the upper canopy at approximately 14' above ground there was another decay cavity in the center of the canopy, where a large scaffold branch had failed many years ago. I suspected advanced decay in the trunk at this location. See Appendix A - Photographs - Photo 9

Photo 9 - Tree 2 with decay cavity formed by failed scaffold circled at center of tree, approximately 14 feet above ground.

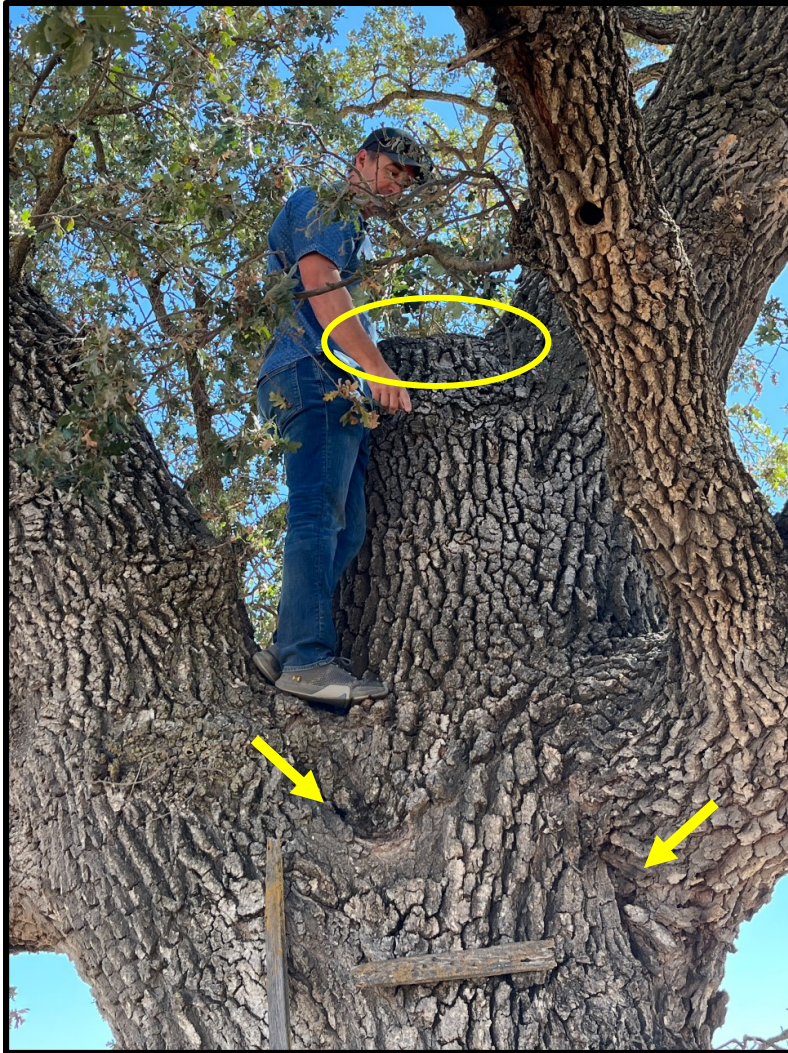
During the aerial inspection, it was discovered that the opening of the decayed scaffold in the upper canopy was 13" in diameter. The depth of the cavity was 13'2" deep. When the distance to the ground from the outside of the cavity was measured, it was 14'3", which illustrated that the entire trunk of the tree was hollow. See Appendix A - Photographs – Photos 9 -14.

Photo 10 - Tree 2 perspective view of decay cavity formed by failed scaffold circled at center of tree. Cavity is circled. Other decay points below the open cavity are indicated by arrows.

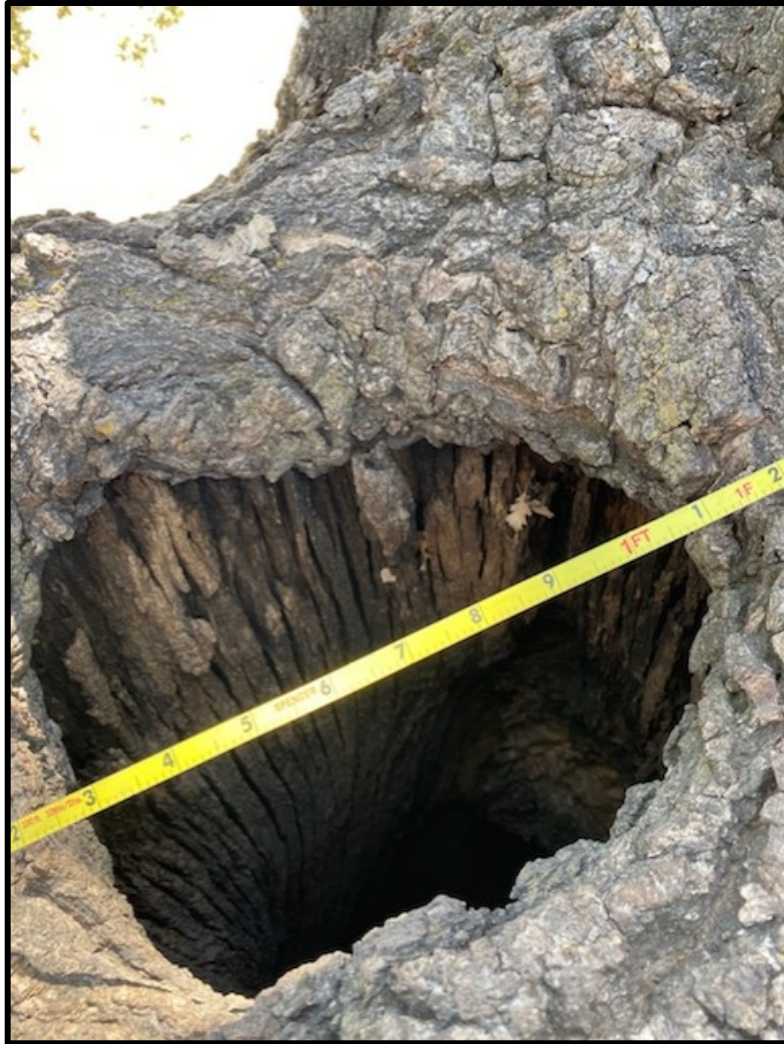
Photo 11 - Tree 2 view of decay cavity formed by failed scaffold. Opening measures 13"

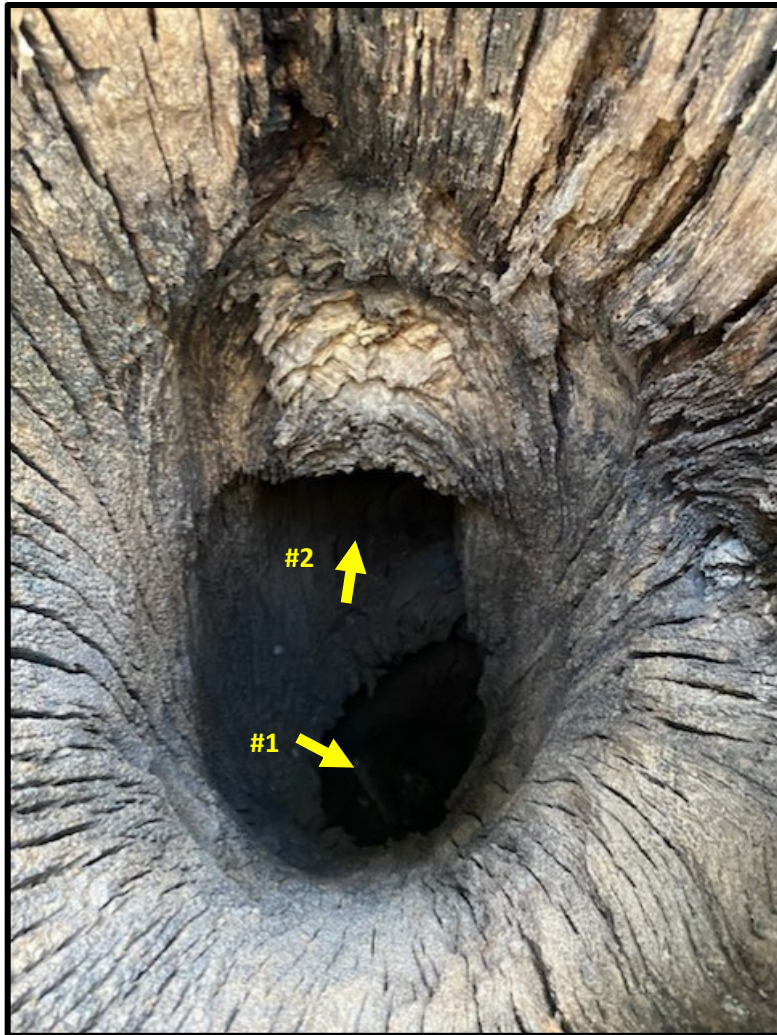
From the cavity opening, the decay continued upward into the scaffold branch growing east. This scaffold is very likely to fail due to weak trunk structure. See Appendix A - Photographs – Photo 12.

Photo 12 - Tree 2 view of interior decay cavity formed by failed scaffold. Arrow 1 shows depth of cavity down to roots of tree. Arrow 2 shows decay that has advanced into eastern scaffold branch.

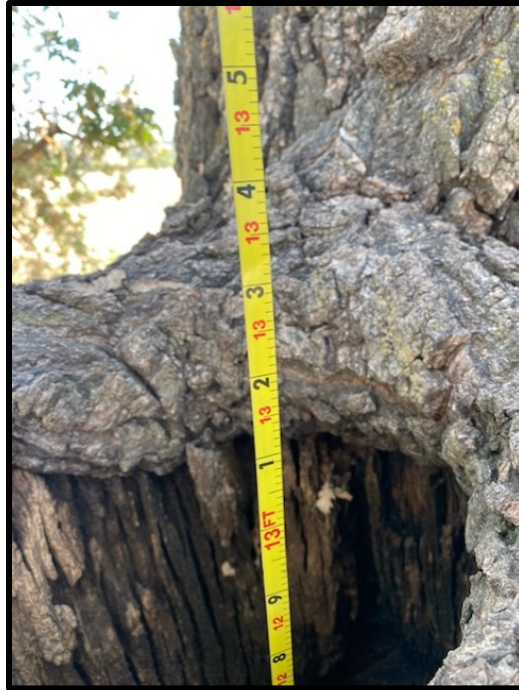
Photo 13 - Tree 2 measurement of interior depth of decay cavity formed by failed scaffold. 13' 2"

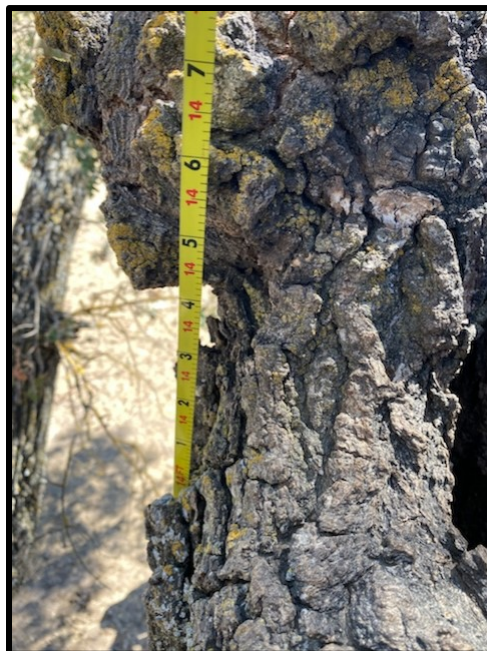
Photo 14 - Tree 2 measurement of exterior depth of decay cavity formed by failed scaffold. 14' 3"

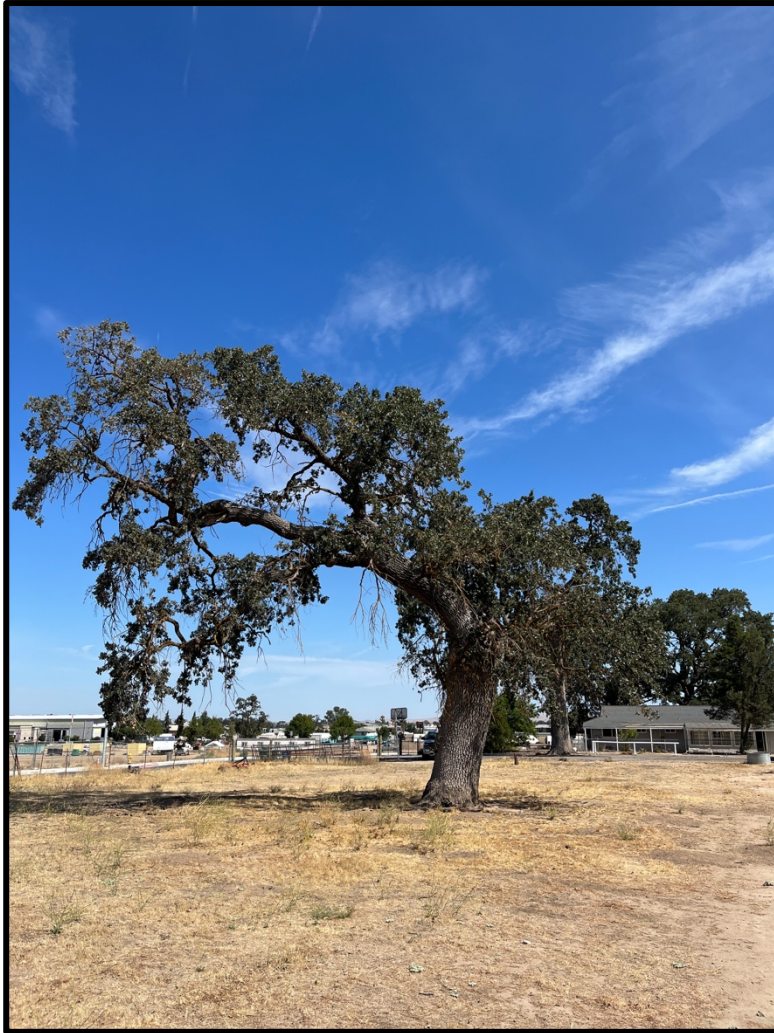
Tree 3 – A 47" diameter valley oak was in Very Poor condition. When I sounded the trunk with a rubber mallet, it resounded hollow on the southwest side. A large wound left by a scaffold branch failure in the crown of the tree has since decayed and left a 3'x 4' hollow at approximately 14' above ground on the east side of tree. Another decay cavity on the north side of the tree at the same height as the previous, measured approximately 2' in diameter. Remaining scaffold was overextended and attached to the decaying trunk. The remaining parts of this tree have a high likelihood of failure. See Appendix A - Photographs – Photos 15 & 16.

Photo 15 - View of Tree 3 to north. Overextended scaffold to west. Large decay cavity at connection to trunk.

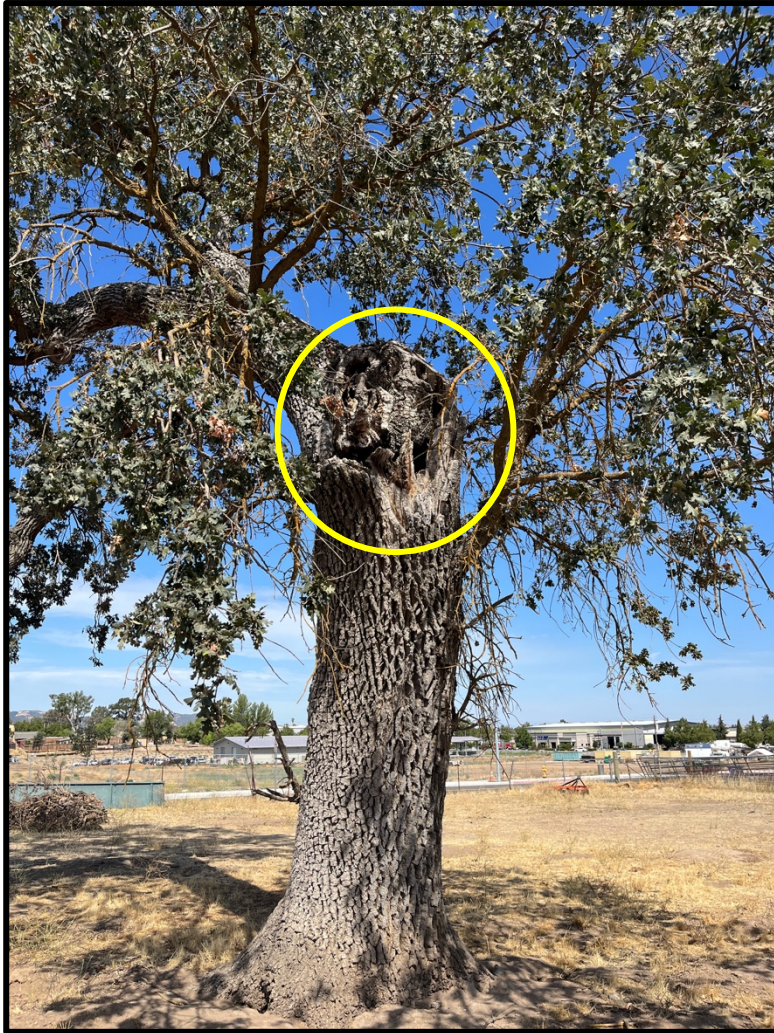
Photo 16 - Tree 3 with large decay cavity at scaffold connection to trunk.

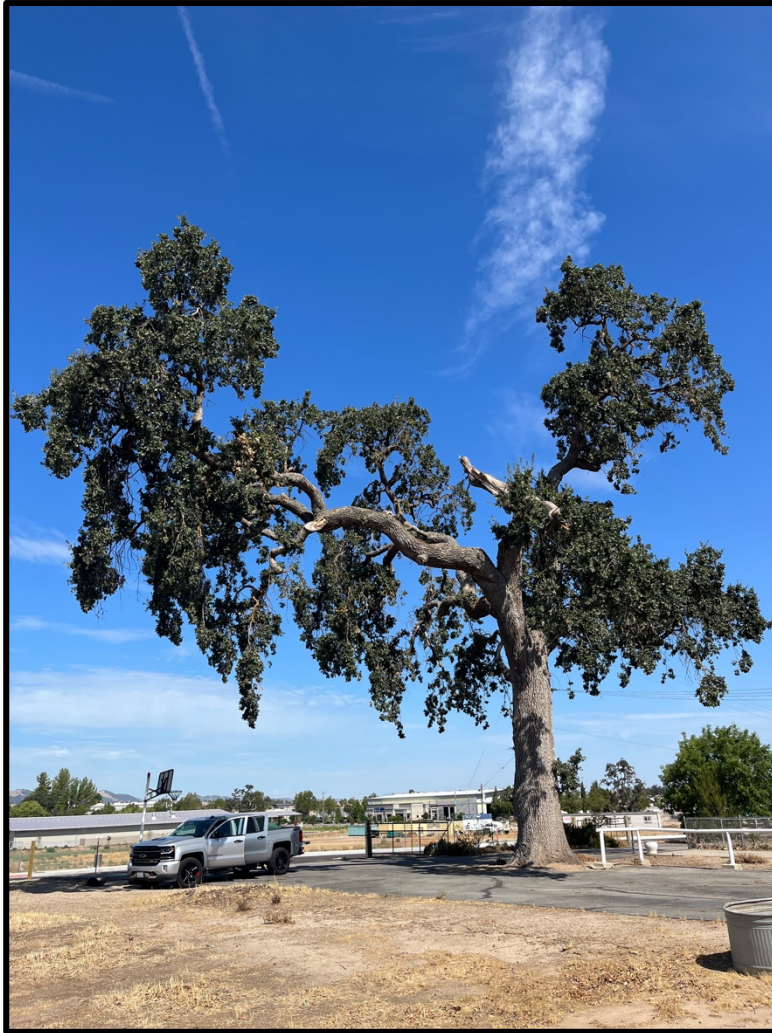
- **Tree 4** – A 52" diameter valley oak was in Very Poor condition. The tree was growing off-site but had critical root zone (CRZ) and crown encroachments into your proposed construction area. This tree has had several large scaffold branch failures. At the failure points, significant decay was visible. The remaining scaffolds were overextended and potentially had similar internal decay and had a high likelihood of failure. See Appendix A - Photographs – Photo 17.

Photo 17 - View of Tree 4 with to northwest. Numerous failed scaffold branches due to overextension and internal decay.

Mitigation: I highly recommend removal of this tree due to the advancement of decay in the scaffold branches which is compromising their structural integrity. Crown reduction needed to reduce the risk of scaffold branches failing would take up to 50% of the live canopy and jeopardize the tree's health. Because this tree is off site, you will need to coordinate with the owner regarding removal.

At minimum this tree should have all overextended branches reduced to help prevent further failures and protect any buildings or other targets you may place on your property within striking distance of the tree. If the owner of the tree chooses to retain it, you will need to design buildings, service and loading zones outside of the CRZ.

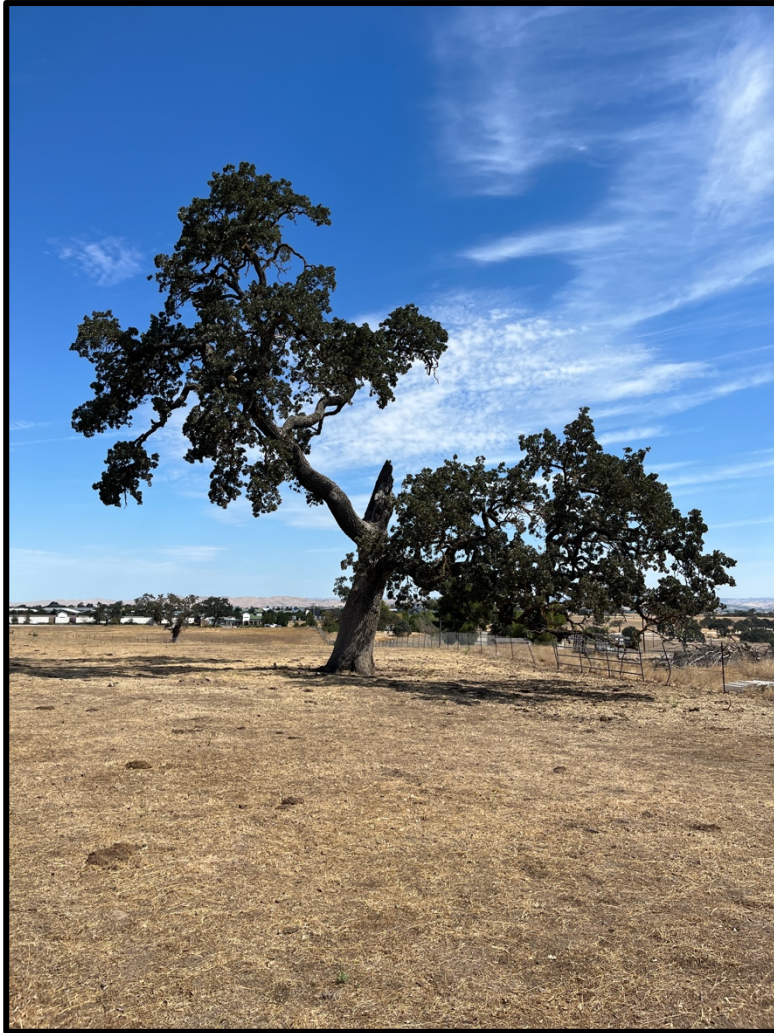
- **Tree 9** – A 51" diameter valley oak was in Very Poor condition. Multiple large scaffold branches had failed. Extensive decay was present at branch failure points. Only 2 overextended scaffold branches remain, and they are connected to a decaying trunk.

When I sounded the trunk with a rubber mallet, it resounded hollow. A 3' long by 10" wide decay cavity was on the northeast side of trunk. This tree has a high risk of complete failure. See Appendix A - Photographs – Photos 18 & 19.

Photo 18 - View of Tree 9 to north. Numerous failed scaffold branches due to overextension and internal decay.

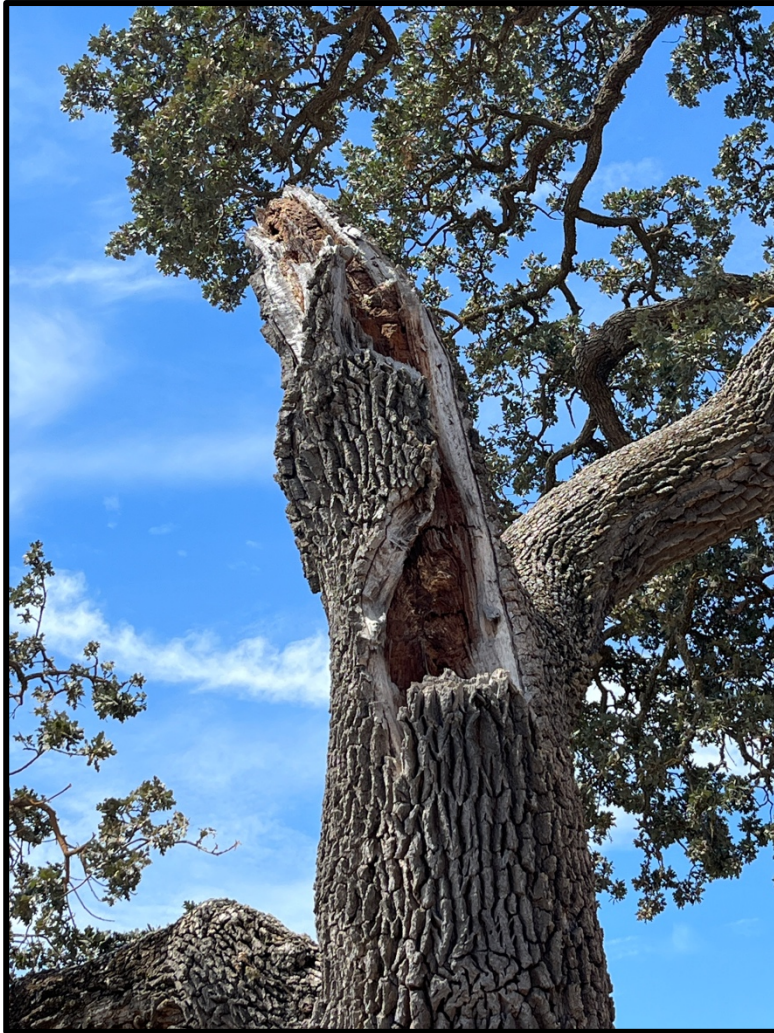
Photo 19 - Tree 9 close-up of failed scaffold branch with internal decay.

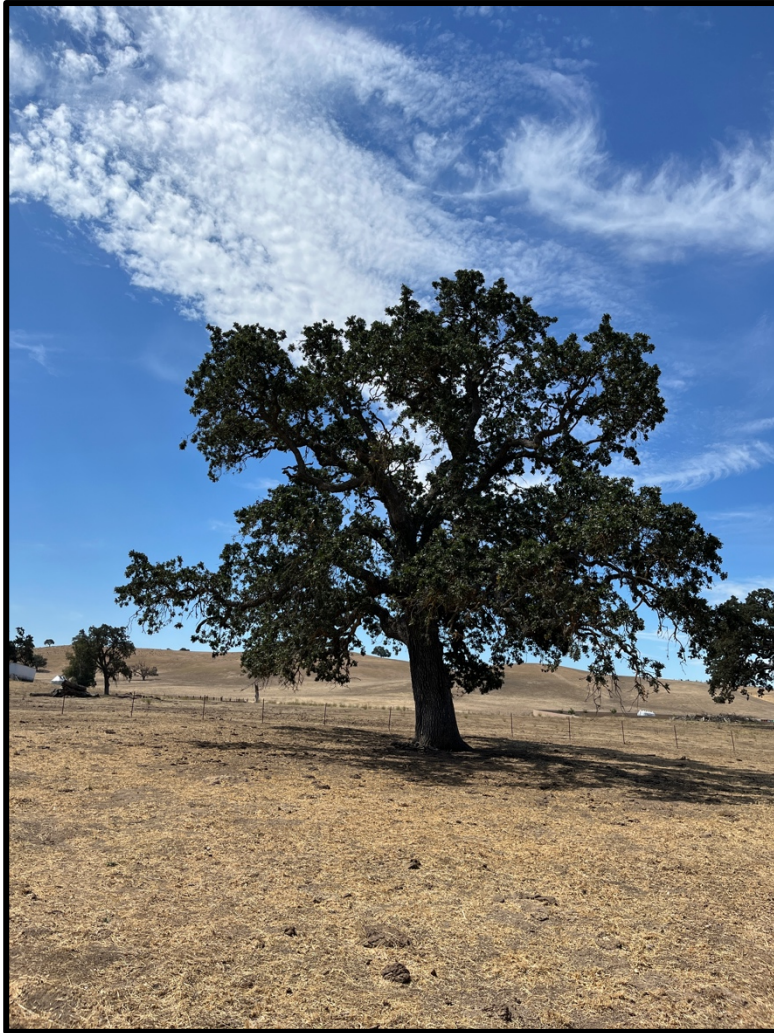
- **Tree 10** – A 51" diameter valley oak was in Good condition. The trunk of the tree resounded solid when sounded with a rubber mallet. Tree form was good, but there was some large dead wood and decaying scaffolds. This tree can be retained, but it should have maintenance pruning performed prior to commencement of your project. See Appendix A - Photographs – Photos 20 & 21.

Photo 20 - View of Tree 10 to south.

Mitigation: Reduce end-weight on overextended branches. Remove dead wood 2" diameter and larger. Remove decayed and structurally unsound scaffold branches.

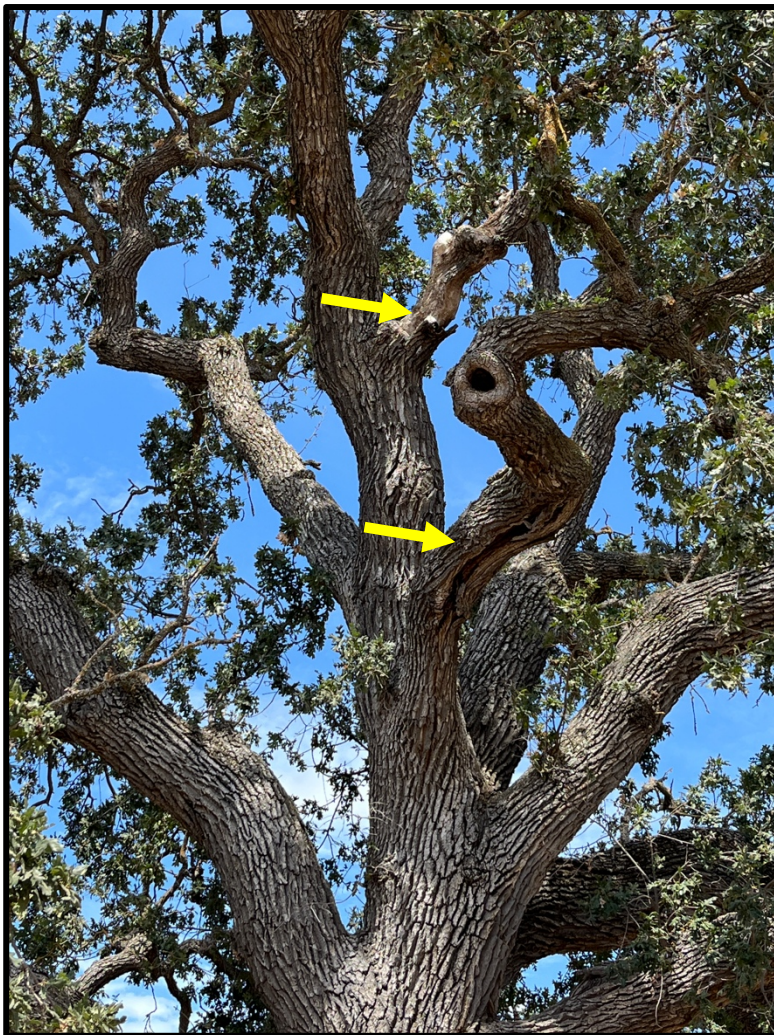
Photo 21 - Tree 10 with decayed scaffold branch indicated by yellow arrows.

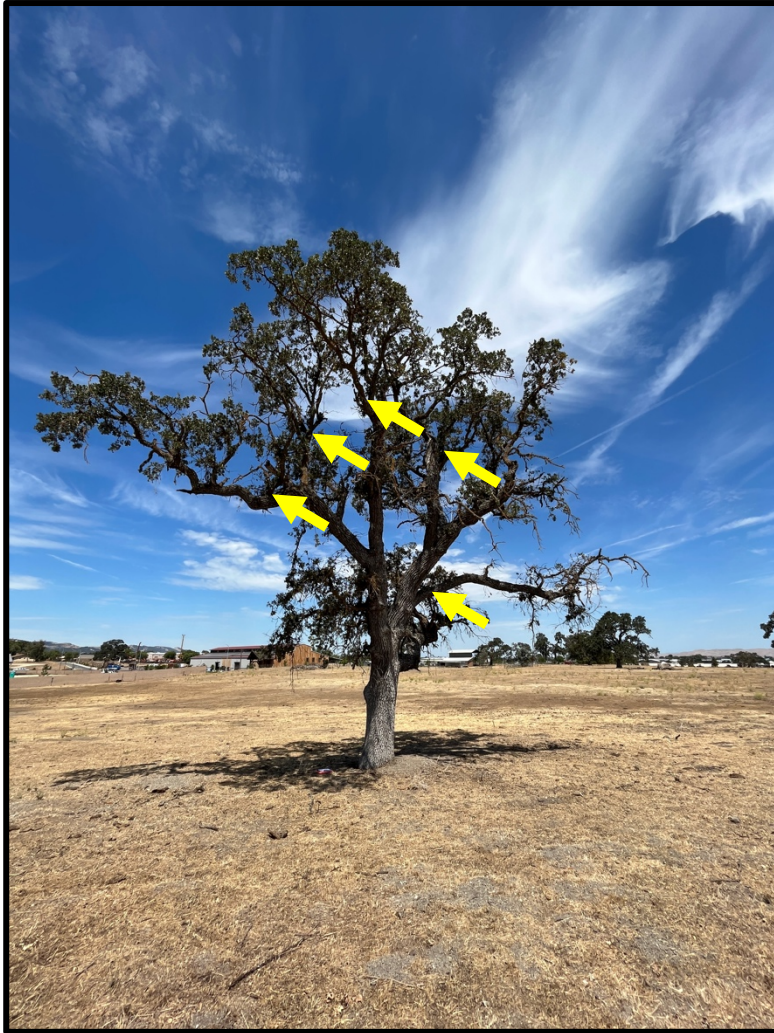
- **Tree 11** – A 30" diameter valley oak was in Very Poor condition. The tree was in severe decline due to drought stress and root disease. Many of the smaller branches had died. I detected decay at the root crown on the southwest side of the tree. I found an ant nest at the root-crown decay area indicating ants are excavating and nesting in dead roots and root crown. The dead roots contribute to the decline of the canopy and compromise the stability of the tree. At least five, 12" average diameter scaffolds had extensive decay on the east side of the tree. To reduce scaffold failure risk, up to 50% of the live canopy would need to be removed, which would compromise the health of and already unhealthy tree. See Appendix A - Photographs – Photos 22-24.

Photo 22 - View of Tree 11 to north. At least 5 decayed scaffold branches would be removed which would reduce the tree at least 50%. Arrows indicate branch removal points.

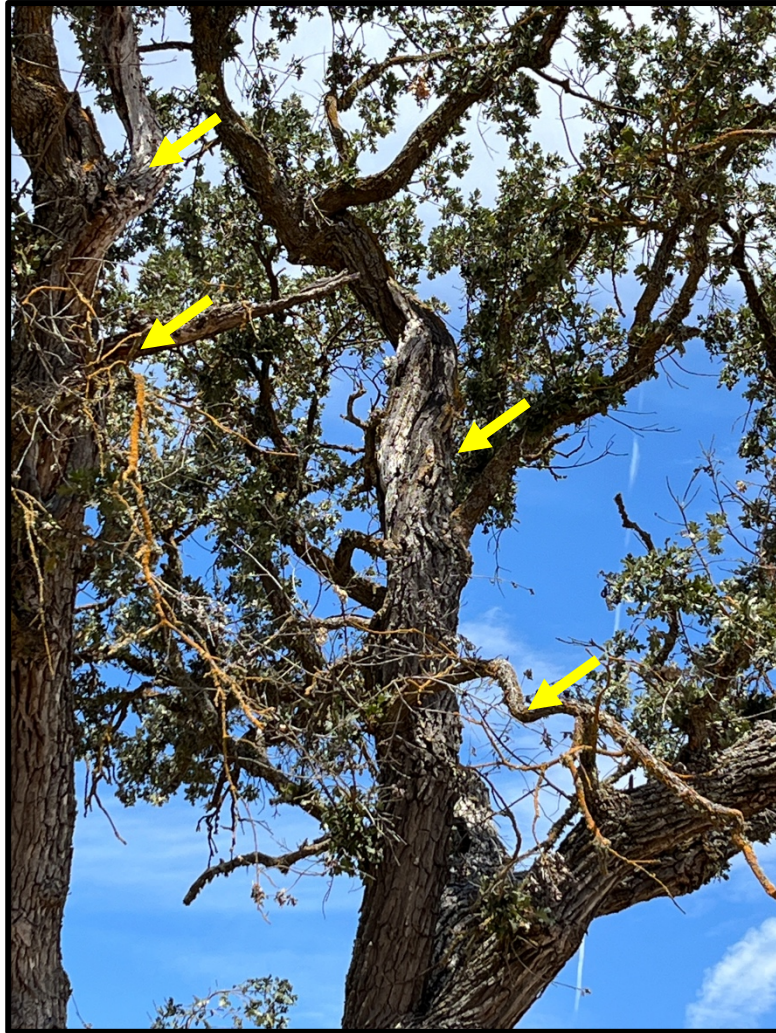
Photo 23 - Tree 11 close up of declining canopy, decayed branches, and dead wood indicated by arrows.

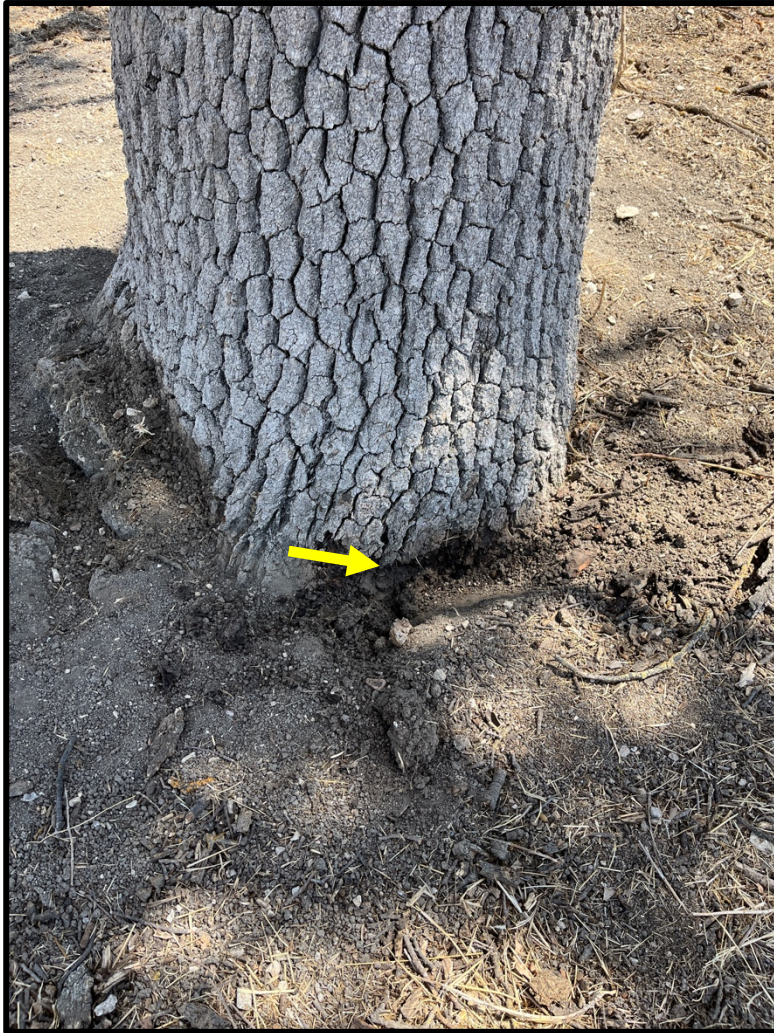
Photo 24 - Tree 11 close up of root crown decay at southwest side of tree indicated by yellow arrow. Ant nest discovered here which indicates dead and rotting wood.

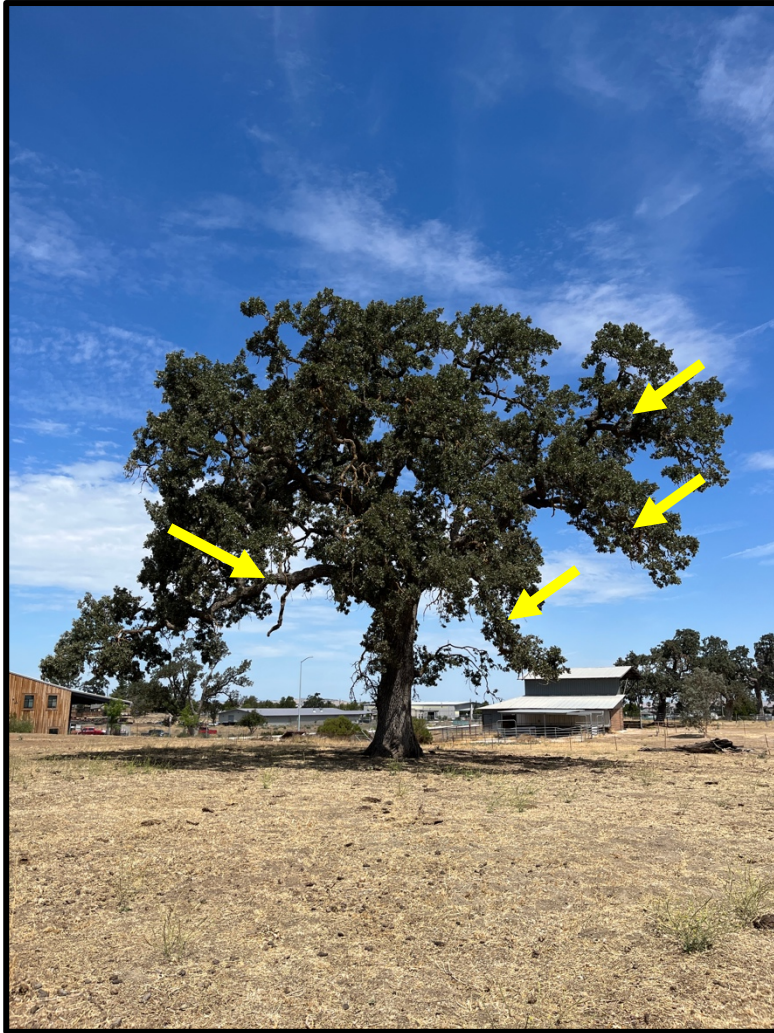
The tree had a full canopy with a balanced form. On the south side of the tree at the root crown, there was an area of decay in the underside of one of the anchor roots. Like trees 1 and 2, the decay is likely caused by *Armillaria mellea*. I also noted the lower trunk was bulging and larger than normal which may indicate butt-rot caused by *A. mellea*. Further, I observed that the eastern scaffold branch was decayed, and large dead wood was present throughout the canopy. See Appendix A - Photographs – Photos 25 - 28.

Photo 25 - View of Tree 13 to north. Note overextended scaffold branches indicated by arrows.
