August 17, 2022

Re: Oak Tree Assessment report for Ardmore Road Project, 2930 Union Rd, Paso Robles, CA 93446

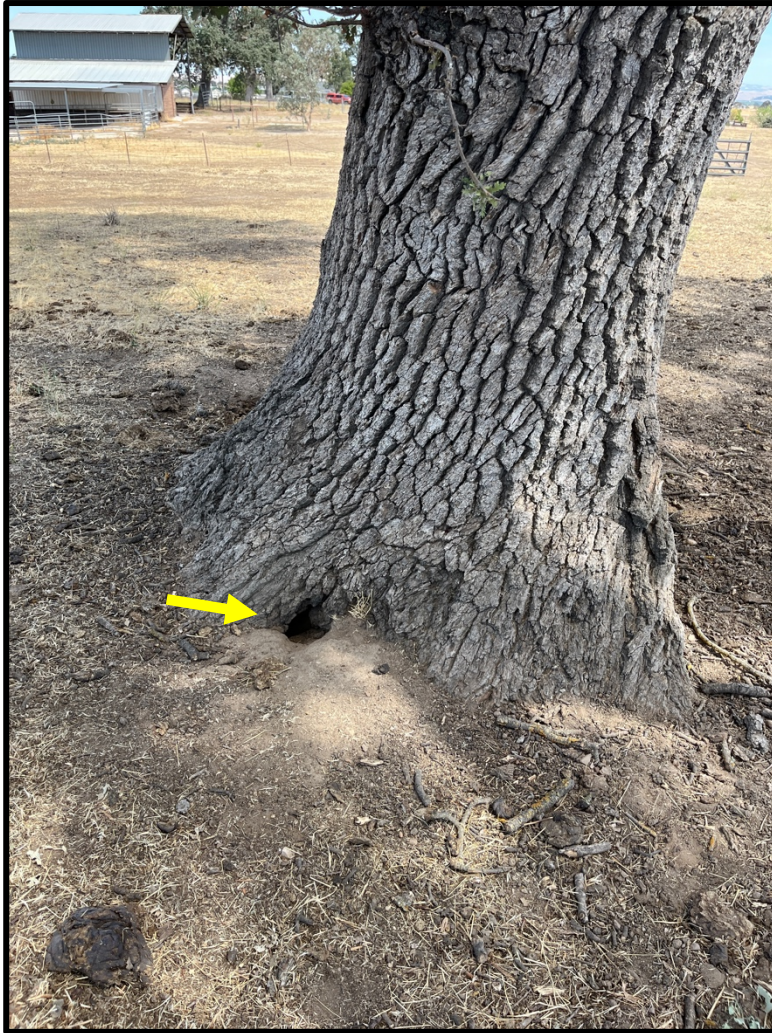
The tree had a full canopy with a balanced form. On the south side of the tree at the root crown, there was an area of decay in the underside of one of the anchor roots. Like trees 1 and 2, the decay is likely caused by *Armillaria mellea*. I also noted the lower trunk was bulging and larger than normal which may indicate butt-rot caused by *A. mellea*. Further, I observed that the eastern scaffold branch was decayed, and large dead wood was present throughout the canopy. See Appendix A - Photographs – Photos 25 - 28.

Photo 26 - Tree 13 with root decay cavity on south side of tree indicated by arrow.

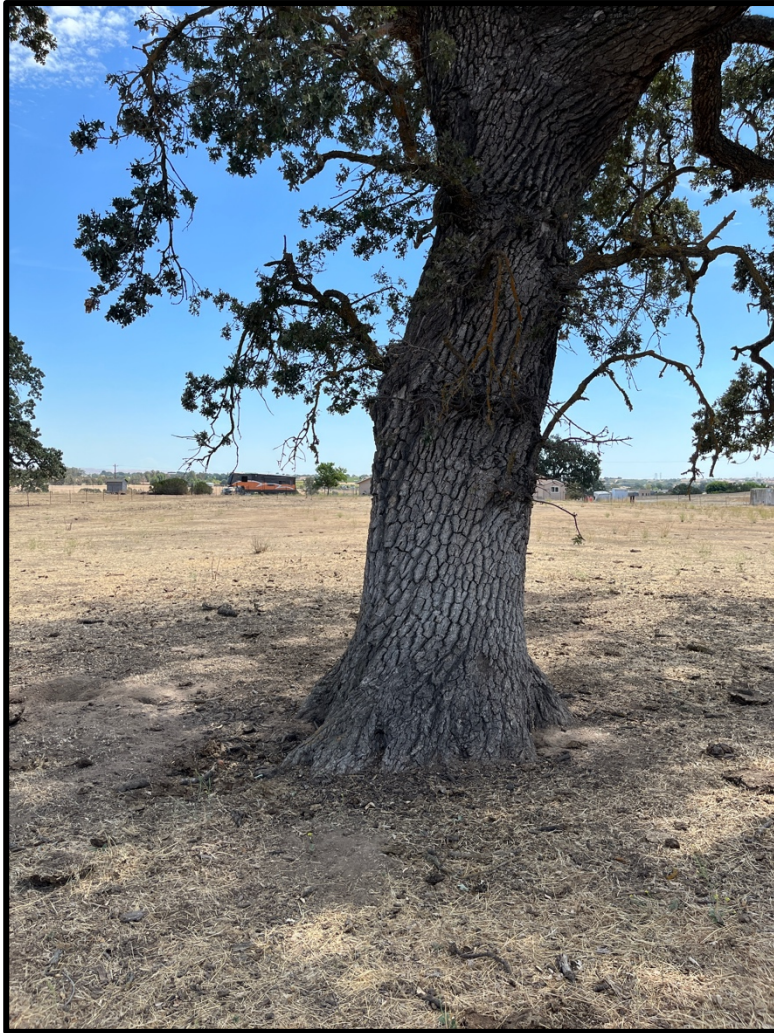
Photo 27 - Tree 13 with bulging root-crown indicating possible butt-rot.

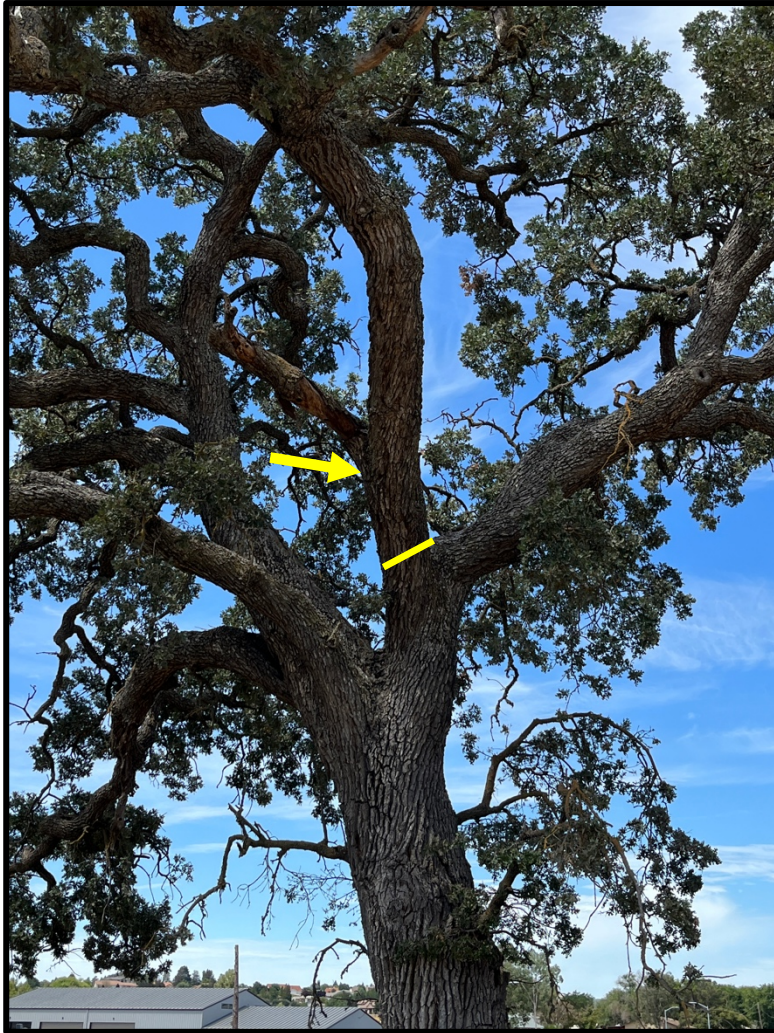
Photo 28- Tree 13 with decaying scaffold branch east side of canopy indicated by arrow. Line indicates locations for removal

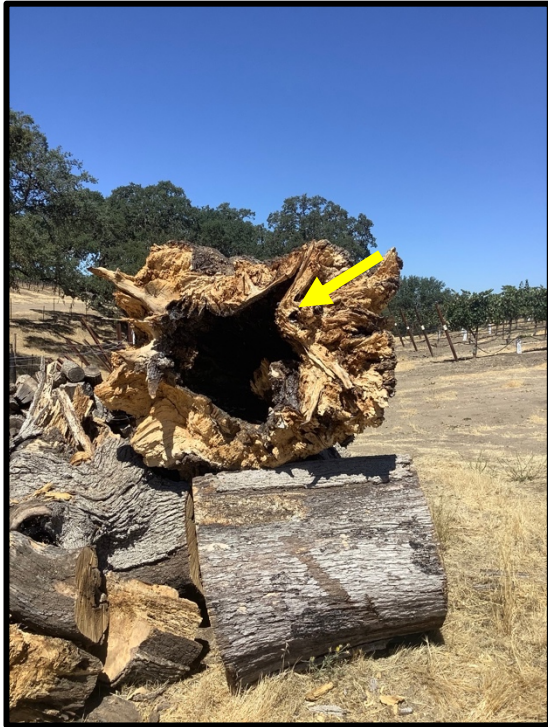
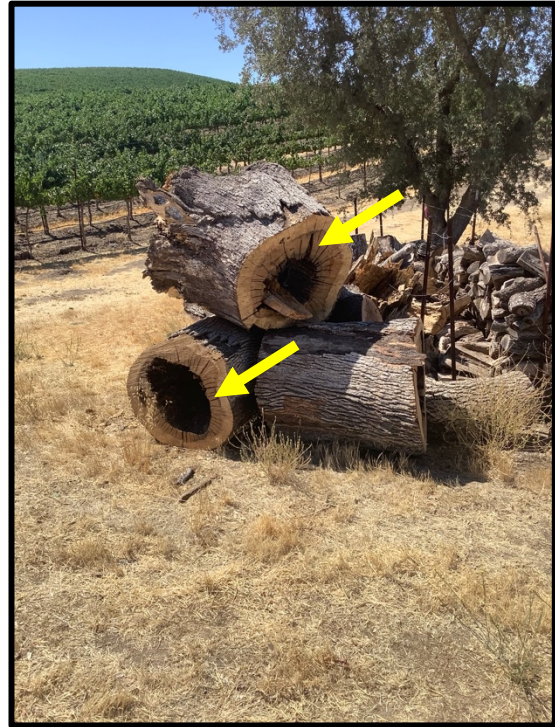
Armillaria mellea, a.k.a. Oak root fungus is a common disease in valley oaks and is likely the cause of the decay in the roots and the trunk. Christopher J. Luley in his guide *Wood Decay Fungi* calls this fungus *Number one of the “Big Three” of the important decay fungi*. Again, according to Mr. Luley, “Armillaria is a root and butt rot fungus that increases the risk of tree failure and is a pathogen capable of killing cambium of roots and lower trunk of stressed trees”. See Appendix A - Photographs - Photos 29 & 30 for example of failed oak due to root and butt rot.

Photos 29 & 30 - Example of oak tree that failed due to root and butt-rot. Photo 29 shows failed roots. Photo 30 shows internal decay of trunk.
