## Oak Tree Impact Report

**Project Location:** 420 Creston Road, Paso Robles,

**Re:** Oak Tree Impact Report in regard to proposed residential development at 420 Creston Road.

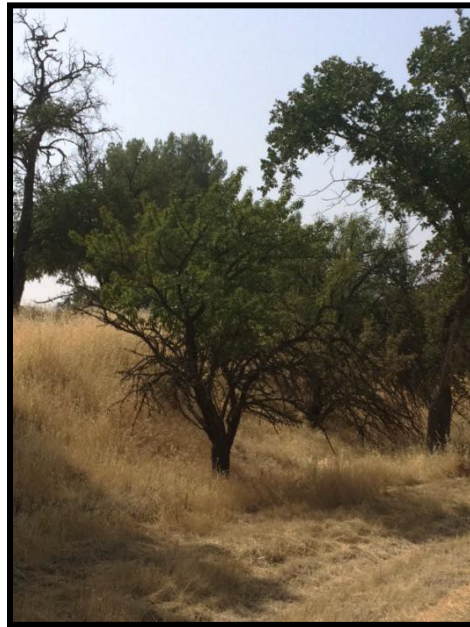
**Photo 16** - Pines

The pines along the eastern border were young and vigorous; however, their potential for red turpentine beetle (*Dendroctonus valens*) infestation is high. Aleppo pines also grow to 60 or more feet tall and are prone to large branch failure. Furthermore, pines are highly flammable. If left in place, the branches of these trees would encroach on buildings, pose failure, and fire hazards.
